Complications Caused by Neighboring and Building Construction in Urban Areas- Three Case Studies

Abolfazl Eslami* and Hasan Moghaddasi

Department of Civil and Environmental Engineering, Amirkabir University of Technology, Iran

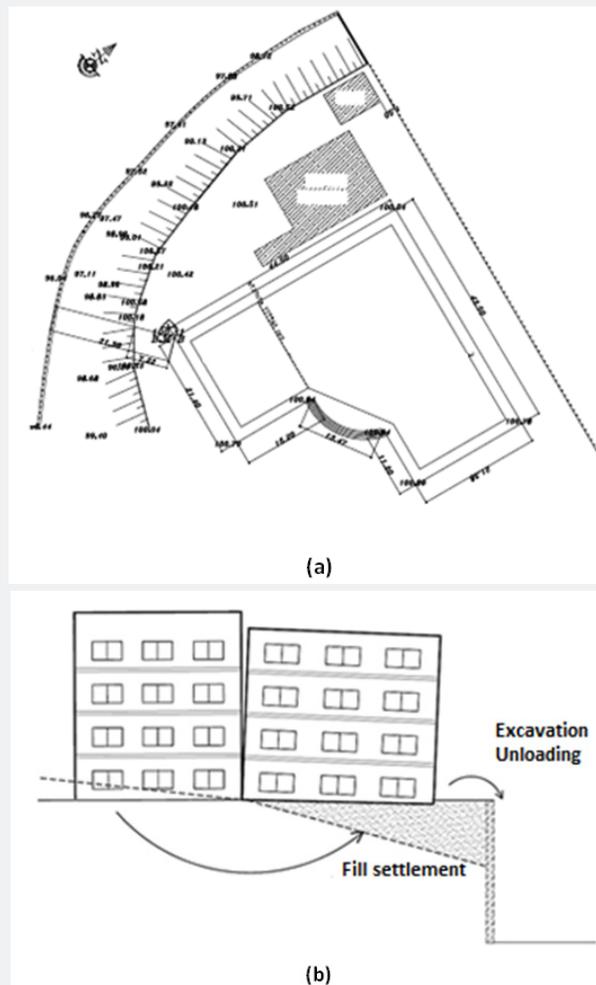
The first case is a 4-story building located in Tehran, Iran [7]. As depicted in Figure 2 the building experienced instability in form of rotation. The damages appeared as internal and external cracks as shown in Figure 3. Observations have shown cracking was more considerable in upper floors, which indicates there have been other factors influencing the rotation apart from land sliding. Therefore, a comprehensive investigation has been carried out to find out the causes of this instability. Overall, three factors were considered to be as the main causes. Firstly, the building was built partly on a fill, which has led to non-uniform settlement and consequently rotation of the building. In addition, in the structural design, the bracing system designed for this building was asymmetric which has caused an additional torsion in the building. Furthermore, the building was adjacent to an excavation, which has caused lateral displacement, and subsequently, rotation of the building.

Figure 2: Case study No. 1, a) Building plan, b) Schematic view of instability.

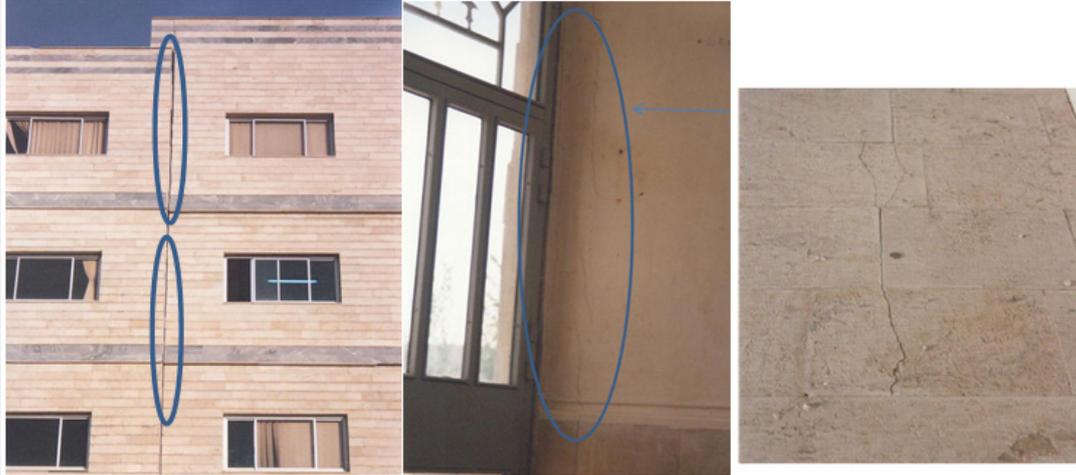
Figure 3: Damages caused by differential settlement (Case study No. 1) [12].

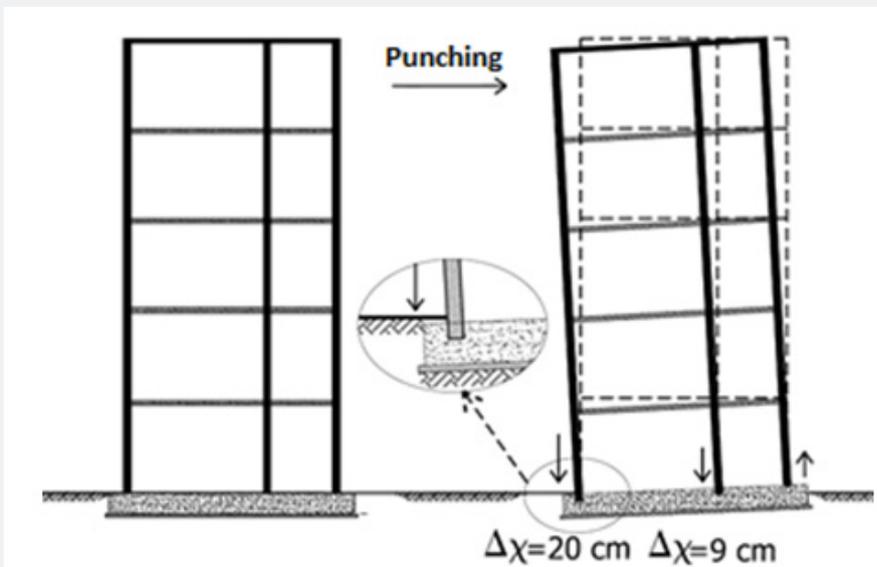
showed that the columns in six parts of the mat foundation has experienced punching shear failure, with the settlement values varying between 5 and 20cm. This differential settlement has caused turning in the building, and subsequently, appearing damages in the appearance Figure 3.

The investigation operations included boring of four test pits (TP1 to TP4) using an auger, depth of which is presented in Table 1 site soil consisted of a non-engineered fill layer with 1m thickness, underlain by a layer of fine clay with low plasticity in brown, which was classified as CL according to the Unified soil classification. Also, an intermittent layer of fine sand was

observed in the depth of 10 to 11m. The SPT number values in the mentioned layer varied between 8 to 11 per 30cm penetration and the groundwater level was at the depth of 2m. Therefore, the site soil did not suffice the applied loads, which could bear the approximate load of a three-story building Figure 4.

Figure 4: Schematic view of instability for Case study No. 2.

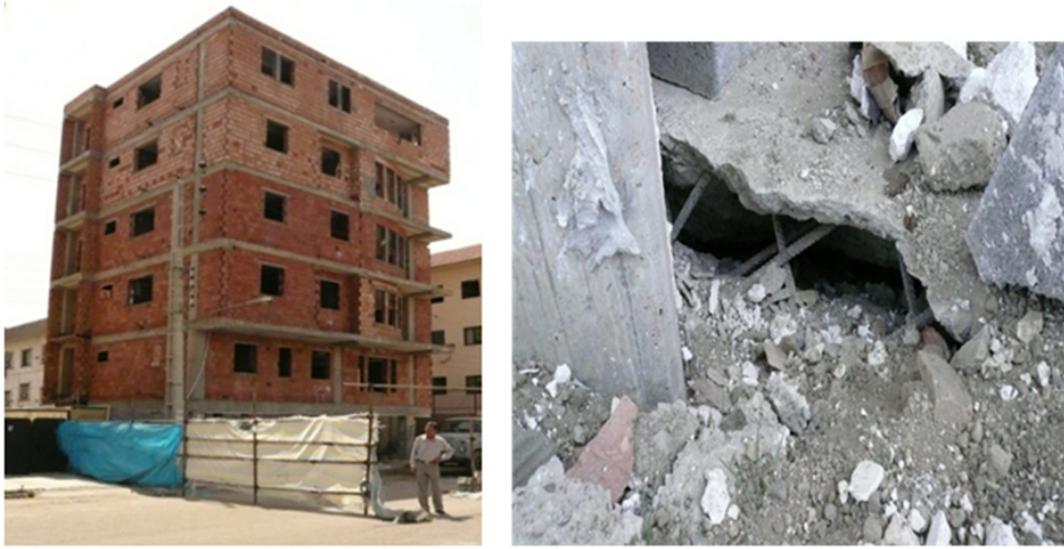
Several factors have caused this instability all of which were related to construction stage:

a) The thickness of the mat foundation was 70cm according to the design, while the thickness of the constructed foundation was 60cm.

b) Eliminating the foundation heel for about 110cm in the northern and southern side, and 20cm in the western side.

c) The compressive strength of the concrete was not sufficient either (89 to 167kg/cm² according to the coring samples instead of 210kg/cm²).

d) Another external cause was considered to be the accumulation of the materials in the west side of the building on various floors which has led to the non-uniform settlement of the building Figure 5&6.

Figure 5: Punching failure of the building columns for Case study No. 2.

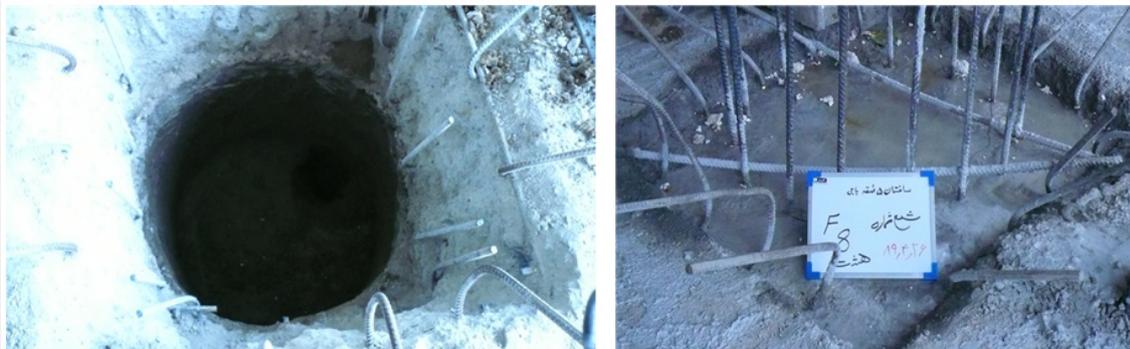
Figure 6: Case Study No. 2: a) construction of semi-deep foundation, b) arrangement of semi-deep foundations on plan

In order to cease the problem, in the first step, the substructure was improved by semi-deep foundations. This measure provided an appropriate support for jacks, and increased the foundation bearing capacity along with preventing the differential settlements and punching failure. It also improved the uplift capacity of the foundation. Then, the building was brought back to its initial condition by jacking. The final step was strengthening the substructure which was

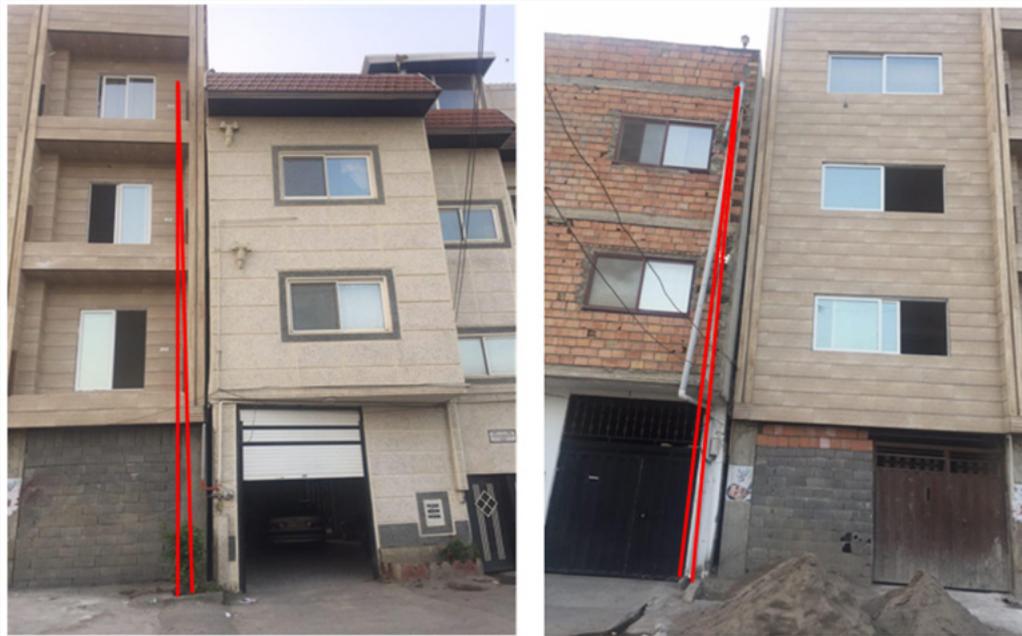
The third case study is about the settlement induced on a building due to the adjacent construction of a new building as shown in Figure 8 [9]. It was located in Mazandaran Province

Figure 8: Case Study No. 3: non-uniform settlement of adjacent buildings caused by the settlement of the new building.

The structure is a residential three-story building, with allocated dead and live loads equal to 700kg/m^2 and 200kg/m^2 , respectively. The initial foundation system was a strip foundation with the total area of 48m^2 and contact stress of approximately 6t/m^2 . The foundation system sufficed the geotechnical criteria against applied loads. However, the construction of the four-story building in the west side of the current building has imposed stress of about 8t/m^2 . Considering the overlap of the stress bulbs, the stress below the existing structure has increased up to 14t/m^2 , which exceeds the allowable bearing capacity of 7t/m^2 .

Because of the clay layer in superficial surfaces, more differential settlement is anticipated as the consolidation occurs with time.

property. In this regard, employing bored piles or micropiles have been proposed in combination with the existing footing so that in addition to increasing the bearing capacity, tensile capacity against seismic loads and decreasing the stresses caused by neighboring, it provides more promising serviceability performance and restricts the settlements.

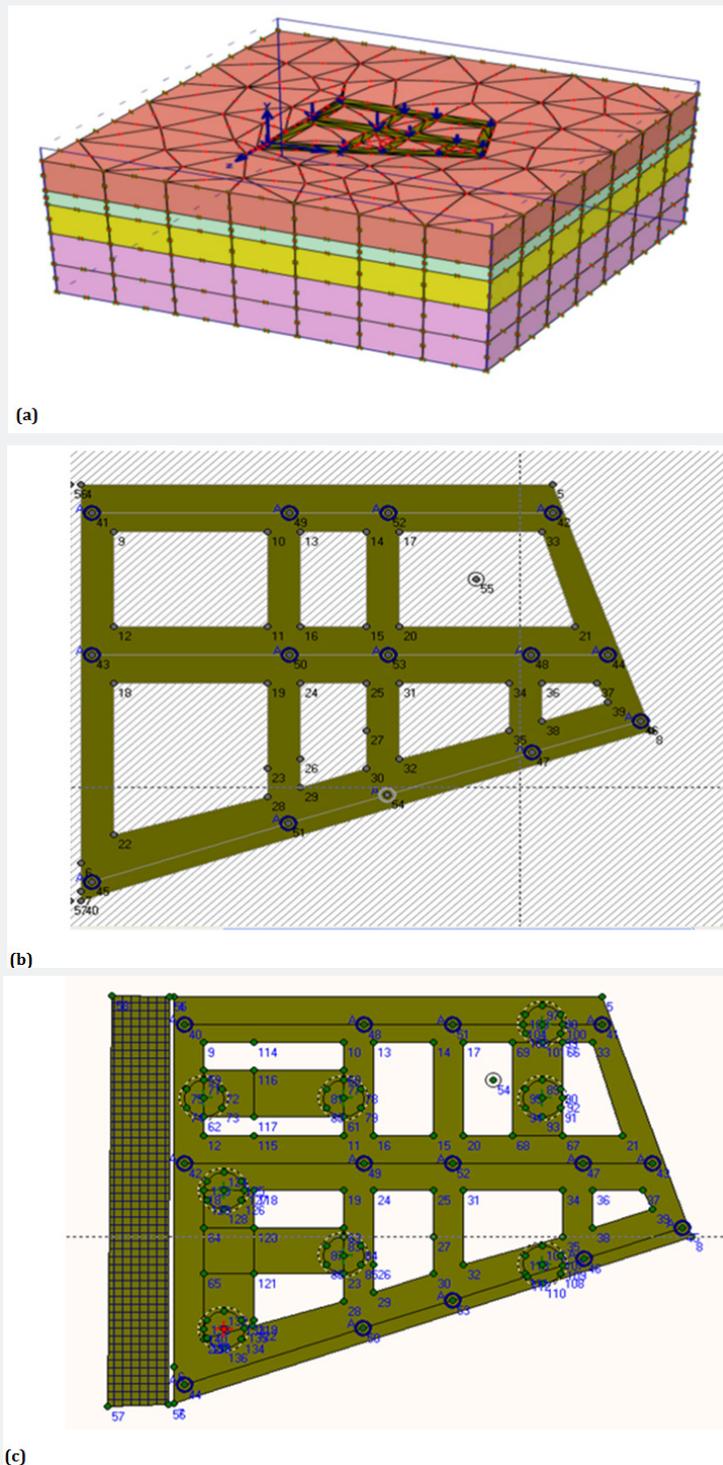
Figure 9 demonstrates the soil layers as well as foundation geometry before and after modifications. As presented, for the enhanced foundation, eight bored piles were added in different parts of the existing foundation.

Figure 9: Case Study No. 3 FEM models:
 (a) Initial foundation, design loads,
 (b) Initial foundation, design loads plus load imposed by adjacent construction,
 (c) Improved foundation, design loads plus load imposed by adjacent construction.

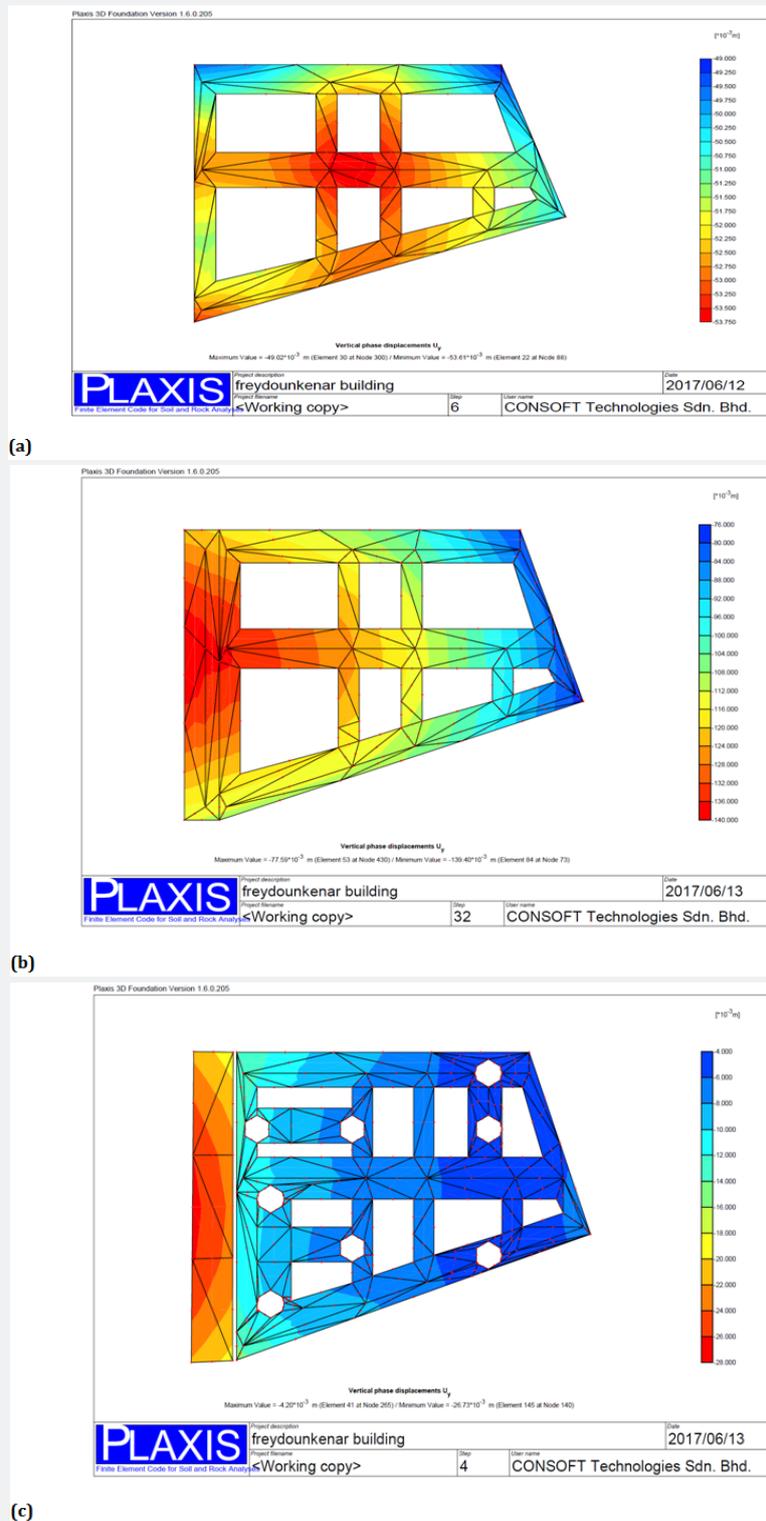
The results of settlement analyses are shown in Figure 10. Figure 10(a-c) are the settlement contours for above-mentioned models 1 to 3, respectively. It can be inferred by the results that the minimum and maximum settlement of the initial foundation was

54mm in center and 49mm in the peripheral area, respectively. The differential settlement is therefore 5mm which is within the allowable range. However, according to Figure 10b, when applying additional load in the west side of the foundation, the

maximum settlement occurs in the west part of the foundation, which equals 140mm. Also, the minimum settlement pertains to the east side of the foundation which is 76mm. Consequently, the differential settlement is 64mm [10].

Figure 10: Case Study No. 3 settlement analyses:
 (a) Initial foundation, design loads,
 (b) Initial foundation, design loads plus load imposed by adjacent construction,
 (c) Improved foundation, design loads plus load imposed by adjacent construction.

For improving the performance of the foundations, eight bored piles were considered with the embedment length and diameter of 11m and 1000mm, respectively. According to Figure 10c, employing additional piles results in significant decrease in the values of settlement, subsequently, providing safe performance.
