# Rocks Fall in the Cape Aokas (Bsjaia): Geological Study Contribution and Reinforcement of the Rocky Slope

The Cape Aokas situated in the oriental coastal region of Béjaïa city (Algeria). The cape takes its origin from the babor mountain chain to the Mediterranean Sea along the Aokas city. Its relief is characterized by abrupt slopes. On May 9th, 2005 rocks fall in large mass (20,000 to 30,000m<sup>3</sup>) from one of the walls constituting the cape, blocked traffic on a busy road (RN° 9) at the entrance of Aokas city. The excavation work of fallen rocks was quickly undertaken by the authorities: 23 days after the rock fall, the road was reopened to traffic. The topometric monitoring was implemented between April and September 2014 during the summer. The reflection was started to find the best way to strength permanently the rocky slope. In this paper, we present a comparison between the stabilizing system applied to the rocky slope and an optimization proposal in both following cases: without earthquake and under reference earthquake solicitation.

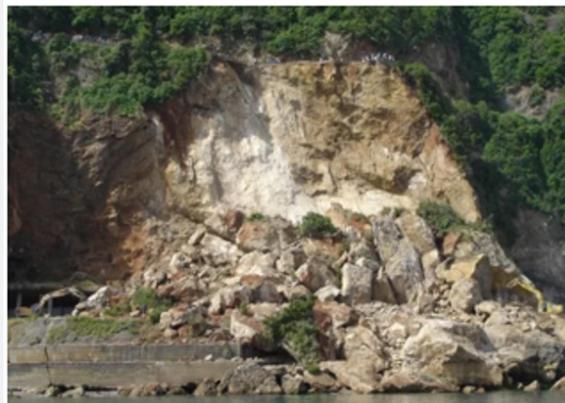
A spectacular cliff rock fall occurred on May 9th, 2005 covered the roadway of National Road N° 9 on a about 150m linear (Figure 1), at the entrance to the Aokas town (Figure 2). These rocks fall, preceded by several rocks, have not made a victim. The traffic on this busy road, the only way of communication between neighboring districts: Jijel and Béjaïa (about 20,000 vehicles/day) was completely blocked for three weeks, isolating the Aokas city. The old national road, located 60m beneath the modern one, was completely destroyed and constraining residents to a long

**Figure 1:** Global view of the cliff rock fall on the NR 9 at the western entrance of Aokas.

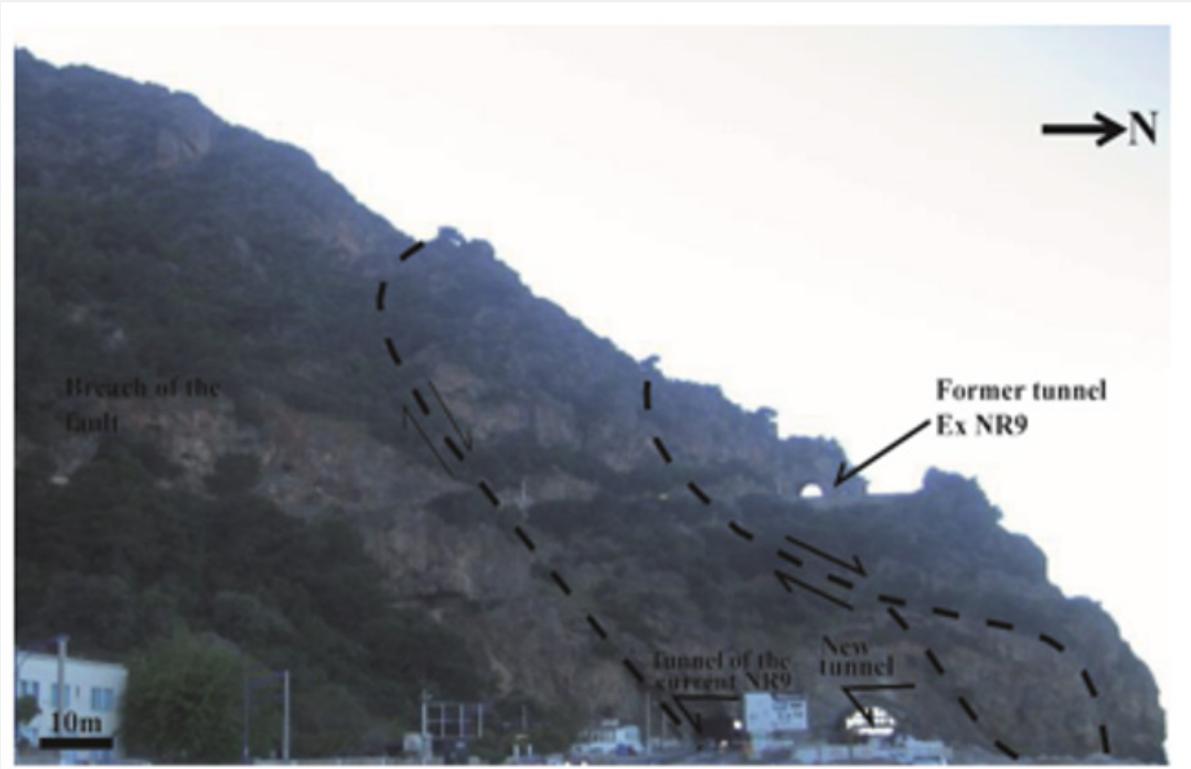
Figure 4: Cutting of the rock massif by normal faults connected to the first family.

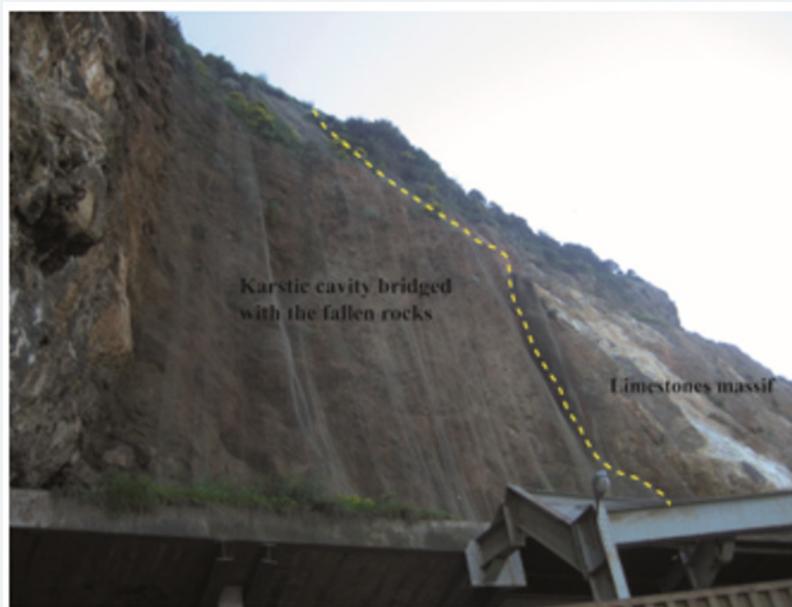
Figure 10: Breaking surface (S) cleared by the rock fall in the calcareous slope and destabilization of the fallen rocks of karstic cavity.

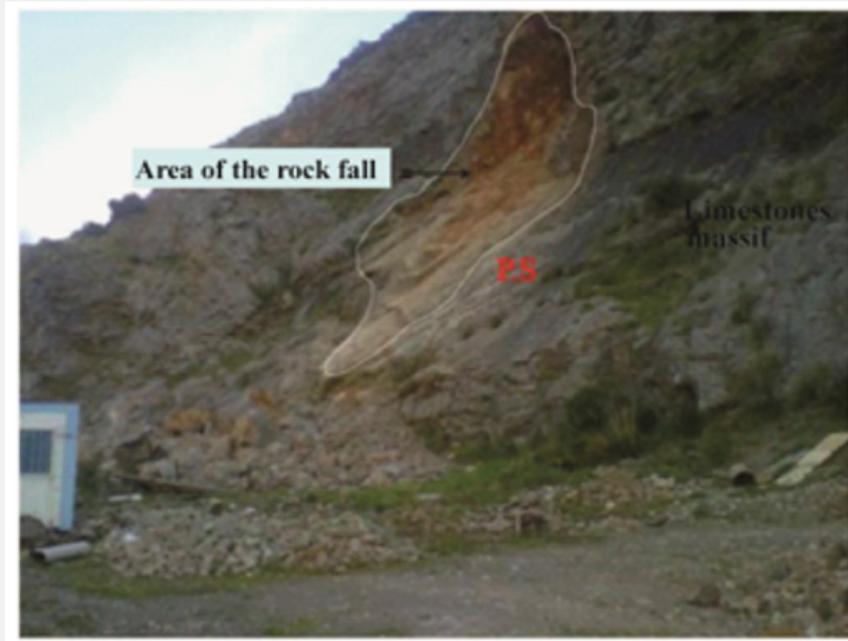
On April 2014, a rock fall of about 100m<sup>3</sup> is occurred in the Cape Aokas calcareous massif at the level of the former career front (Figure 11), upstream the former NR 9 and in 1, 1km to the rock fall area of May 2005. The plan cleared by this rock fall corresponds to stratification plan (PS), of direction included

Figure 11: Rock falls at the former career front in Aokas area.

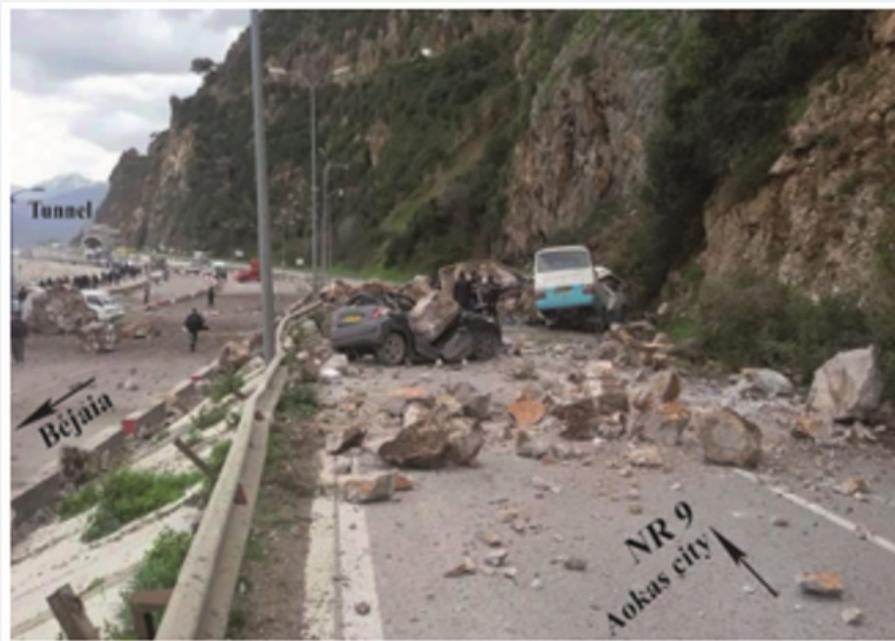
between N050 °E and N060 °E with a downstream dip of 70°. Recently, in February 2015, seven persons were killed, and 20 others injured by a rocks fall near the Cape Aokas tunnel (500m of the head West, Tala Khaled) in Pk 26 of the NR 9 at the East of Béjaïa (Figure 12).

Figure 12: Damages caused by the rocks fall of February, 2015.

The rocks fall is occurred in outside period of frost after an episode of moderated precipitation between February 14th and February 21st, 2015 (36mm to Béjaïa, Station of Béjaïa-Airport). Since the beginning of 2015, the North of Algeria knew a moderate seismic activity, Especially the Western and the Southern of Algiers. No earthquake of magnitude superior then 3 was registered in the region of Béjaïa.

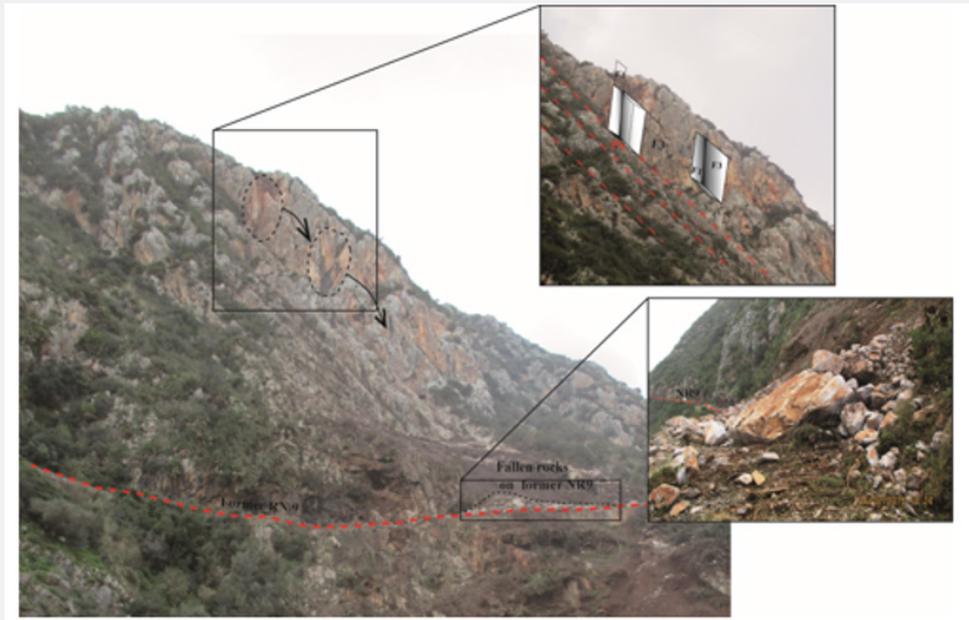
fall corresponded to the detachment of two dihedral unitarian volume esteemed between 3 and 5 m<sup>3</sup> from a rocky bar, at a height of 160m of the current road (Figure 13). These two dihedrals have provoked the fall and the other blocks detachment of different volumes in the versant unstable equilibrium. The observations and the made measures show that both collapsed compartments were bounded by three plans. The first two correspond to both fractures families (F1 and F3) and the third plan corresponds to the stratification plan, a direction between N050 °E and N060 °E with an unfavorable downstream dip of 70°.

Figure 13: Panoramic photos of dihedrals detached and fallen rocks in the former NR9.

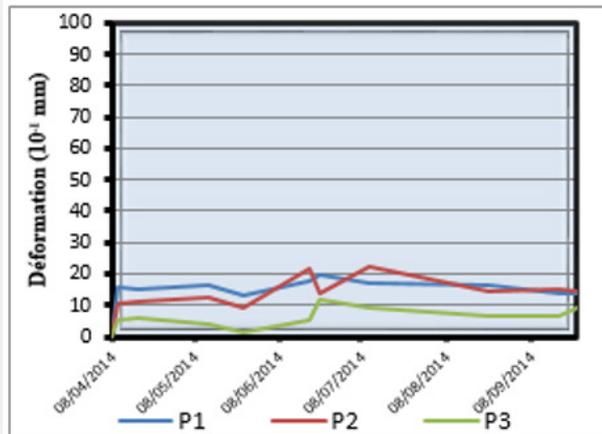
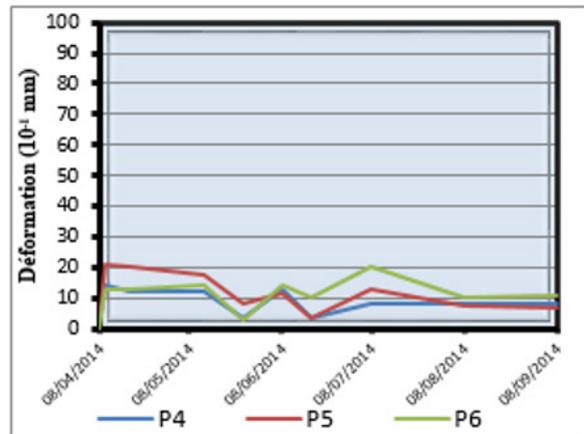
Figure 14: Total results of the measures displacements.

- i. Until June 2014, the measures displacements remained lower than 2mm.
- ii. During the summer period, characterized by an important tourist activity and very dense road traffic on the NR9, the displacements measures varied between 0, 5mm and 2, 3mm.
- iii. Since the beginning of august, 2014, no deformation

The total displacements measured remained lower than 2, 5mm, thus lower to the uncertainty of measure.

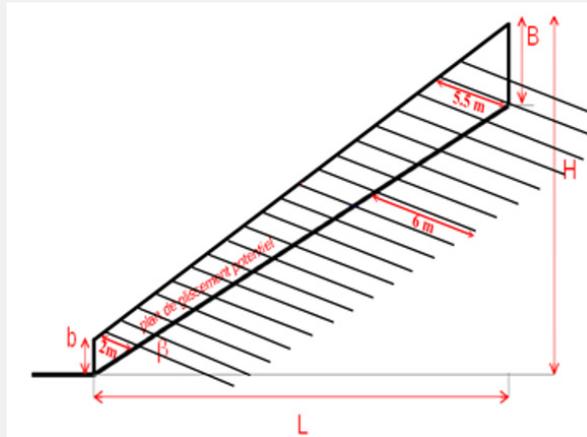
Figure 16: Passive realized nailing.

The realized strengthening System is consisted of steel bars with an equal diameter of 20mm and elastic limit equal to 950MPa, setting place in drillings of an equal diameter of 90mm and tilted by 20° with regard to the horizontal, with an average

square stitch of 0, 71m x 0, 71m (Figure 16). The length of sealed bars at the back of potential sliding plan (F1) (Figure 8) is fixed to 6m on the other hand the total length of bars is determined according to their position in the slope. It varies between 8 m and 11, 5m (Figure 17).

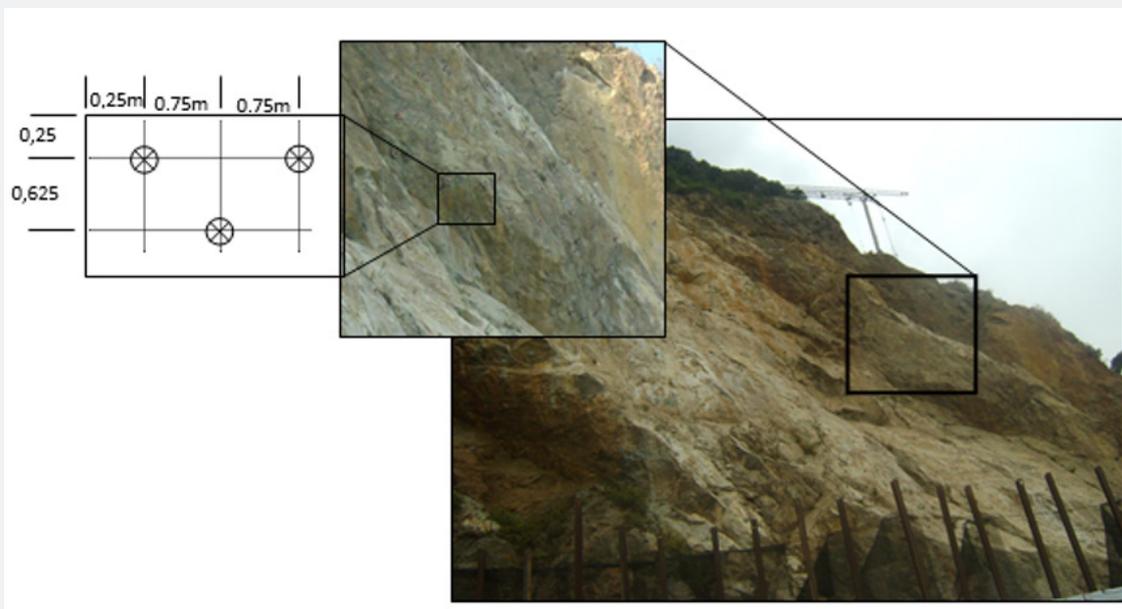
Figure 17: Reinforcement by Nailing realized in the slope cleared by the rock fall of May, 2005.

The reinforcement, thus validated by the contracting authority, is widely oversized with safety factors equal in:

The reinforcement rests on small diameter bars (without consideration the reduction bound to the corrosion), in steel very stiff and according to a small dimensions square stitch, induced an intense cutting of the rock massif. The remainder of article presents a possible optimization of the nailing.

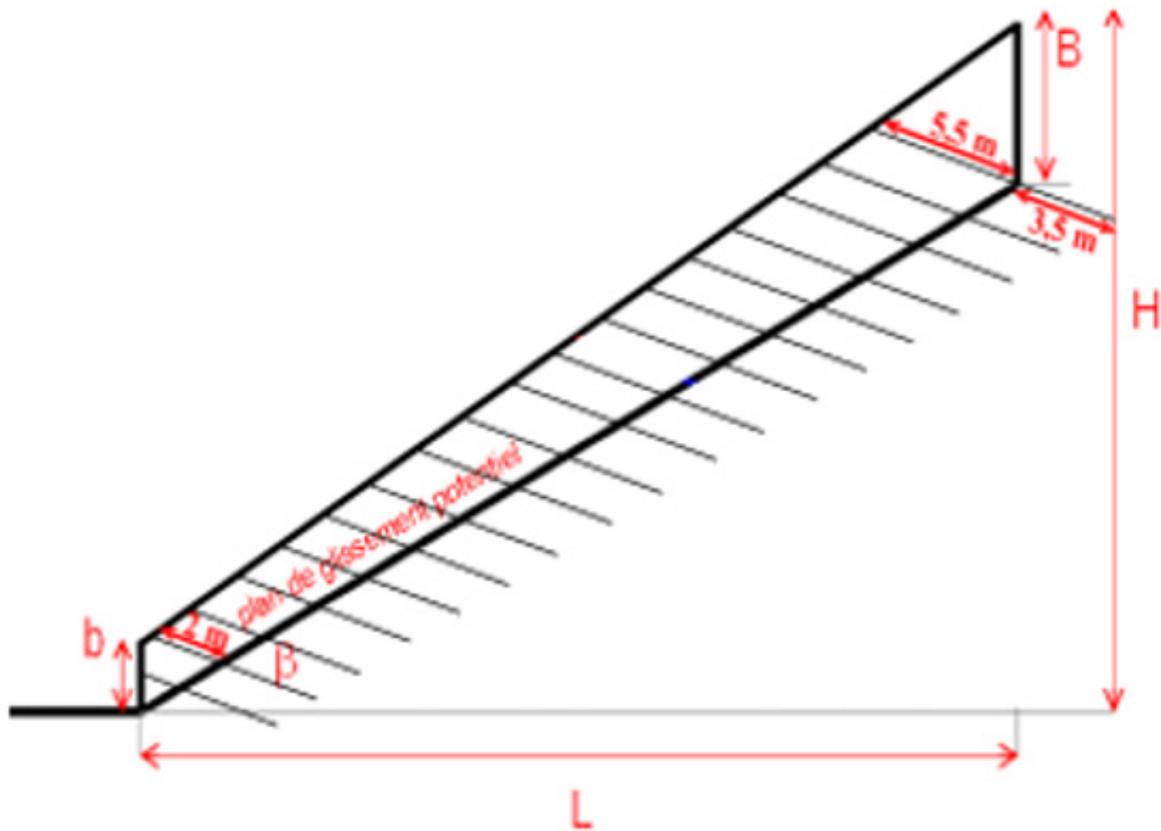
Figure 18: Optimized passive nailing.

The bars implementation an equal diameter of 50mm (with a reduction of 8mm in diameter among 100 years due to the corrosion) and of elastic limit equal to 500MPa, with an average square stitch of 2,04m x 2,04m, allows to result in equal safety coefficient in:

The length of sealed bars in the back of the potential plan sliding (F1) (Figure 8) will be at least 3, 5m at the back of the unstable potentially plan (F1). The bars total length is determined according to their position in the slope. It is between 5m and 9m (Figure 18).
