Effects of Overused Top-hammer Drilling Bits

Seunghyuk Hwang¹ and Hyongdo Jang^{2*}

Abstract

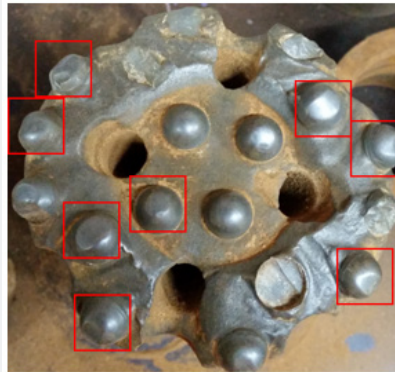
Drill bit failure is governed by various conditions. The influencing factors of the bit failure can be broadly classified into manufactures, end users, and rock types. Especially, rock properties must be clearly understood to evaluate the performance of drilling and the wear of drilling tools as the rock tool wear is significantly dependent upon the rock type [4]. The hard rock consists with high silica and quartzite generates extremely high pressures that increased the chance of the bit button removal rate, regional failures, and crushes of the tungsten carbide (WC/Co) bit surfaces [5]. Another critical factor to drill bit failures is the overusing. The mining industry often refers it to 'overboard' which is an industrial terminology of overused bits. Industry classifies overboard bits if the diameter of the flat face of the bit button is larger than one-third of the original button diameter. Figure 1 is an example of an overboard ST68-102mm drill bit from MMTC (Mitsubishi Material Trading Corporation) shows flat worn tungsten carbide

buttons. The overboard bit tends to cause cracked buttons which leads to tremendous adverse effects on the tool efficiency and triggering drill hole deviations. In other words, the rate of button damage increases when a bit is overused. Furthermore, the overboard bit significantly drops the penetration rate. When a wear flat of a button is equivalent to one-third of the button diameter, the penetration rate will be dropped by 5%. Further use of the overboard bit to two third of the wear flat will drop its penetration rate by 30% [6]. A common industrial practice to extend the

Figure 1: Example of an Overboard Drill bit Having Flat Worn Carbides Indicated in Red Squares (ST68-102mm Drill Bits from Mitsubishi Materials Trading Corporation, Kalgoorlie, WA, Australia).

drill bit service life is the bit button grinding. The industrial rule of thumb suggests having around 10 times of bit button grinding for the bit sizes around 100 mm. Furthermore, the performance of the entire drilling operation can be significantly enhanced by proper bit button grindings. The grinding of bit buttons naturally causes the tungsten carbide material loss [5]. However, the ideal shape of the button by removing sources of stress concentration should be consistently maintained to protect the WC/Co buttons from catastrophic fractures.

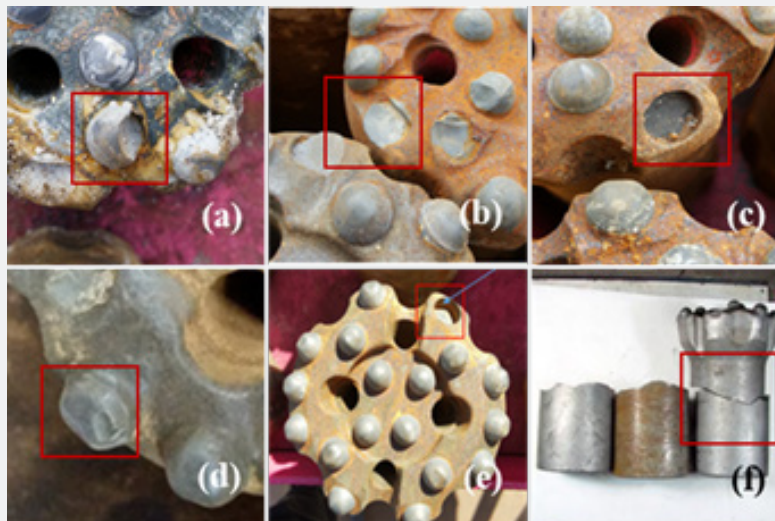
Figure 2: Common Carbide Button Bits Failure Modes.

- a) Button chipped.
- b) Button sheared-off with body level.
- c) Button sheared-off below body level.
- d) Cracked carbide.
- e) Lost button.
- f) Failure at Skirt.

The main reason for the button chipped (BC) failure is the overboard. If a bit is overused, the overboard causes to create micro-fractures on the WC/Co buttons that are likely developed to further cracks. Figure 2 (a) shows a typical primary breakage on top of the WC/Co button. In excessive condition, trailing edges with more than two chipping progress on the same button crossing through the bottom line of the button. Prior to the button chipped via brittle fracture, the WC/Co undergoes a plastic deformation at an overused carbide component with high-stress concentrations [7]. The button chipped failure can be prevented with a regular inspection of bits to grind the wounded WC/Co surface to remove micro-cracks if necessary. The button chipping phenomenon can also be reduced using a bit with a softer grade WC/Co or increasing rotation speed while drilling [8].

The failure mode button sheared-off with body level (SOW) usually shows a clear flat sheared surface on a button as shown in Figure 2 (b). This failure normally left trailing edges and mainly occurred due to the overuse of bits with poor operational skills. The WC/Co button is often sheared off when encountered with unexpected metallic materials (i.e., rock bolts or cable bolts) during the operation. The failure mode sheared-off button below body level (SOB) has similar features with the SOW failure mode as shown in Figure 2 (c). The failure mode can occur due to the incorrect size correlation between a button and a button-hole which can be acknowledged as a manufacturing error. The main causative factor of cracked tungsten carbide (CC) failure in Figure 2 (d) is the bit overusing. As the fracturing progressions to the BC failure, the bit overusing generally creates micro fractures in WC/Co and weakens the WC/Co material. Visible cracks arise from these micro fractures after excessive use of bits and a fine abrasion mechanism is generated. After the material resistance to thermal fatigue is exceeded, small cracks start to grow through the cobalt phase into the tungsten phase. WC/Co grains start to get fragmented into debris and create material. The reptile skin pattern becomes visible once WC/Co starts to fracture and rock debris is pressed into cracks. Subsequently, entire WC/Co grains will be removed by abrasion, which also affects the cobalt phase as well [9]. The lost buttons (LB) failure mode (Figure 2 (e)) rarely occurs as the failure is not caused by the mechanical impacts during the drilling operation. The main cause of the failure mode

is the free hammering of the bit in the air. The free hammering generates massive dynamic shock impacts that propagate back and heat up all steel parts of a drill rig. Especially when a bit is free hammered in a borehole, the probability of the failure of gauge buttons is increased as they are easily impacted by the borehole wall. Another main cause of the lost button's failure is improper soldering of the buttons in a bit base steel which can be considered as a manufacturing error [10].

The failure at skirt (FS) mode seldom occurs during the drilling operation which is mainly caused when a bit is excessively used in extraordinary situations. For instance, if an excessive rotational speed is applied, a stuck bit gets heated along the thread inside the steel body which can cause the skirt failure. In addition, incorrect collaring practices could be another reason but material fatigue from excessive hammering is the most common cause of the failure. On the other hand, material failure could be acknowledged as a manufacturing error [10]. In the majority bit failure modes, the regular bit inspection is the most effective method to reduce bit failures. Through the regular inspection, proper grinding intervals of the bit for the given geological condition can be determined to prevent possible bit failures and productivity loss.
