The Use of Bored Injection Piles ERT in the Liquidation of an Emergency Situation of the Building

Sokolov NS^{1*}

Department of Civil Engineering of the Chuvash State University, Russia

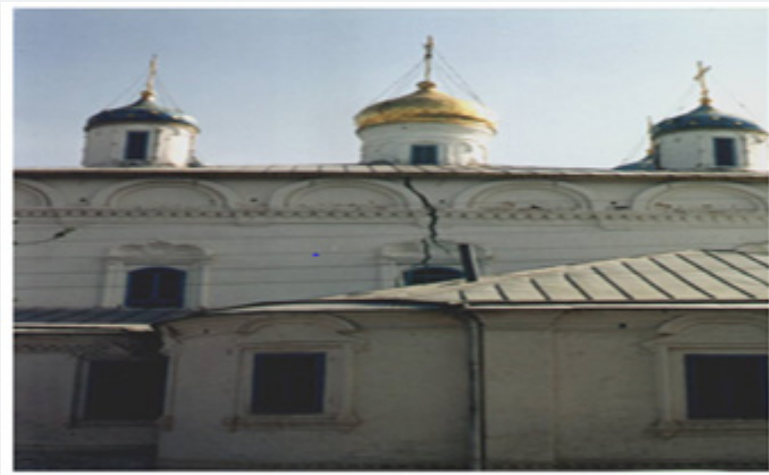
So, in 2004, in April, vertical cracks of a deformation nature appeared on the outer walls of the building of the Cheboksary Vvedensky Cathedral (Figure 1). The first defects appeared at the level of the attic on the walls of the northern and southern parts of the Cathedral, i.e., the building of the temple split into two parts. The crack opening rate reached 10÷15 mm/day. An emergency was created, which led to its possible collapse. The promptly created extraordinary commission ascertained the cause of the accidental deformations of the Cathedral and the influence of the construction of the building of the residence of the Bishop of Cheboksary and the Chuvash diocese from the side of the altar at a close distance from the temple. The construction of a two-storey brick building on strip foundations with prefabricated hollow-core floor slabs began in the autumn of 2003.

period of 2003-2004. Thus, the deformation of the Cathedral began just at the time of thawing of the foundation. The commission found that, most likely, the building of the Cathedral was set in motion because of the process of squeezing soil from under the soles of the foundations. The following activities were promptly organized: geotechnical monitoring of crack development (Figure 2); inspection of the technical condition of the emergency building, in order to identify the residual bearing capacity, as well as engineering and geological surveys. The construction of the Vvedensky Cathedral (1651) is a brick building, with dimensions in the plan of 37.4×35.3 m (Figure 1). It consists of the main part-a temple with a height of 13m with an apse up to 4.5 m high, three chapels with apses. The height of the aisles is 4.2 - 4.5 meters. The apse consists of semicircular protrusions, covered with a vault and oriented to the east. The foundations of the Cathedral are shallow - striped rubble on lime mortar. Depth 2.0 - 2.4 m. One of the points of emergency response measures is the development of a working project for strengthening the foundation of the foundations.

Figure 1: Crack above the window opening of the temple (northern facade).

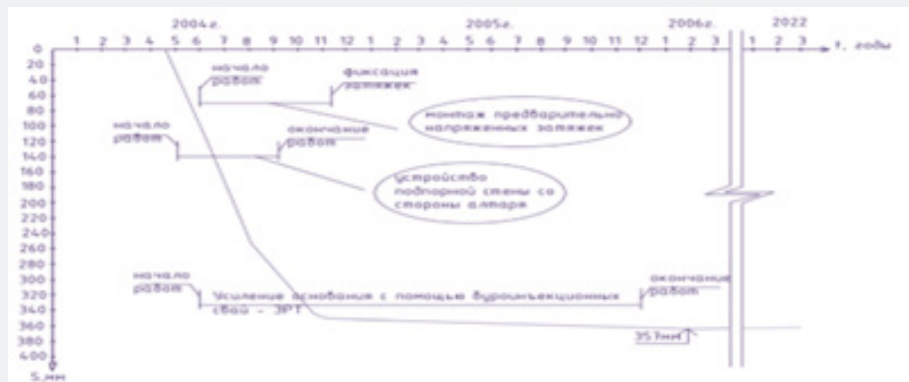
Figure 2: The graph of the expansion of the deformation crack at the level of the cornice of the wall of the northern facade (lighthouse 1).

The rate of crack development was established in the range of 10÷15 mm/day. An urgently created emergency commission for the development of emergency measures to save the historical and cultural monument of federal significance established that

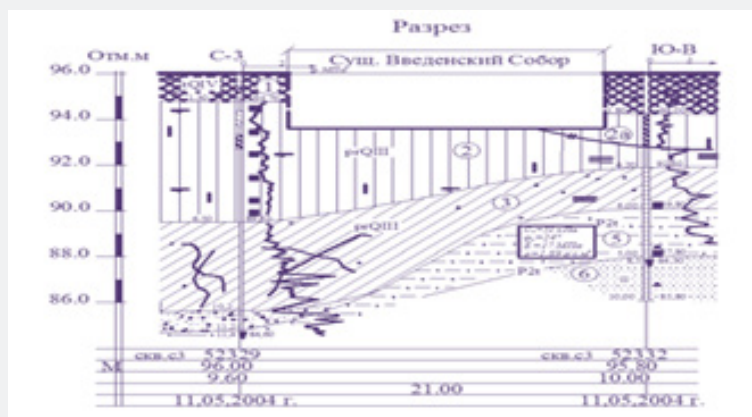
Analyzing the results of engineering and geological surveys, it can be concluded that the physical and mechanical properties of the base soils have deteriorated. Particular attention should be paid to the low value of the modulus of total deformation $E_0 = 2.1$ MPa, for layer 2a - loess loam soft-flow consistency (s). By the decision of the extraordinary commission for the development

Figure 3: Engineering-geological section.
