Research Article

Unusual Puncture Marks on Poly Vinyl Tubing – A Case Study

Ramakrishnan PN*

Department of Physics, Directorate of Forensic Science, India

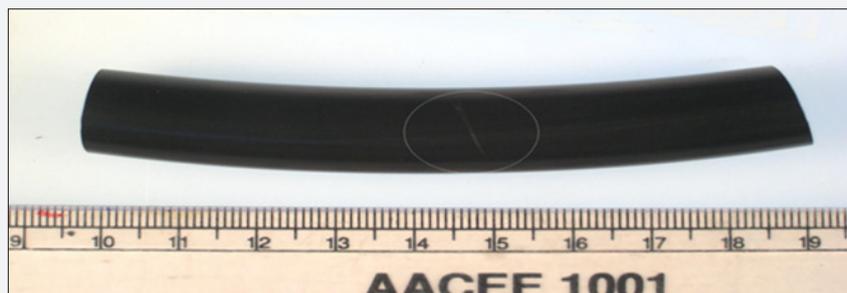
Figure 4 : a: Thin end sharp blade surgical knife (reverse), b: Thin end sharp blade surgical knife (Obverse).

iii. The Figure 4 is the photograph showing the black colour, 1.7mm thickness and 12mm diameter cylindrical polyvinyl tubing having the suspected puncture marks/damaged.

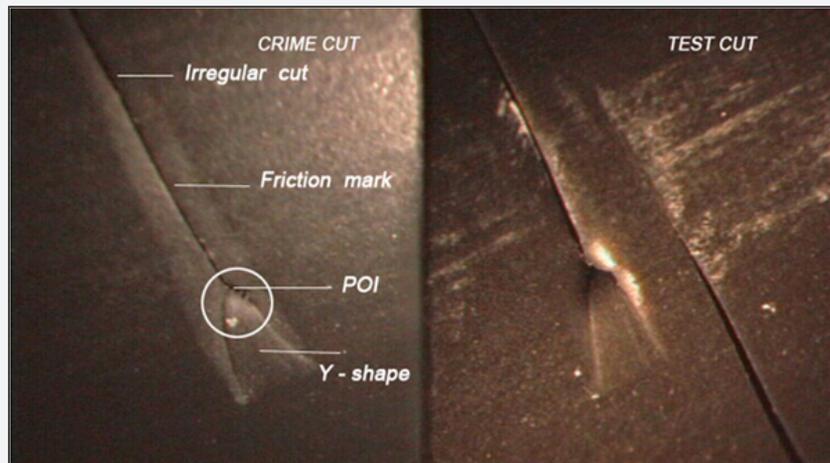
Figure 6 : Crime cut & Test cut with knife-1.

i. The test cut marks made on the P.V. tubing was compared with the suspected cut mark using the Leica comparison microscope. The external view of the puncture made by the knife (Figure 1) depicts several characteristic

features as shown in the Figure 6. In this figure the most obvious characteristic is the friction mark left by the knife blade [1-6]. This friction mark will reflect the general shape and size of the knife's blade portion. This is usually caused by the P.V. material gripping the surface of the knife blade as it enters the tubing. This is the evidence worth looking for in a puncture. It can provide certain clues to link the type of knife used to make the puncture. From the Figure 6 the Point of Insertion (POI) can be identified as the characteristic unusual feature of puncture mark.

ii. The tear mark in POI is the characteristic of a single edge blade knife with blade thickness of approximately 1-3mm. It has characteristic shape of "snake's tongue or Y". This is caused by the back of the knife tearing the P.V. tube apart as the knife is inserted [1]. This is the point which is having the forensic relevance in determining and forming an opinion that the questioned knife submitted could have made the tube puncture based on the microscopic observation [2] of the punctures.

v. The comparison made between the puncture marks made by the above said three knives, whose close-up blade edge view is given in Figure 9, on the P.V. tubing showed the difference in puncture made by each knife. The comparison made showed that the knife in the Figure 1 had caused the puncture mark on the tubing shown in the figure-4 and its comparison shown in the Figure 6.

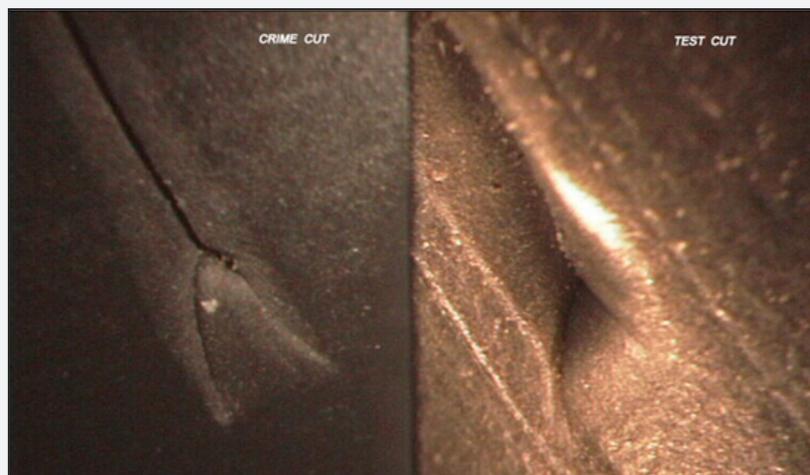
Figure 7 : Crime cut & Test cut knife-2.

iii. The Figure 7 shows photomicrography of the puncture marks formed by a relatively thin blade of the broken knife (Figure 2) with serrated single edge blade. The cutting edge is serrated the full length of the blade to the choil. The external view of the cut shown in the Figure 7 gives the friction mark present and POI. Even though this is a single edge blade knife the “snake’s tongue-Y” is having a characteristics difference from that of the “Y” in the Figure 6.
