## Mini Review

# Phenomenon of initial brittle crack in high cycle fatigue

**M. Sc. Dzubiella-Fett Laura, THM Mr. Pfeil, Lothar THM, Mr. Moritz Rädels and THM Prof. Dr.-Ing. Jörg Gollnick\***

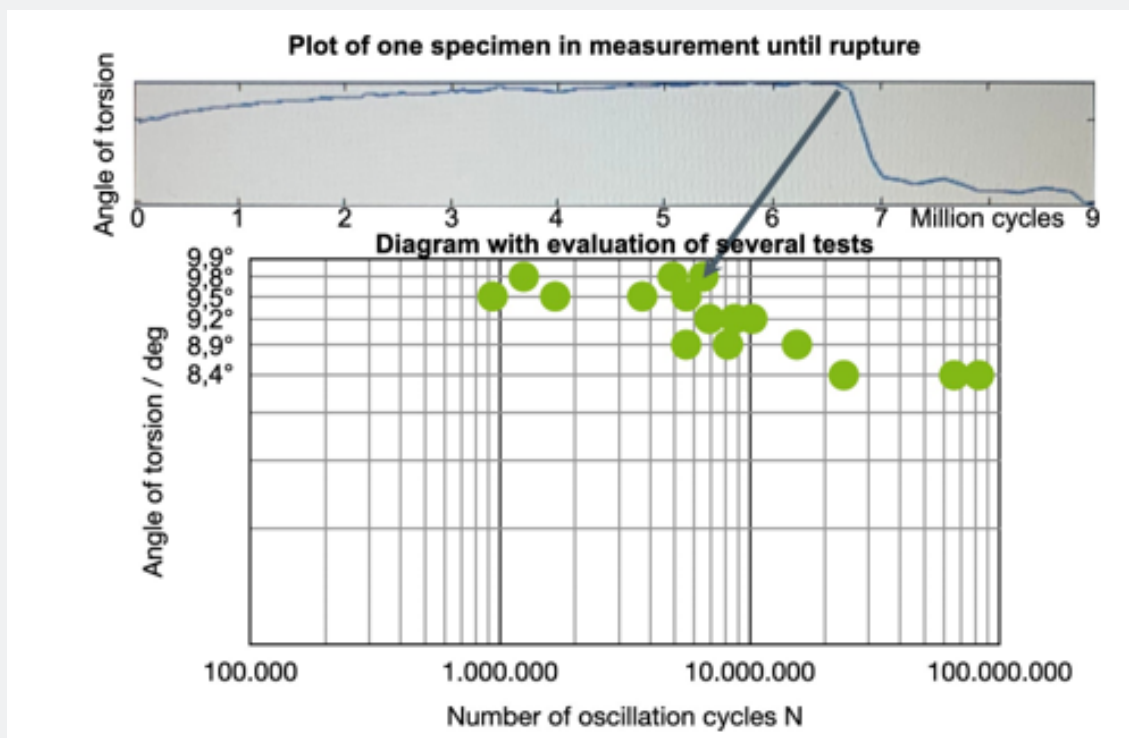
Numerous tests show a clear correlation between the height of the load (angle) and the lifetime until crack initiation. A typical measurement shows, that the angle suddenly reduces significantly, Figure 2. This can be explained, by a loss of stiffness due to the crack initiation.

Figure 2: Measurement of cycles until crack initiation with constant oscillation angle.

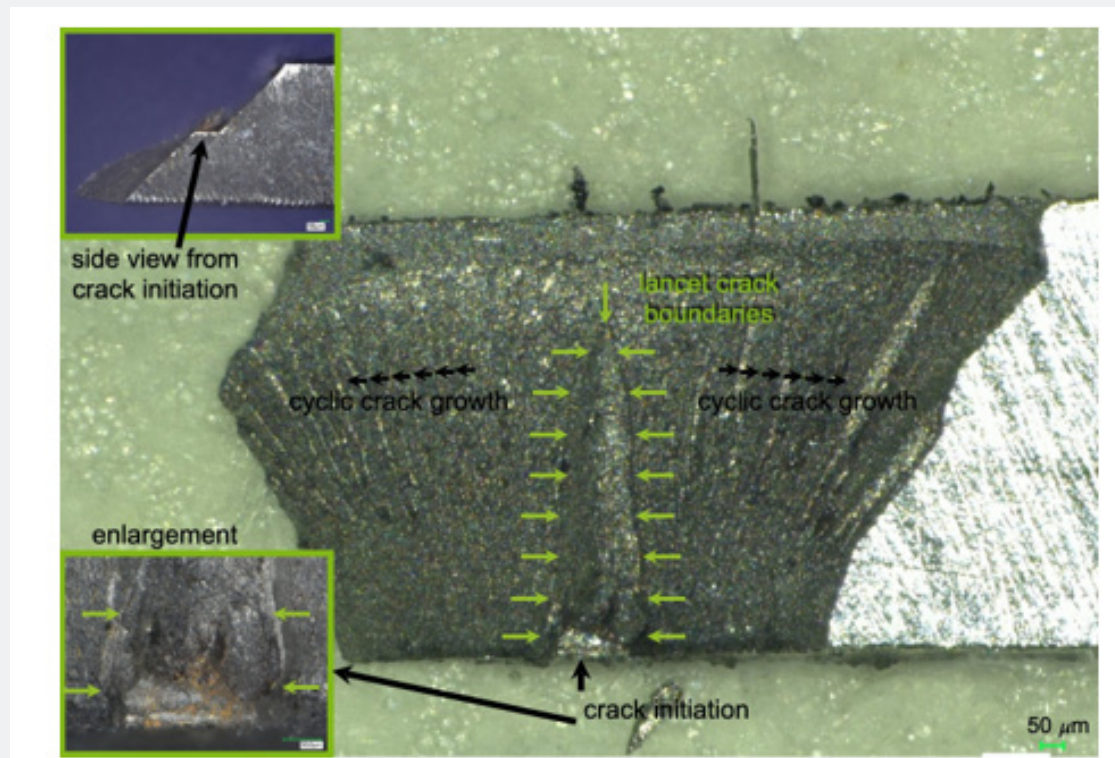
It is to mention, that crack occurs spontaneous and in full length, showing a lancet geometry. The bar is not yet broken. After the spontaneous crack, the cyclic crack growth starts. This spontaneous crack behavior has never occurred before in experiments to determine durability of a component. Neither, this cracking procedure is in accordance to the typical crack initiation and crack growth mechanisms, described in literature [1].

**Figure 3:** Microscopy shows the geometry of the initial crack.

The spontaneous crack is showing a lancet geometry regarding the boundaries of the crack plane. For this spontaneous crack, typically a hydrostatic stress state, according to Griffith's theory of brittle cracks, is to be expected. A small crack initiation at the surface is required to confirm this theory. At the crack initiation point, a small crack surface can be seen.

The crack plane is located in the center of the plate. It is precisely horizontal. This can be seen in the side view. It is to be assumed, that the crack starts from the side walls, visualized in the enlargement. Crack stop can be assumed to synchronize with sudden breakdown of the actual stress state at the crack boundaries. This is caused by the high-frequent oscillation and the loss in stiffness. Adjacent to the crack plane boundaries, cyclic crack growth can be observed on both sides. The cyclic crack growth leaves the center plane and proceeds under an angle of approximately 45°, indication, that the stress state now also is dominated by shear stresses.

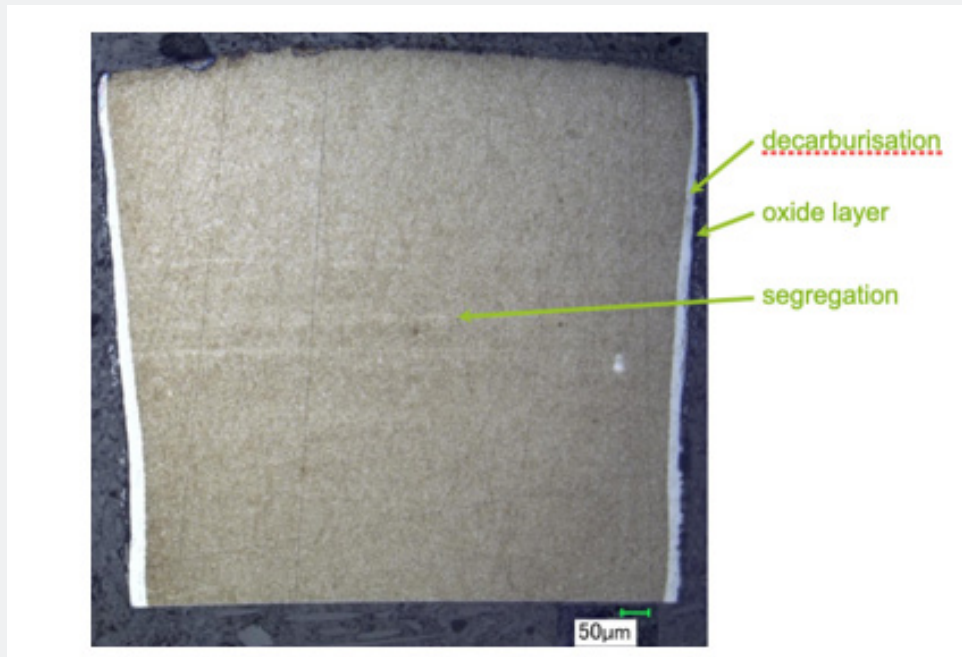
Microscopic examinations show a minor enrichment of impurities in the center plane of the metal sheet, Figure 4. This content of segregation is strictly within the tolerances, given by the standard. Nevertheless, it is a clear indication, that the development of the crack reproducibly lies within this center plane. The embrittlement of the impurities is obviously making the

difference to provide a plane for the spontaneous crack growth.

It is also visible, that the preparation of the specimen was done by laser cutting. This definitely leads to an embrittlement of the lateral surface layer by oxidation and decarburization. In the decarburized zone, the lateral shear stresses are able to produce micro cracks open to the surface. This helps to explain, that the stress state can initiate the micro crack, it does not explain the brittle crack proceeding in depth.

Figure 4: Microscopy showing laser cut and segregation.

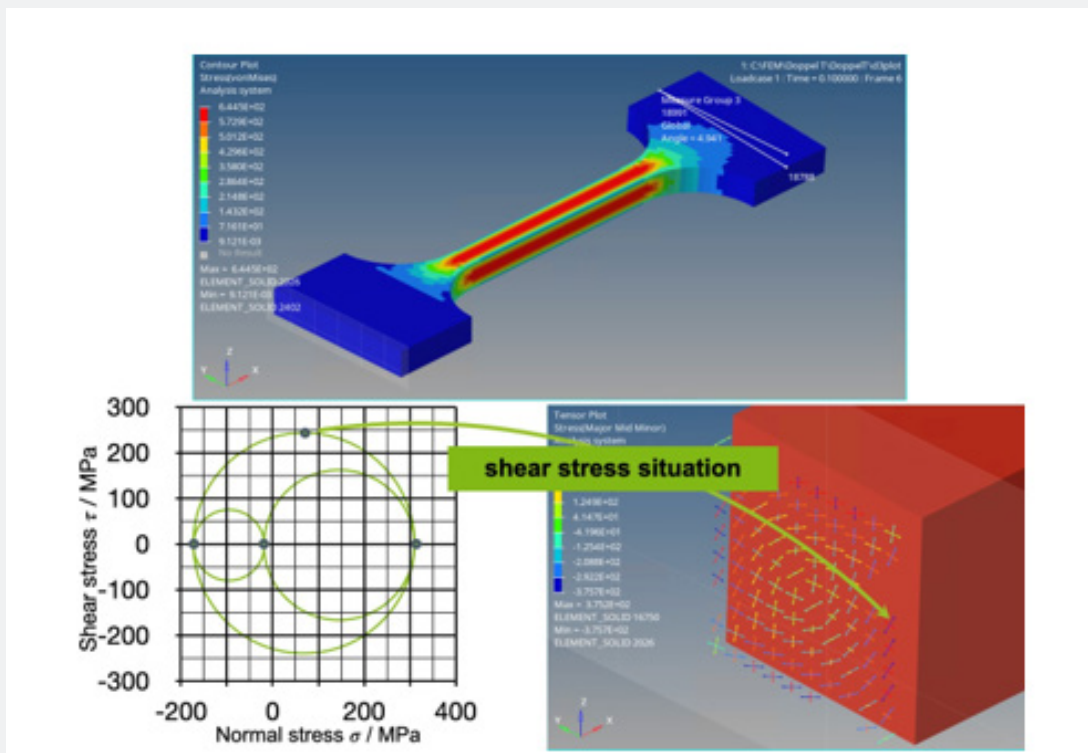
A finite element simulation model shows the calculated stress state at the moment of maximal amplitude in the torsion. At the relevant position, the stress state is dominated by shear stresses at the surface lateral, correlating with the expectations from calculation according to the approximation of St. Venant. This stress state is initial for the crack start, Figure 5.

High stresses, calculated by using von Mises equivalent stresses, are observed at the lateral surfaces. A detailed view in a relevant cross section provides information about the major stresses. At the relevant position center of the lateral surface, Mohr's circle interpretation shows the domination of shear stresses. Summarizing all described mechanisms, the crack initiation is caused by shear stresses, inducing a micro crack in the decarburized zone at the lateral surface.

Figure 5: Interpretation of the stress situation.

Once, this micro crack is reaching a critical depth, Griffith's theory explains the spontaneous crack growth, leading to a brittle crack with the lancet geometry. Cyclic crack growth follows finally and results in a complete destruction of the cross section.
