Circumferential Ceramic Liner Fracture in a Squeaking Hip

We present a case of a painless, squeaking ceramic on ceramic total hip replacement secondary to an unusual circumferential pattern of liner fracture.

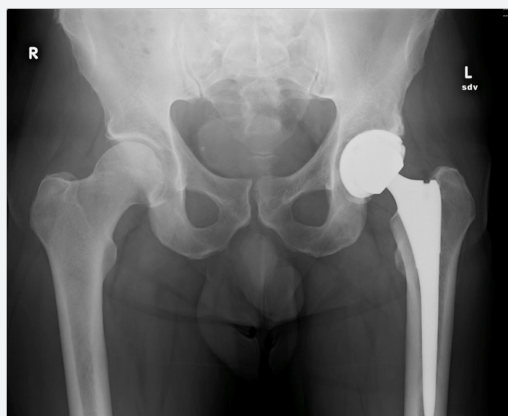
The patient underwent investigation to find a cause of the noise generated by his hip. Plain radiographs of the hip did not demonstrate any mal-alignment of the prostheses or eccentric position of the head to suggest liner wear (Figure 1). The gentleman subsequently underwent a revision of the cup and liner in July 2013. During revision it was found that the ceramic liner had fractured circumferentially with multiple fragments (Figure 2), with minimal wear of the liner or the head.

Figure 1: Pre-operative radiograph demonstrating normal alignment and head position.

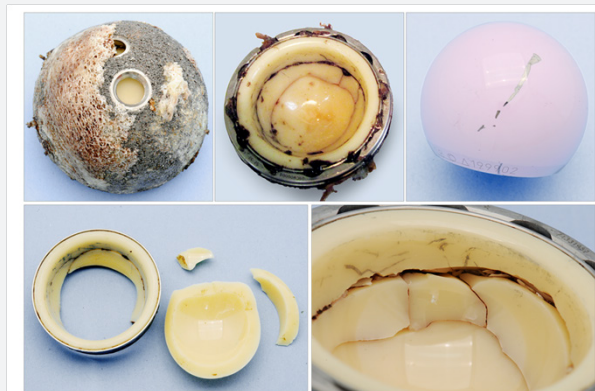
Figure 2: Photographs of the retrieved head, liner, and shell demonstrating the circumferential liner failure.

Evaluation of the device incorporated qualitative macro analysis and photography of the components in terms of degradation mechanisms and identification of the part and lot numbers. Analysis demonstrated that the liner had catastrophically fractured, the ceramic rim of which was intact due to the supporting titanium ring. There were several large and innumerable small ceramic fragments. It was noted that there was minimal wear of the liner and femoral head indicative that either the failure had occurred within a short time of revision or more likely that the intact rim had acted as the entire bearing surface. In this case it was noted that the remaining bearing surface was displaced inwardly towards the posterior surface of the acetabular shell. Overall the fracture pattern was essentially circumferential and in three distinct regions:

- i. adjacent to the lower edge of the titanium reinforcing ring
- ii. a large piece encompassing the polar region of the liner
- iii. Intermediate between the ring and the large polar piece.

Bioengineering concluded that the ceramic liner is relatively thin and the fracture pattern was commensurate with having a titanium constraining ring. It is noted that the part number was 71331652 and lot number 08CT17907, the importance of which will be discussed in light of a field safety correction notice from March 2011.

This case illustrates that painless squeaking of a ceramic-on-ceramic hip replacement is not always a benign problem, and may indicate catastrophic liner failure. Squeaking in this case is likely the result of a combination of ceramic debris between the bearing surfaces and loading of the head against the fractured ceramic edge. Furthermore it raises question about the suitability of the R3 design and its clinical safety that may warrant further investigation. The authors recommend thorough investigation of all patients that have a R3 Bilox Forte ceramic liner or similar that present with a noise generating hip as it may indicate catastrophic implant failure.
