# Causes and Mechanisms of Cracks in Gas Turbine Blades

**Zakaria Boumerzoug\* and Sara Amouria**

*LMSM, Mechanical Engineering Department, University of Biskra, Algeria*

The aim of this study is to present the causes and mechanisms of cracks in gas turbine blades. The turbine blade chosen is manufactured from a nickel alloy. Defective blade was studied by visual observation, penetrant testing, and optical microscopy. The zone and causes, as well as the mechanism of crack development were determined.

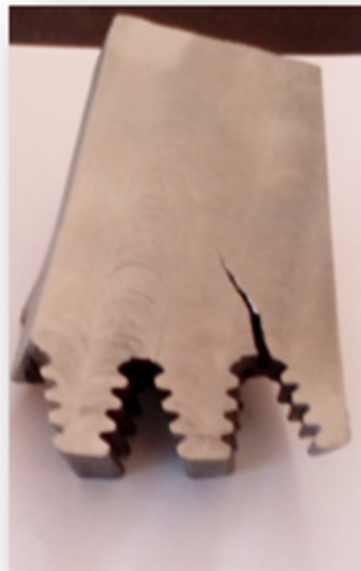
**Figure 2:** Macro view of a crack formed in a gas turbine blade.

Figure 2 shows a macrographic view of the formation of a crack observed in one of the gas turbine blades. This crack is very wide at its initial point and then narrows as it moves inside the blade. It is noted that this crack can be due to one of the following factors:

- a) Temperature of the burnt gases which is very high
- b) Thermal stresses
- c) Thermal properties of the material
- d) The phenomenon of fatigue of the material
- e) Vibration fatigue in certain areas

It has been reported that turbine blades are susceptible to damage and cracking in the contact areas of components that experience both centrifugal and oscillatory vibrations [18]. By definition, a component subjected to fatigue in the presence of a mating component under contact load experiences micro-slip along the contact interface and results in a significant reduction in fatigue life. This behavior is called contact fatigue which results in an increase in tensile and shear stresses at the contact surface,

which acts as a damage generator leading to crack nucleation, growth and eventual failure faster than in conventional non-friction fatigue conditions (simple fatigue) [17] (Figure2).

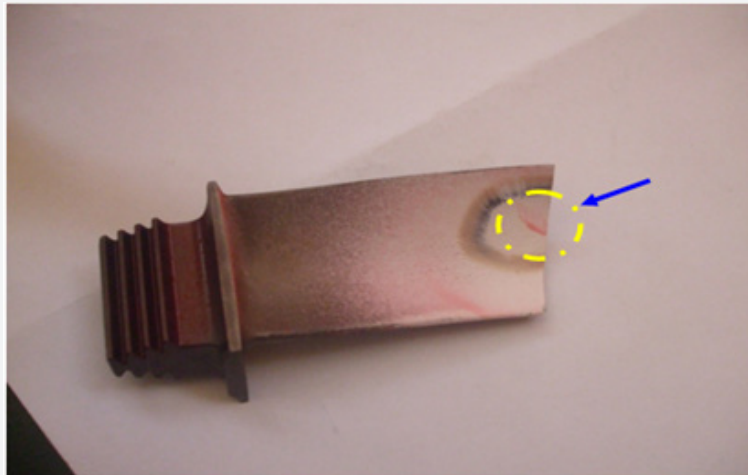
**Figure 3:** Macro view of a crack formed in a gas turbine blade.

Figure 3 shows another crack formed at another location on the gas turbine blade. This crack is not large compared to the first crack shown in Figure 1, but it is in its early stages of propagation (Figure3).

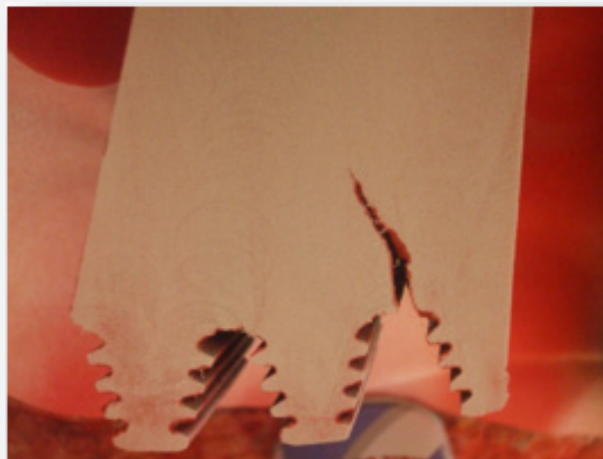
**Figure 4:** Macro view of the crack after penetrant test.

Figure 4 shows a macro view of the gas turbine blade after

the penetrant test which revealed only the crack visually observed and no other cracks (Figure 4).

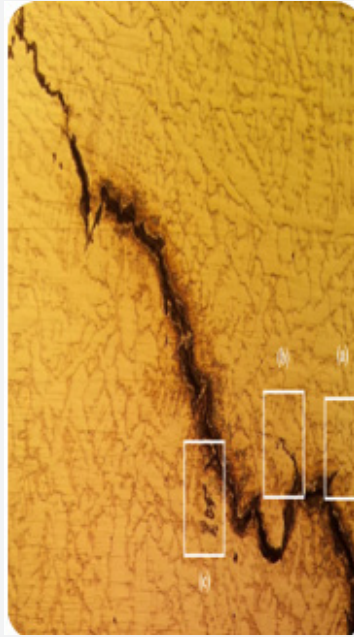
**Figure 5:** Optical microscope observation of the crack.

Optical microscope observation of the crack tip (Figure 5) shows that the crack propagates in a zig-zag shape with some small ramifications of small cracks as mentioned by rectangles a, b and c. It is noted that the crack type is transgranular (Figure 5). Turbine blades are susceptible to damage and cracking in the contact areas of components that experience both centrifugal and os-

illatory vibrations [18]. A fatigued component in the presence of a mating component under contact loading experiences micro-slip along the contact interface and results in a significant reduction in fatigue life. This behavior is called contact fatigue which results in increased tensile and shear stresses at the contact surface, which acts as a damage generator leading to crack nucleation, growth and ultimately failure at a faster rate than in conventional non-friction fatigue conditions (simple fatigue) [17].
