The Disastrous Flash Flood of Mandra in Attica-Greece and now What?

Department of Water Resources and Environmental Engineering, School of Civil Engineering, National Technical University of Athens, Greece

Abstract

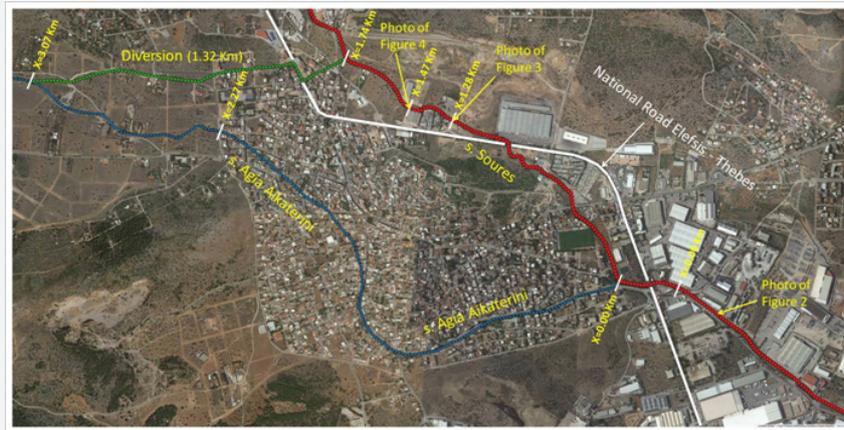
Figure 1 are characterized by significant morphological changes due to the intensive construction activities in the greater area that resulted in a dramatic decrease of their available cross-sectional areas and the occurrence of floods even at low flow rates. The need to face the frequent flood problems in Mandra resulted in the beginning of the final study of the storm water works in July 2012; its environmental terms were approved in July 2014 and the boundaries of the two streams were specified in January 2016. The main components of these structural works, which are shown in Figure 1, are

Figure 1: The main streams of Mandra and their technical works (based on Google Earth).

- i. the regulation of *s. Soures* (length= $L=1.74\text{km}$, flow rate= $Q=91\text{-}125\text{m}^3/\text{s}$ and cross-sectional area= $A=24.0\text{-}34.4\text{m}^2$), and
- ii. The partial diversion of the *s. Agia Aikaterini* ($L=1.52\text{km}$, $Q=47\text{m}^3/\text{s}$ and $A=12.5\text{-}24.0\text{m}^2$) to *s. Soures*. Downstream of its diversion location, the *s. Agia Aikaterini* continues to flow through the town of Mandra via an existing, enclosed rectangular conduit ($L=2.27\text{km}$, $Q=10\text{m}^3/\text{s}$ and $A=3.4\text{m}^2$) that is shown in Figure 2 until it meets *s. Soures*. Then, the latter

- i. the minimum required cross sectional area of the streams (without the diversion) varies between 20 and 40m^2 ,
- ii. The s. Soures flows almost parallel to the National Road Elefsis-Thebes (Figure 1),
- iii. The s. Agia Aikaterini passes through the town of Madra under its main streets, it was expected that during the flood the streams of Soures and Agia Aikaterini were

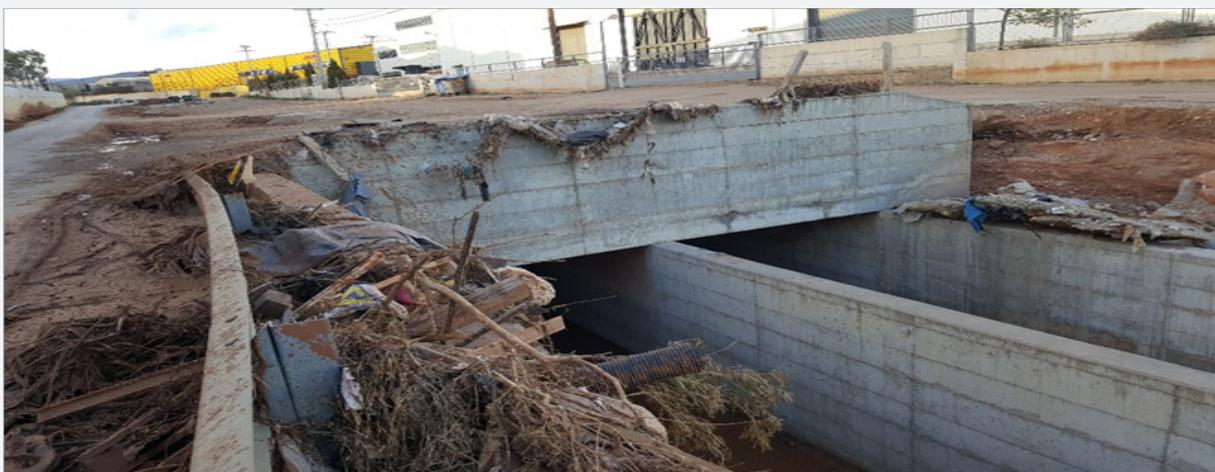
ends up at the beginning of the existing, regulated part of the *s. Soures* that consists of a twin channel, each of dimensions $4.0\times 3.0\text{m}^2$, i.e. $A=24.0\text{m}^2$, which is shown in Figure 2 after the flood incident. The flow rates were determined for a return period equal to $T=50$ years. Moreover, according to the flood risk management plans for Greece that were announced for public consultation in 2017 within the implementation of the Floods Directive 2007/60/EC [5], the region of Mandra belongs in one of the nine low zones of high flood risk in the Prefecture of Attica.

Figure 2: Photograph of the regulated part of the *s. Soures* after the flood.

replaced by the roads of Madra. Moreover, due to very high flow velocities (in certain areas the terrain was very steep) and bottom shear stresses, the flood caused significant soil erosion and carried away not only large quantities of solids (practically it was a mud-flow), but also extremely large and heavy objects, such as buses and cars. Without ignoring possible downstream or debris effects on the flow behavior, the traces of the mud-flow on the wall on the left side of the photograph of Figure 2 verify the description of the IFRC [4]

'Watermarks were visible at anywhere from 1.0 to 2.5m in height' and clearly show that even the cross-sectional area of 24.0m² of the regulated part of the s. Soures was not sufficient to carry the flood.

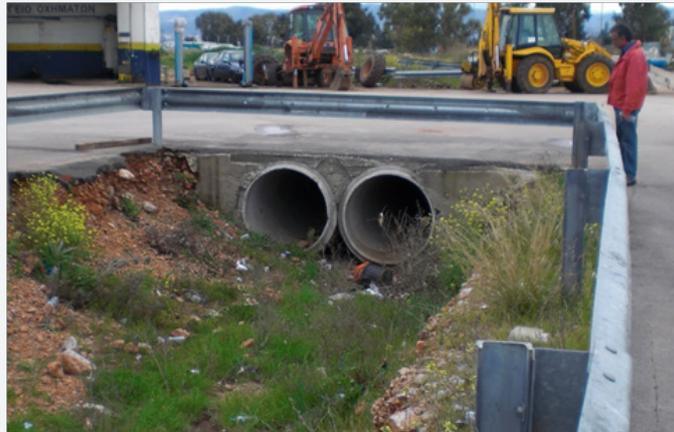
Figure 3: Photograph of a culvert of s. Soures at $x=1.28\text{km}$.

an investigation of the flood event [6], the General Inspector of Public Administration stated that 'bureaucracy and human factors played a crucial role in the tragedy', 'wrong evaluation of the priorities impeded the construction of the necessary flood protection works in the region' and 'responsibilities should also be sought in the past when various public infrastructure, such as the National Road Elefsis-Thebes, and private constructions were erected over the two major filled-in streams while the necessary water drainage pipes were either too small or they were not built at all' [7]. Indicatively, Figure 3 & 4 show the culverts of s. Soures at $x=1.28\text{km}$ (two pipes; $A\sim 2.0\text{m}^2$) and at $x=1.47\text{km}$ (two openings; $A\sim 10.0\text{m}^2$) under a building, respectively. Taking into account that

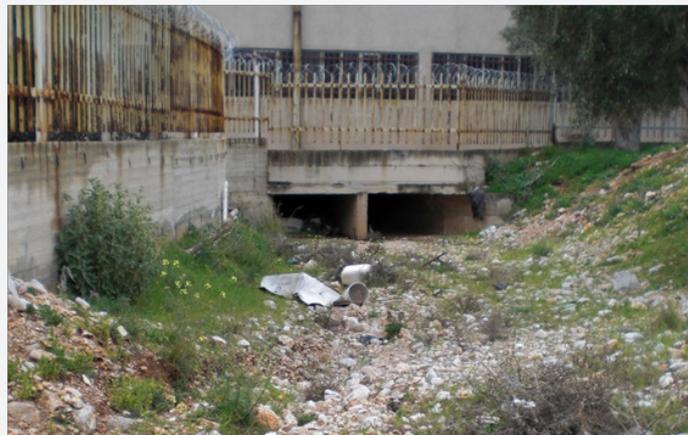
Figure 4: Photograph of a culvert of the s. Soures (under a building) at $x=1.47\text{km}$.

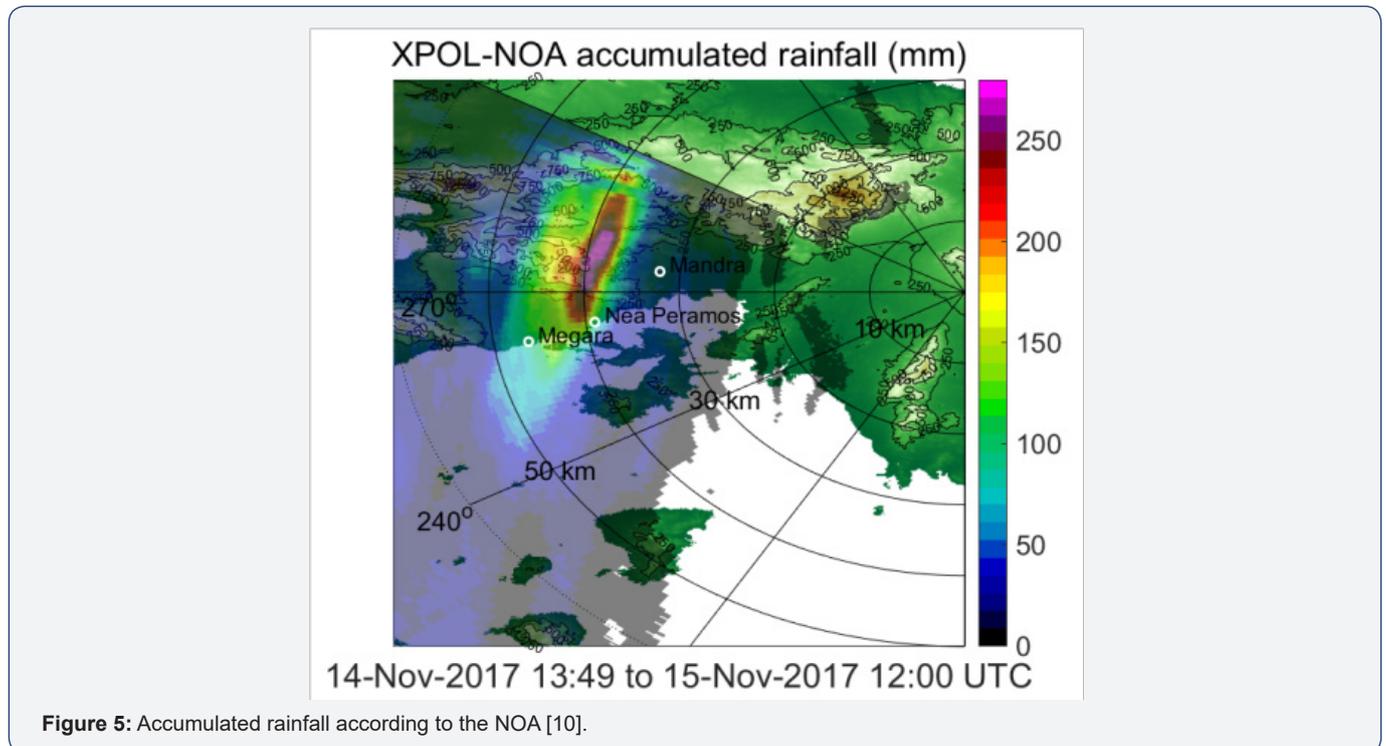
November, the transportable polarimetric weather radar XPol of the Institute for Environmental Research and Sustainable Development measured on the 15th of November a zone of very intensive rainfall over the greater area of Mandra of a total height higher than 200 mm in 6 hours (Figure 5). Furthermore, scientists of the University of Athens announced that the Poseidon Weather Forecast System of the Hellenic Centre for Marine Research [11] 'has shown 48 hours before the storm that in the mountain Pateras more than 50 mm of rainfall was expected'. Moreover, scientists of the University of Athens used satellite images of the NASA Global Precipitation Measurement (GPM) Integrated Multi-satellite Retrievals for GPM [12] to estimate that 'the region upstream of Mandra received within 7 hours a height of rainfall higher than 150mm that corresponds to 40% of the total annual rainfall in the region'. All the above-mentioned estimations were announced in the mass media after the flood. The measurement of the radar of the NOA and the weather forecast of Poseidon could possibly have been used to predict the actual rainfall; the Citizen Protection Ministry and the General Secretariat for Civil Protection expressed a different opinion claiming that that there was no reliable rainfall forecast [13]. Regarding the estimation of the FFG in Mandra, it is very difficult to make even an approximation, since the FFG depends strongly on local conditions; for example, local FFs in Poland are usually triggered by rainfall lasting up to two hours with the mean rainfall intensity ranging from 20-80mm/h, i.e. an expected FFG value would be around 20mm/h [14]. Nevertheless, a total rainfall around 200mm in 6 hours can be considered as a value that is well above any expected FFG in any region and certainly would have triggered a warning of an operating EWS.

Figure 5: Accumulated rainfall according to the NOA [10].

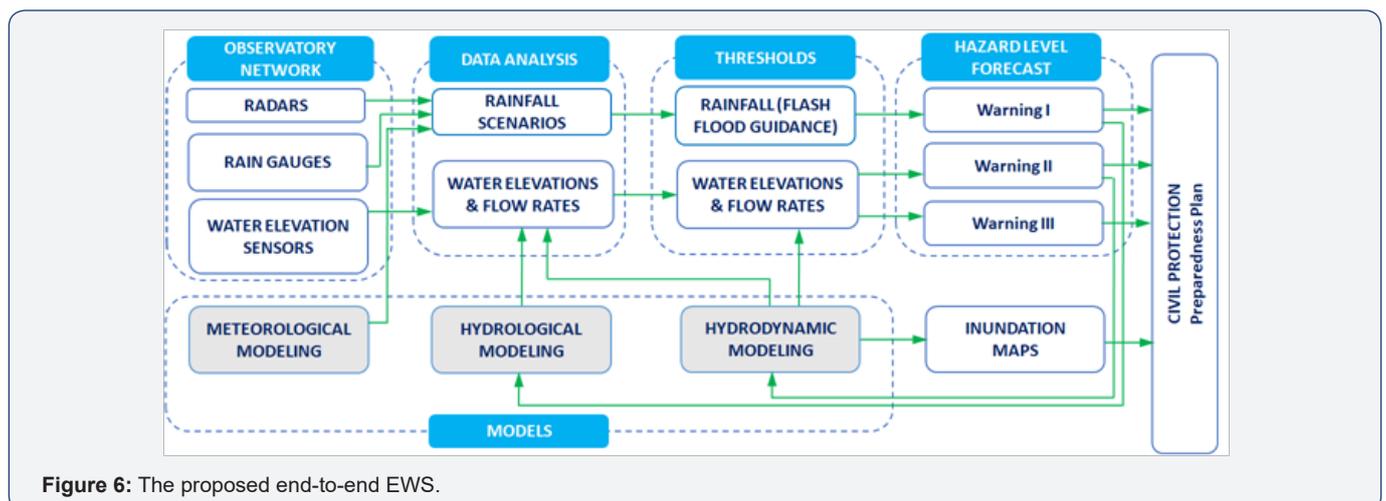
- b. Development and implementation of an EWS that can be applied at the level of the Prefecture of Attica, which includes the town of Mandra. The main components of such an EWS that is shown in Figure 6 are

Figure 6: The proposed end-to-end EWS.

- i. the observatory network for collecting environmental data that include rainfall and stream flow information, upon which to base warnings, and
- ii. the IT infrastructure that allows for the collection and analysis of network data, warning preparation, and

communication channels for distributing warning and other information to constituents [18].

The EWS should be operated in small time steps of 5-10 minutes to be able to cope with fast FFs. Every time step, rainfall data from the radars are collected and compared with

predictions of meteorological models; then, a precipitation analysis - forecast is performed by nowcasting methods to produce rainfall scenarios that allow their direct comparison with rainfall thresholds, for example FFG values. In case the rainfall threshold is exceeded, the first level of 'warning' is issued and hydrological modeling calculations are performed for all rainfall scenarios to determine the corresponding runoff and flow rates. These flow rates are compared with discharge thresholds, for example flow-rates for T=5 years; in case these thresholds are exceeded, the second and most important level of 'warning' is issued. For FF of relatively long lead times (>40 minutes), hydrodynamic modeling calculations can be performed for all scenarios to determine the flow rates and the water levels at specific locations of the streams and compare them with corresponding thresholds; when thresholds are exceeded the third level of 'warning' is issued. The threshold values for water elevations and flow rates are calculated via hydrodynamic models that are also used to determine the inundation regions that are embedded in the preparedness plans, which should also be in place. Finally, the population should be aware of the FF hazard and be prepared to take appropriate actions when a warning is received.
