Design on Rehabilitation of Landslide and Intake Waterproof Barrier of SHPP Nakra

During the construction of small hydro power plant (SHPP) Nakra it was concluded that there is a need for developing of additional designs. The additional designs are related to the rehabilitation of landslide affecting the cut slopes near the future penstock and construction of waterproof barrier in front of the intake structure of the hydro power plant. This paper deals with some aspects related to the additional designs which are out of the original scope of the design works.

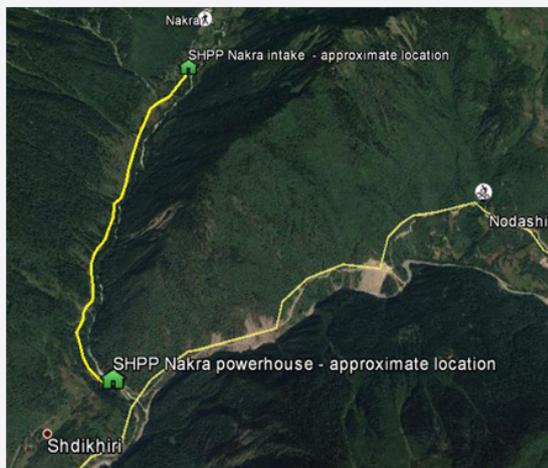
Figure 1: Project area of SHPP Nakra.

The project site of the SHPP Nakra is located near to the village of Nakra in north region of Georgia. According to the original design developed by Macedonian company Akvavat (Skopje, R. Macedonia) the small hydropower plant should be constructed on the Nakra River. During the execution of the construction works due to various reasons additional designs was needed to be developed. One of the reasons for new designs was the instability of the cut slopes of the existing unpaved road which leads to the village of Nakra and the intake of the hydro

power plant. According to the original design the penstock should be constructed very close to the toe of the road cut slopes. One of the cut slopes was affected by landslide before works for construction of the penstock started. In order to provide conditions for construction of the penstock first task was to rehabilitate the landslide. Hence, one of the additional designs is related to the stabilization of this landslide (Figure 1).

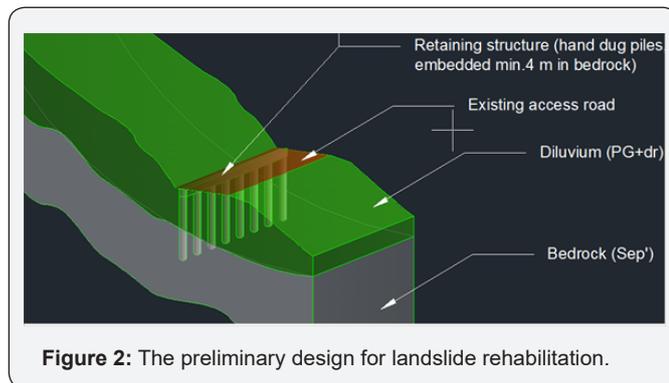
Figure 2: The preliminary design for landslide rehabilitation.

and penstock invert level. The site visit was held later before developing of the final design. The general idea was to stabilize the unstable section of the cut slope and to prevent safe ground conditions for excavation of the penstock trench and installation of the penstock. As per available data on ground topography it was detected that limited area of the considered cut slope is unstable but before site inspection the designers were not certain about the depth of the slip surface. Based on the borehole logs and geodetic data it seemed that it might be a deep-seated landslide. Anyway, in order to be on safe side, the preliminary design was developed assuming that the potential slip surface is deep-seated and the existing road which leads to Nakra village and the intake structure is affected (Figure 2&3).

The initial design concept involved construction of reinforced concrete pile wall fully embedded in the ground. The designed length of the piles was 8,0m and the last section of the piles in length of 4,0m was designed to be embedded in the sound bedrock. The diameter of piles was 1,0m and the axial spacing of the piles was 2,0m. The piles are connected with reinforced concrete cap beam. The pile wall was segmented in separate sections divided by construction joints. In case of extension of the landslide area such approach helps to construct additional wall section without significant modifications of the design. The concept of the design was further developed in detail which is discussed in following chapters.

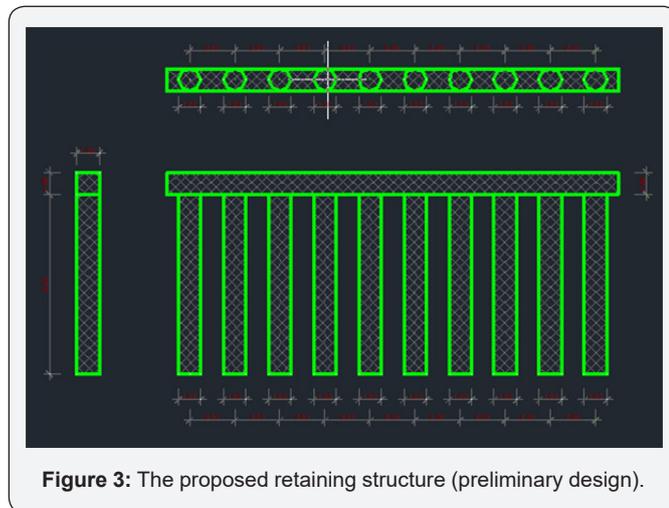
Figure 3: The proposed retaining structure (preliminary design).

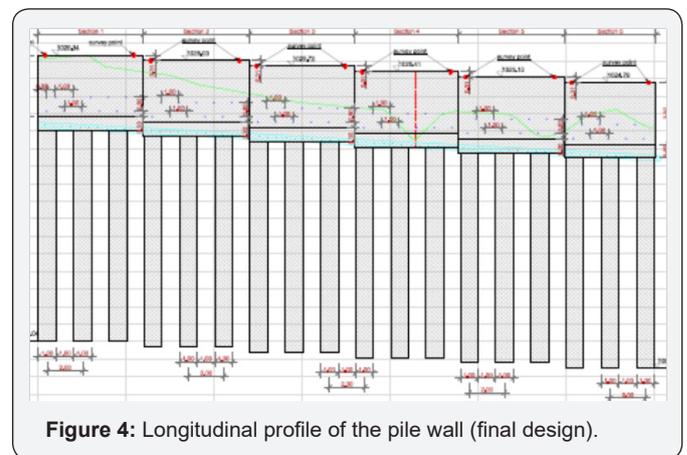
Figure 4: Longitudinal profile of the pile wall (final design).

The method of grouting is one of the major issues for the grouting works therefore special attention is paid to this matter. Also, the construction schedule was very tight so some of the structures had to be constructed in parallel. Before completion of the waterproof barrier design the works for construction of the intake were in progress. Therefore, it was very important to provide a proper access to the upstream side of the intake in order not to obstruct the construction works on the intake (Figure 4).

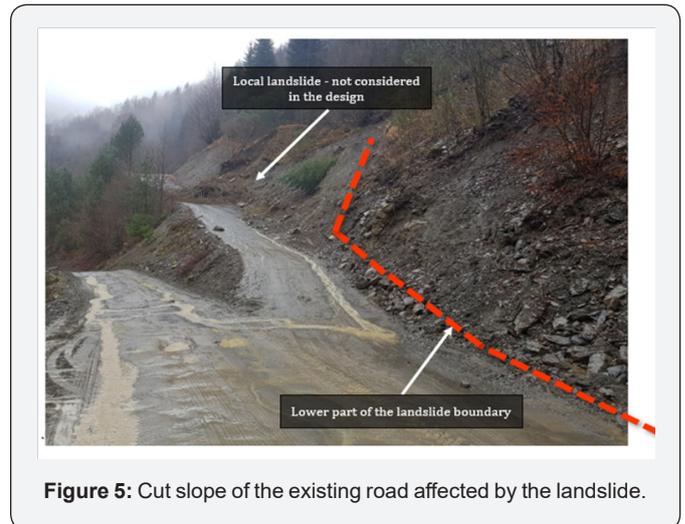
Figure 5: Cut slope of the existing road affected by the landslide.

- A. The initial landsliding was shallow (no more than 2,5m at the deepest point) and the area which was affected has irregular shape with size approximately 20, 0x30m.
- B. The landslide affected one portion of the road cut slope;
- C. The shape of the existing slip surface is curved and irregular probably consisted of several smaller slip surfaces;
- D. The ground is highly saturated;
- E. Almost all of the cut slopes of the existing road are prone to instability, landsliding and rockfalls which means that special attention should be paid during the construction of the penstock;
- F. The space for construction of the penstock and the pile wall is very limited, therefore from construction point of view the pile wall is more feasible to have one row of piles;
- G. Extended geotechnical investigation works should be done; (Figure 5)

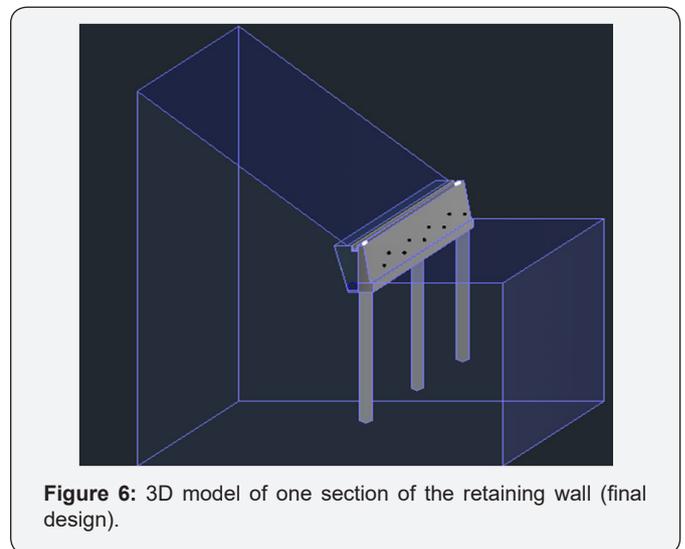
Figure 6: 3D model of one section of the retaining wall (final design).

Based on the findings from the site reconnaissance and the previously provided data the final design on landslide rehabilitation was developed. Unfortunately, at that moment there was no possibility to conduct extended geotechnical investigation works. The proposed rehabilitation measures involve construction of retaining pile wall in the toe of the cut slope affected with landsliding, drainage system of the retaining wall and surface water channel located behind the crest of the pile wall. The pile wall is divided in sections and each section is consisted of one row of reinforced concrete piles with diameter of 1000mm and length of $L=12,0m$. The piles of each wall section are connected with reinforced concrete cap beam (0,8x1,2m). Above the cap beam a wall stem ($H=3,5m$) will be constructed in order to provide conditions for backfilling of the space between the cut slope and the wall stem. The backfilling will increase the local stability of the cut slope in the portion of the slopes close to the pile wall. The total length of the retaining structure is $L=35,0m$ and the length of each wall section is $L=6,0m$ with expectation of the last one which is shorter. The sections of the wall are separated by construction joints (Figure 6).

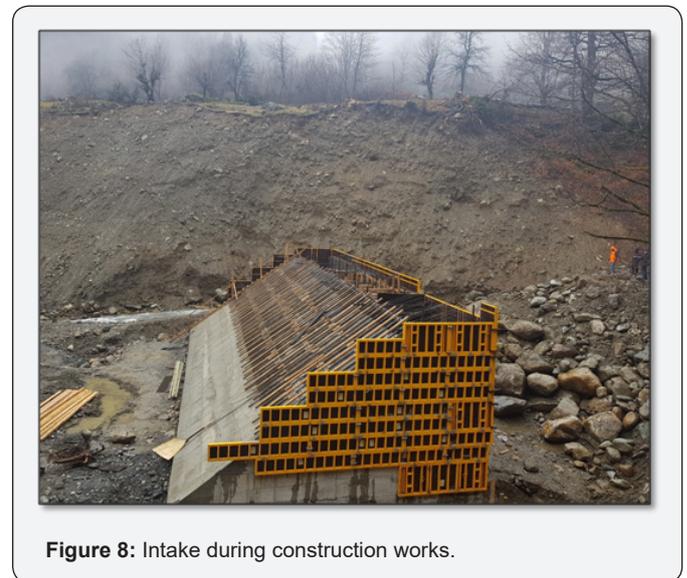
Figure 8: Intake during construction works.

available geotechnical data and the results obtained from the performed "in situ" permeability test, the hydraulic conductivity of the ground in the vicinity of the intake is approximately 1000 (one thousand) times higher than the required value. The objective of proper grouting is to replace the native material removed during drilling with grout that meets or exceeds the sealing capability of the removed native material (Figure 8). The grout curtain will be constructed in several construction steps:

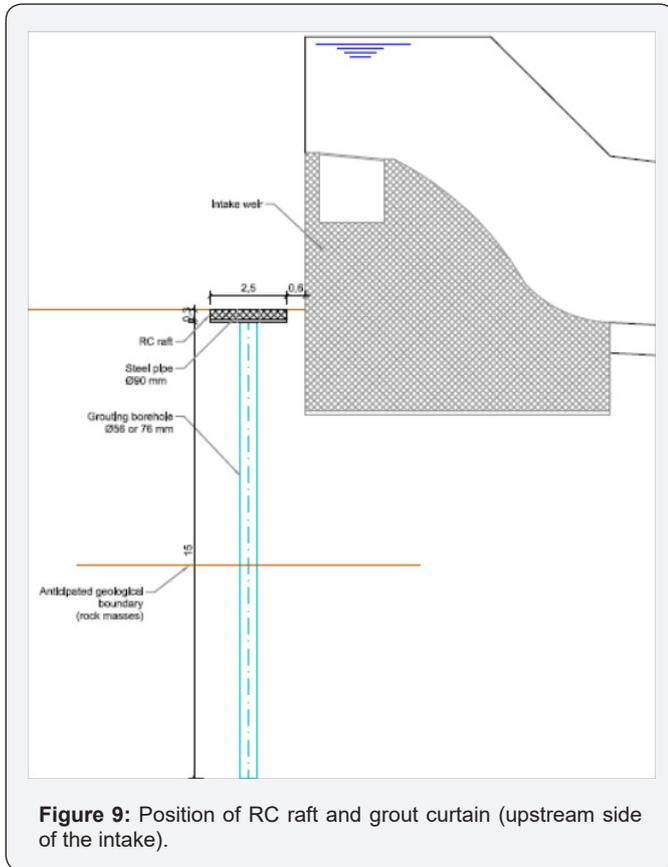
Figure 9: Position of RC raft and grout curtain (upstream side of the intake).

Based on the results from the investigation drilling of boreholes NK-WI 103 and NK-WI-104 located on the right bank of Nakra River, as well as on the results provided from Le Frank site permeability test, it can be concluded that in the area of the intake, certain interventions are needed in terms of improvement of the permeability characteristics of the encountered soil and rock materials to a certain depth. By analyzing the core extracted from the investigation boreholes (available borehole logs) and geological profiles it can be concluded that from the ground surface up to depth of 4,0-8,0m, quaternary alluvial-proluvial /moraine sediments are encountered. These sediments are consisted of clayey sands with low content of clay and gravels with rock boulders which originate from the bedrock. In the depth, the underlying layers are consisted of cracked and decomposed rock masses. Based on the site permeability tests (performed at depth of 0,0-6,0m) it can be concluded that the rock masses have good hydraulic conductivity i.e. there is a seepage of the ground water through the rock masses in the area of the intake (Figure 9).
