Acoustic Emission Testing of Composite Materials Including Specimens Simulating the Embedded Sensors

Nedoseka S^{1*}, Nedoseka A¹ and Shevtsova M²

¹EO Paton Electric Welding Institute. NAS, Ukraine

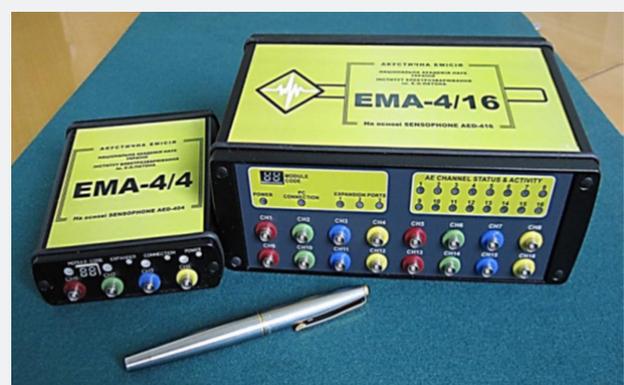
Figure 1: EMA-4 (Evaluation of Materials Ability) devices in 4 and 16 channel versions.

previous paper [2] was to determine the principal testability of one only composite material using sensors, equipment, and AE technologies implemented [3] using EMA-4 devices (Figure 1) so next stages deals with two composite materials and wider spectrum of tests.

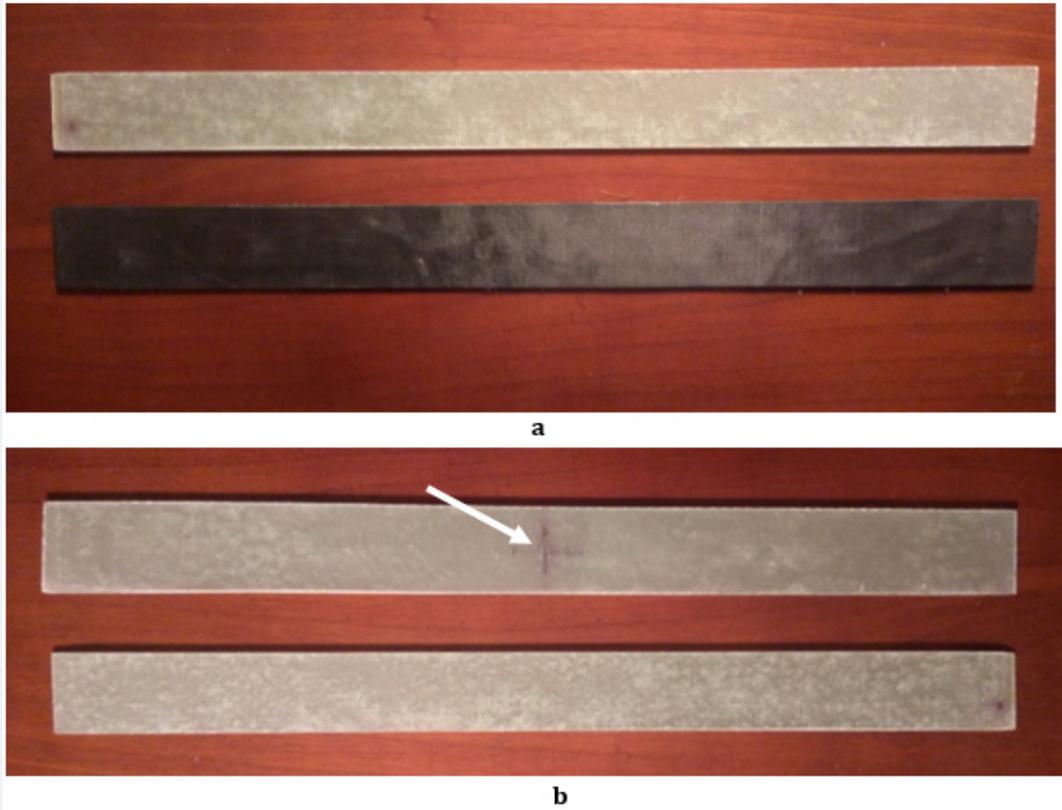
Figure 2: Specimens of fiberglass and carbon fiber are in delivery condition. At the top of (b) position, the cross maker indicated the installation location of the piezoelectric simulator — in the center of the specimen, indicated by the arrow.

The specimens of fiberglass and, so, carbon fiber, manufactured by the National Aerospace University are thin longitudinal strips, measuring 400x35x2.1mm (Figure 2). Specimens of fiberglass are made (Figure 3-5) by the manual laying of Aeroglass 280 fiberglass and Elan-tech EC157 + Elan-tech W152XLR binder (mixing ratio 100: 30). The molding was carried out on a flat duralumin plate using a vacuum method with

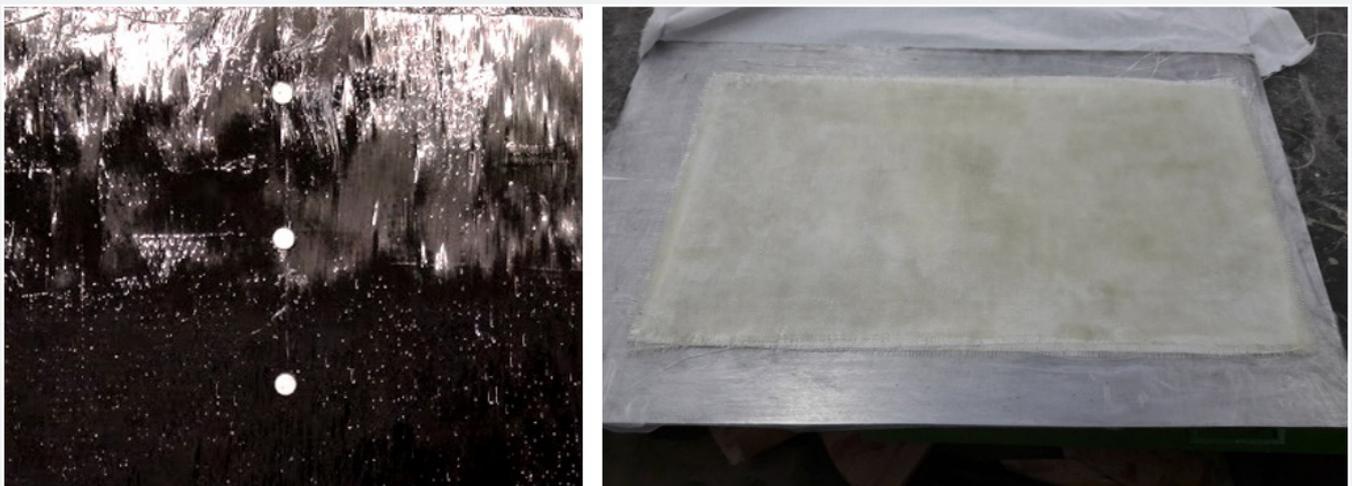
Figure 3: Installation of sensory piezoelectric sensor simulators (shown on carbon fiber, similarly, done for fiberglass) and assembly of a glass cloth for impregnation.

vacuum impregnation of a dry blank of Aeroglass 280 fiberglass fabric and pre-installed simulators of sensor sensors made of CaCO₃ calcium carbonate 0.5mm thick and 5mm in diameter. Forming pressure 0.09 MPa. Time-temperature molding after impregnation: 60 °C for 6 hours. Specimens with the required dimensions were cut from the formed plate with a diamond disc.

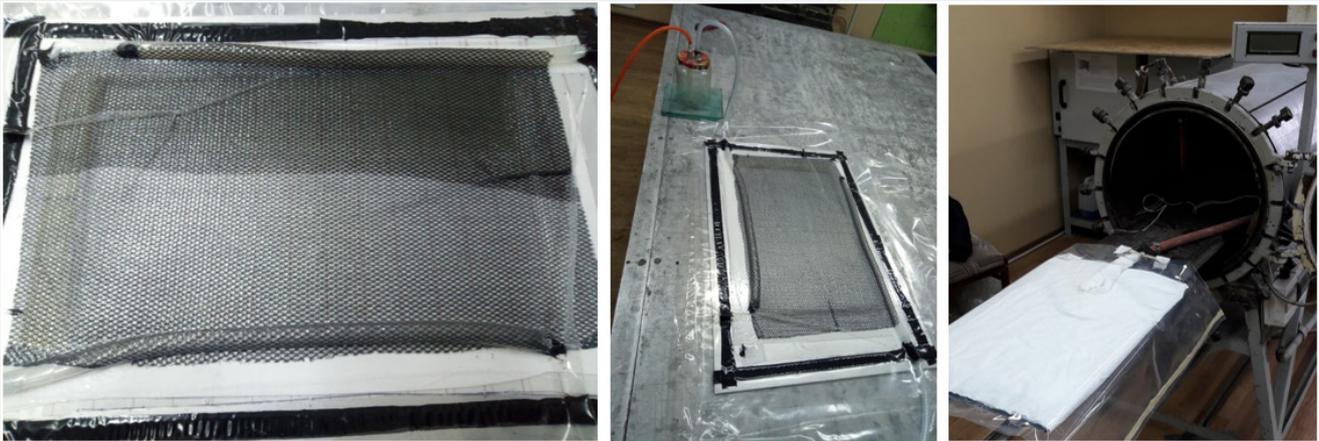
Figure 4: Binder impregnation of the bag under vacuum and specimen curing in the oven.

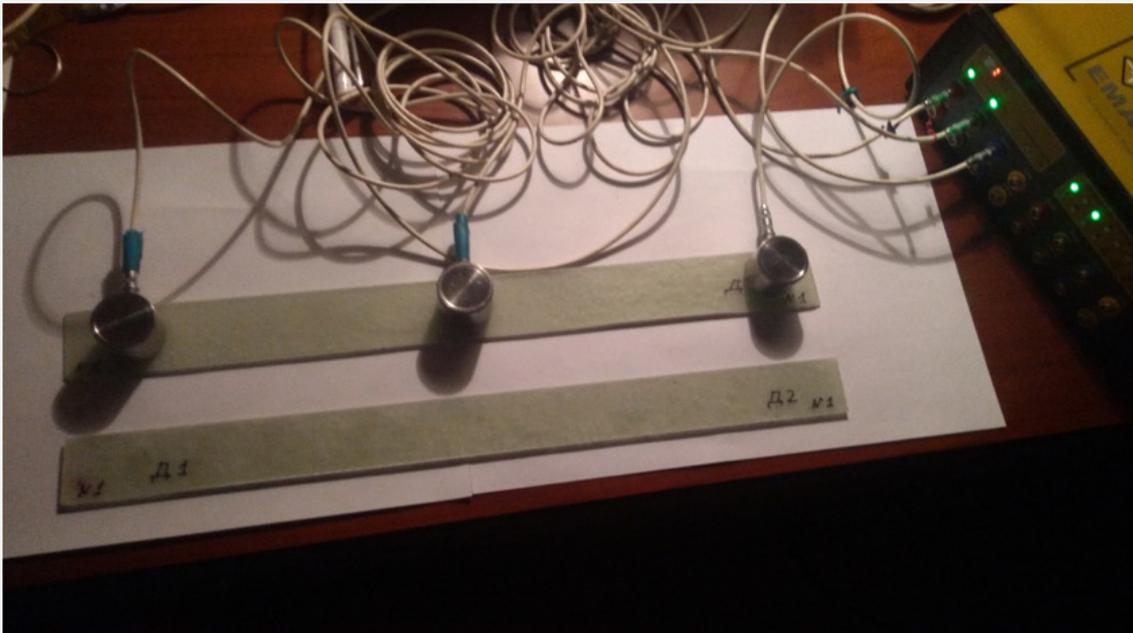
Figure 5: AE sensors on the specimen and the 16-channel EMA-4 device connected to them.

The sensors were placed at a short distance from the edge of the specimen, so that they formed a linear location antenna with a total length of 330mm (Figure5). When installing the third sensor, it was placed in the center of the specimen (in the case of a piezo sensor simulator, directly above it). And, in addition to traditional destructive AE tests of specimens, the different method was used naming "AE scanning". This method based on sounding of specimen without its loading. In this case, one of AE sensors uses as radiant of acoustic waves, and other as receiver. If the specimen of original, not damaged material present, the comparison of acoustic properties of this material and damaged material allows obtaining the numerical value of damage.

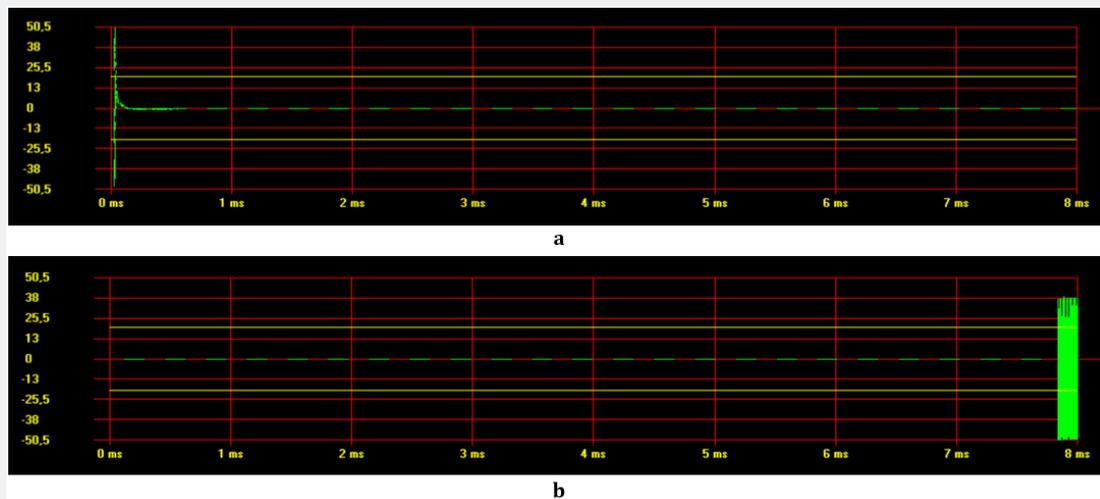
Figure 6: Typical oscillograms of AE signals received by sensors in various cases. The ordinate axis shows the amplitude of the signal, dB; on the abscissa, the time from the start of fixation of the recorded fragment of the waveform.

When the sensor received a signal that was little distorted, it received an oscillogram similar to that shown in Figure 6a, when changing the signal parameters, the oscillogram most often looked like the one shown in Figure 6b.

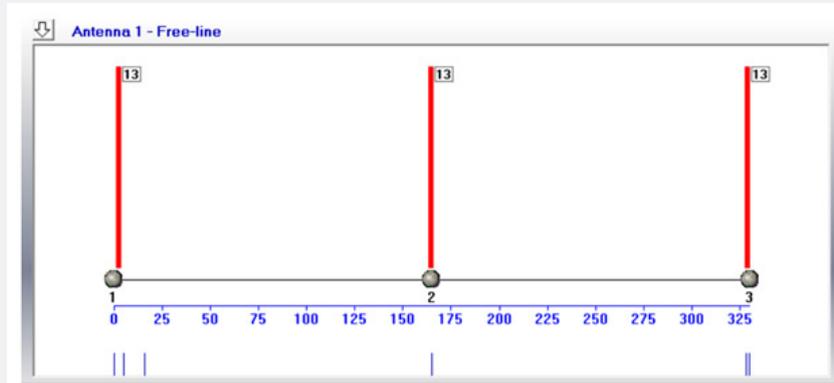
Figure 7: Results of alternate sounding of the specimen without a built-in sensors simulators. High accuracy in determining the coordinates is visible in the figure (the centers of acoustic activity clusters are shown by flags and coincide with the locations of the AE sensors).

When determining the location of AE sources using sensors as a generator of waves, the velocities of AE waves in the material were selected so that the calculated coordinates of the AE signals emitted by the sensors and then received by the AE device, as accurately as possible coincided with the coordinates of the

sensor-emitter (Figure 7). This figure like next similar figures is a screenshot of EMA-3.9 program window part. Lower part show coordinates of AE events obtained before their cluster analysis as small bars. Big bars with flags are results of clustering. Numbers on the flags shows the AE events count in corresponding cluster.

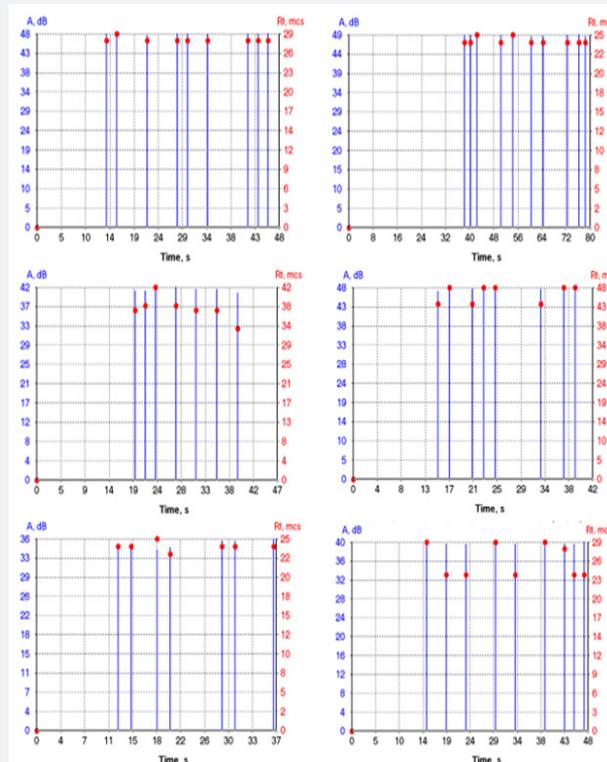
Figure 8: Results of AE scanning of specimens without a built-in piezo sensor simulator. The bars represent the amplitudes of the received signals A(dB), the points represent the time of their rise to the maximum Rt (μs).

To obtain the necessary statistics of stable results, about a hundred experiments were carried out on six specimens three of which had a built-in simulator of a piezo sensor with a diameter of 5mm in the center, which is close in some properties to the PZT19 material used in real piezoelectric sensors. Typical graphs of the results of AE scanning of three specimens without a built-in piezo sensor simulator are shown in Figure 8. In the

left column of the graphs the case is shown when the emitter was sensor No. 1, in the right column when the emitter was sensor No. 2. The bars show depending on the time of the AE signal receiving amplitude A, and dots show the time of their rise to the maximum Rt. When processing the measurements, software filters were used that cut out obviously incorrect data (for example, $R_t = 0\mu s$).

As you can see, the results are fairly stable. Although for different specimens and for different scanning directions there is some difference in the obtained values of the amplitudes A and the rise times of the signal R_t , within the framework of each specific experiment their repetition is high. Note that the minimum amplitude is 36dB, the maximum value of R_t is 48 μ s.

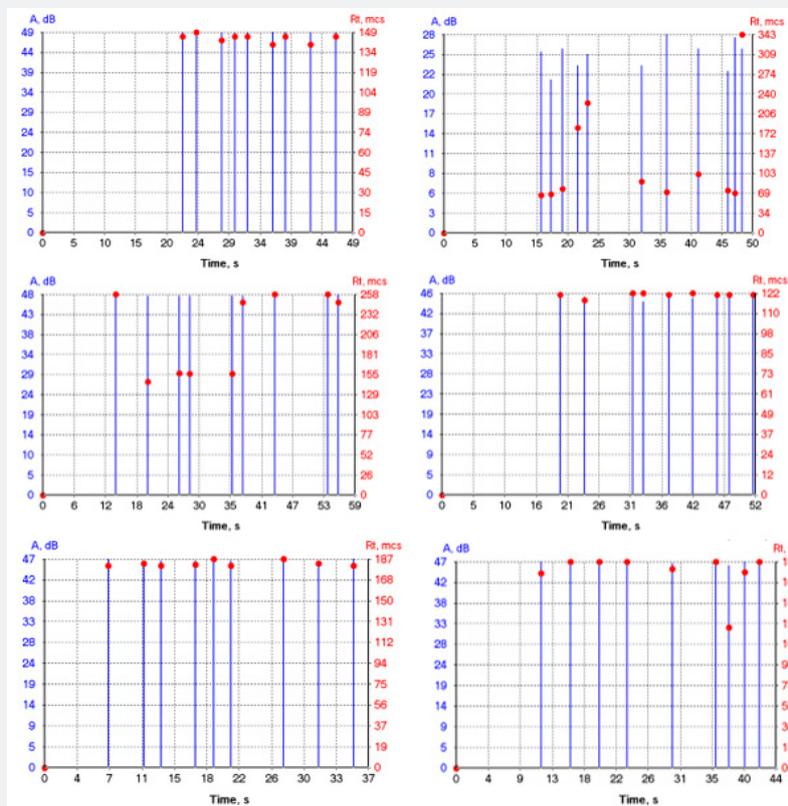
Figure 9: Results of AE scanning of specimens with built-in piezo sensor simulator. The bars represent the amplitudes of the received signals A (dB), the points represent the time of their rise to the maximum R_t (μ s).

Typical graphs of the results of AE scanning for three specimens with a built-in piezo sensor simulator are shown in

Figure 9. In the left column, as in Figure 8, graphs are presented for the case when the emitter was sensor No. 1, in the right column when the emitter was sensor No. 2. To calculate the damage of specimens with a piezo-sensor simulator, the AE parameters obtained by scanning specimens without piezo plates with the same number were used as the initial data. Theoretically, they could be interchanged in any order, since they were cut from the same sheet of material, and the averaged data are not significant. The data was processed in MS Excel. For each specimen, the values of A and R_t were obtained for each of the directions of sounding, then the amplitude growth rate of amplitudes $v = A / R_t$, the damage in each particular case of scanning was calculated. On Figure 10 the results of damage ΔW calculation after scanning for specimens No. 1, 2, 3 are shown by six blue columns. The number under each column corresponds the number of each one scanning experiment. The designation $\Delta W 1 \rightarrow 2$ shows the damage obtained by scanning with signals in the direction from sensor No. 1 to sensor No. 2, and then by analogy for all the specimens, $\Delta W 2 \rightarrow 1$ shows the damage for scanning in the direction from sensor No. 2 to sensor No. 1, and then by analogy for all the specimens. Further, the average damage value for each of the specimen and scanning directions was calculated and shown on fig. 10 as the red columns No. 7.

The analysis presented in Figure 9&10 of the data shows, firstly, the high damage of all three specimens with built-in piezoelectric simulators, which for individual series of specimen scanning ranges from 0.65 to 0.95. Secondly, the specimen No. 1 seems to be the most damaged, for which the highest average

damage is recorded when scanning from sensor No. 2, and, in addition, there is a very large scatter of measured data, which was noted for the upper right graph on Figure 9 which indicates the unevenness of the properties of the scanned material in this direction.

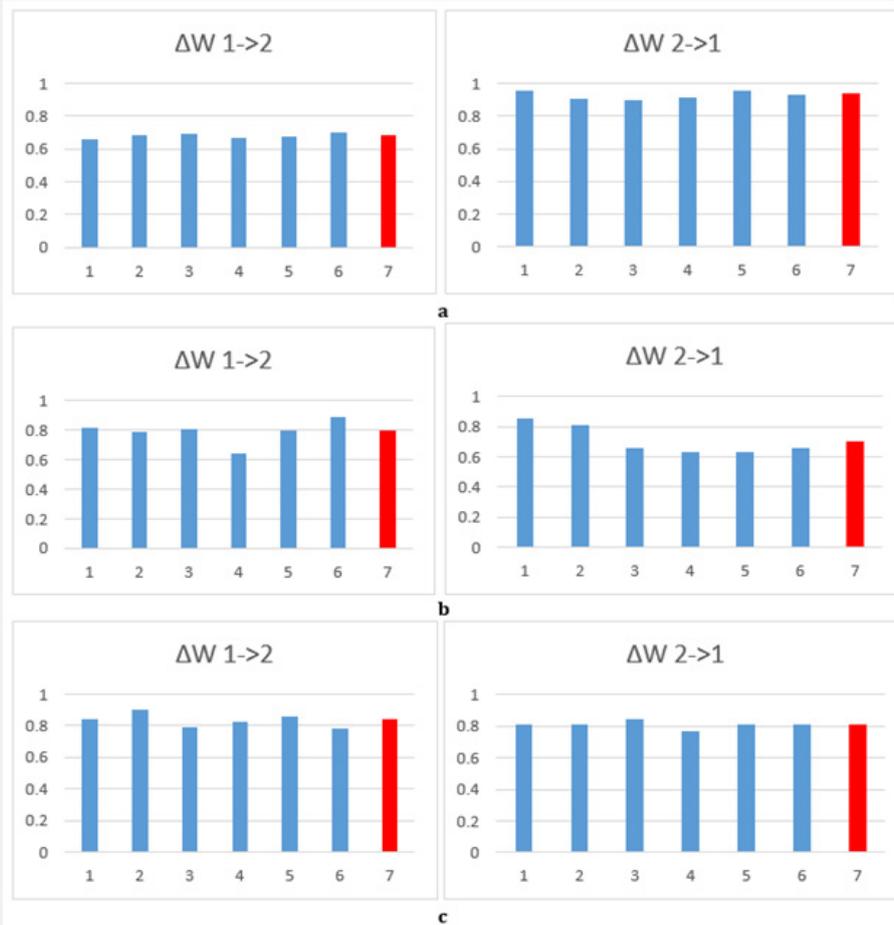
Figure 10: The results of calculating the damage to specimens with a built-in simulator of a piezo-sensor according to AE scanning data: a - specimen No. 1, b - specimen No 2., c - specimen No. 3.

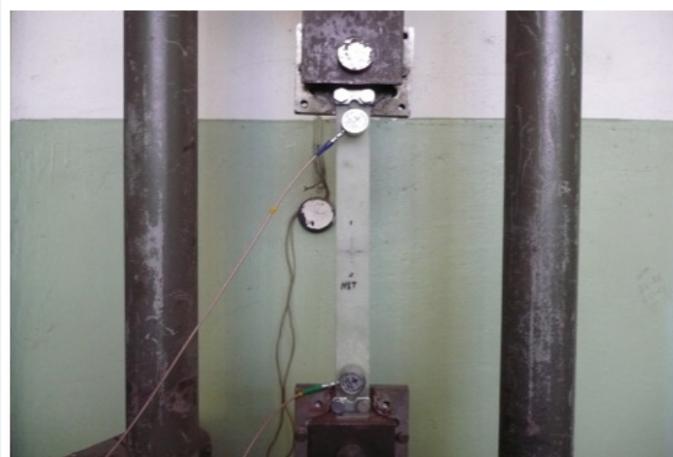
Figure 11: The test machine hold part with fiberglass specimen having embedded simulator of piezo sensor.

It is important to note that such large damage values were obtained when scanning specimens in only one direction. The real integral damage of the material may be differed. Theoretically, in subsequent tensile tests, down to rupture, the AE pattern should differ significantly in the direction of increasing the number of AE events for specimens with embedded simulators of piezoelectric sensors. The places of the greatest AE activity in the area of simulators should also be recorded, since they are stress concentrators. Later, such experiments were conducted. The fiberglass specimens of both types were tested on destructive machine with hard mode of loading (Figure 11).

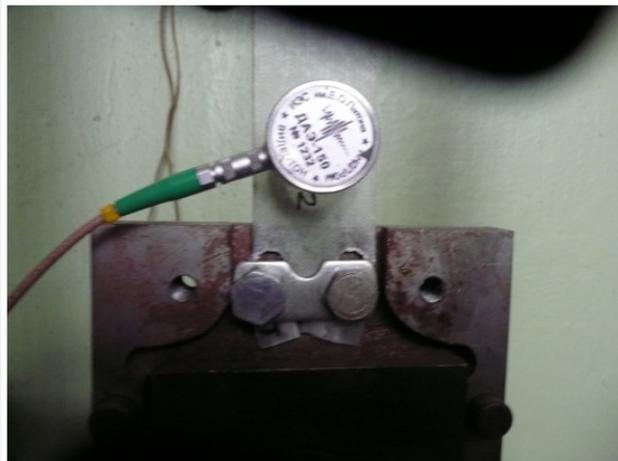
Figure 12: The area of fiberglass specimen destruction. Coordinate of destruction is near 250mm (sensor No 2).

The results of testing of specimen without embedded carbon plate shown that more acoustic signals were radiated by the area of the testing machine holds in which the specimen is fixed. Specimen practically has no serious defects. Destruction occurred in the hold part of a testing machine (Figure 12). Lower some screens of EMA-3.9 program for this experiment is shown. Location scheme (on the bottom) combined with destruction Figure 13 forecast area (on the top). On Figure 14 all loading process is shown. As we can see the forecast of destruction 435.6 to 550Kg is very close to real destructive load 470Kg.

in the center when the embedded carbon plate placed (Figure 15). But it is not critical activity. Destruction, the same as in specimen without carbon plate, occurred in the hold part of a testing machine (Figure 12).

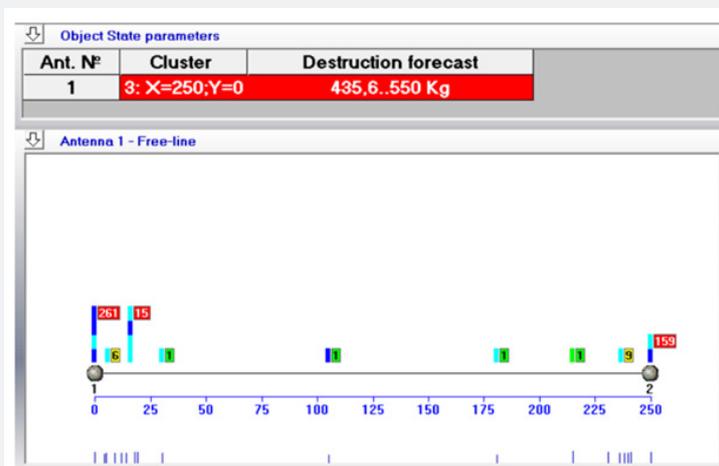
Figure 13: Results of loading the fiberglass specimen without a built-in simulator of piezo sensor. The prognostic destruction value is shown as 435.6 to 550Kg. The prognostic place of destruction is 250mm. The centers of acoustic activity are shown by flags.

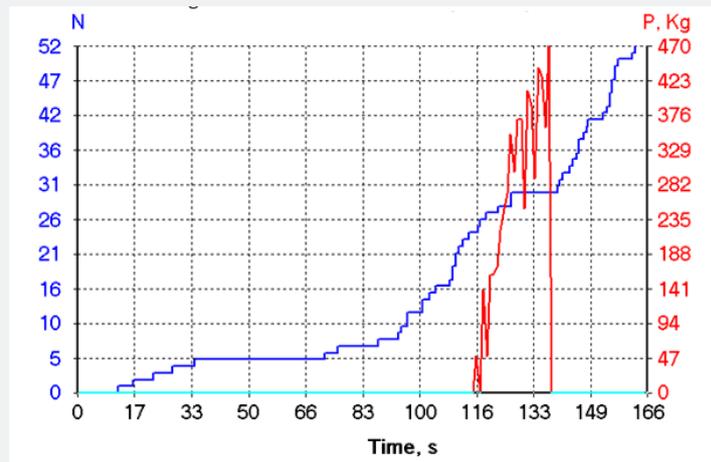
Figure 14: Results of loading of the fiberglass specimen without a built-in simulator of piezo sensor in time. N -summary curve of AE events, P-loading curve.

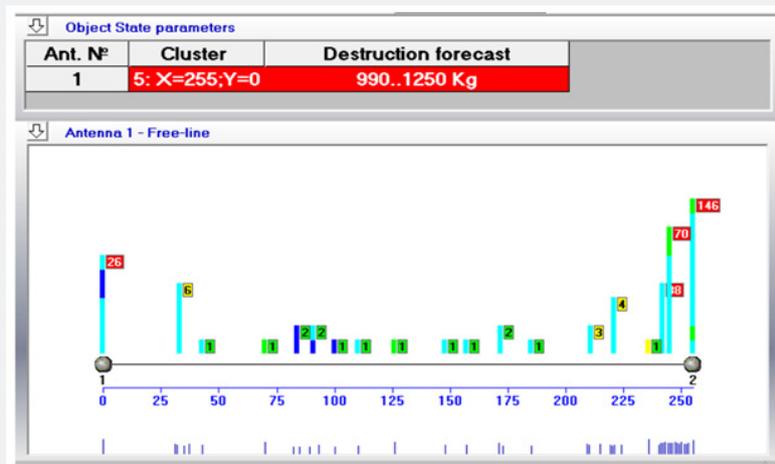
Figure 15: Results of loading the fiberglass specimen with a built-in simulator of piezo sensor. The prognostic destruction value is shown as 990 to 1250Kg. The prognostic place of destruction is 255mm. The centers of acoustic activity are shown by flags.

In the results of testing of specimen already with embedded carbon plate we can see that more acoustic signals again were radiated by the area of the testing machine holds. Specimen with built-in simulator of piezo sensor shows some acoustic activity

As we can see the forecast of destruction 990 to 1250Kg is enough close to real destructive load 1490Kg.

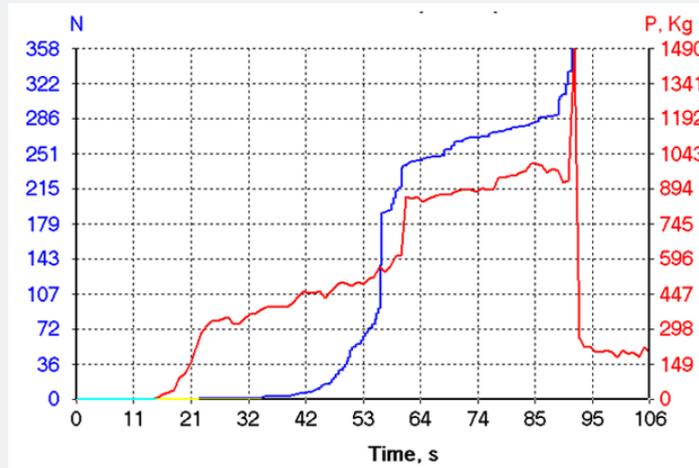
Figure 16: Results of loading of the fiberglass specimen with a built-in simulator of piezo sensor in time. N-summary curve of AE events, P-loading curve.

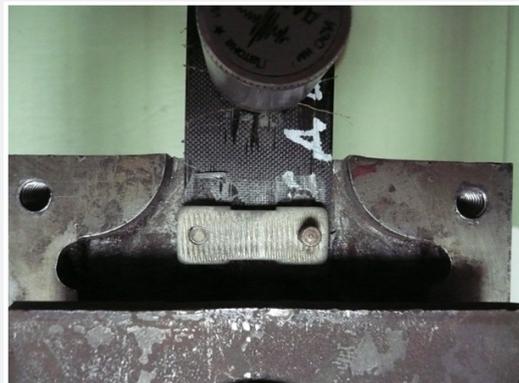
Figure 17: The area of carbon fiber specimen destruction. Coordinate of destruction is near 284mm (sensor No 2).

main result of specimen's destruction was the same as for the fiberglass, near hold part of the testing machine (Figure 17). As we can see the forecast of destruction 242.1 to 305.7Kg is very close to real destructive load 255Kg. So, AE tests conducted shown that acoustic sensitivity and prognostic properties of EMA systems are good both for carbon fiber and fiberglass Figures 18,19. The quality of destruction forecast no worse than when testing real steel pressure vessels [5]. This confirms generally good chances for using the AE method in assessing the state of composites. The obtained results suggest that it is possible in principle to create a method of applying the AE technology into practice when monitoring composite materials of tested types, both in standard destructive testing and scanning

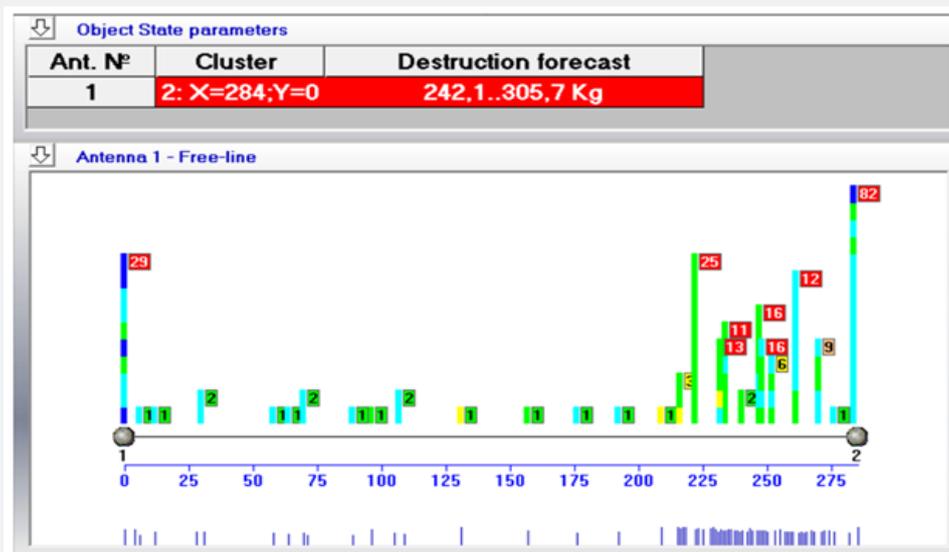
Figure 18: Results of loading the carbon fiber specimen with a built-in AE simulator carbon plate. The prognostic destruction value is shown as 242.1 to 305.7 Kg. The prognostic place of destruction is 284mm. The centers of acoustic activity are shown by flags.

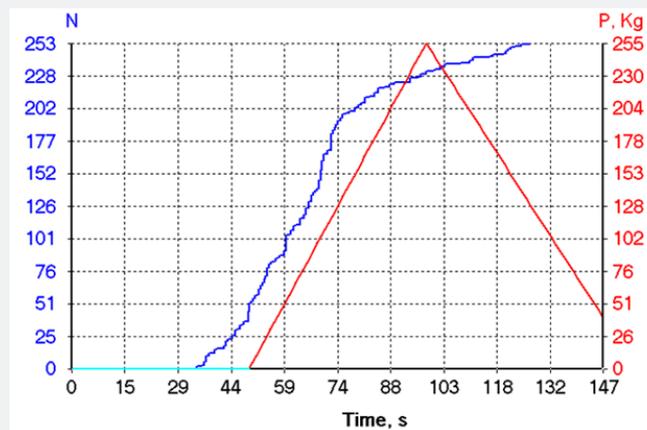
Figure 19: Results of loading of the carbon fiber specimen with a built-in simulator of piezo sensor in time. N-summary curve of AE events, P-loading curve.
