Conservation Process of Two Mural Paintings in El Shinawy Palace

Kholod K Salama^{1*}, Mona F Ali² and Abubakr M Moussa²

Abstract

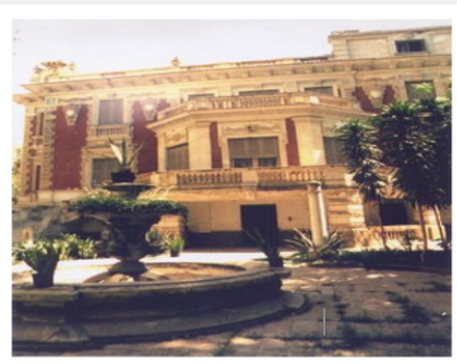
Figure 1: The sinawy palace façade.

The presence of historical palaces is considered the most important monuments which reflect the period circumstances build in. El Shinawy palace (Figure 1) was built for Mohamed Mohamed Bek El Shinawy (a rich merchant-parliament member-senator (the owner of the palace) in the 20th century or to year 1928 the whole space of the palace is 4164 m². That palace is full of all kinds of accurate fine arts (Figure 2). The palace has got an award signed by Mussolini-Italian governor- as the prettiest

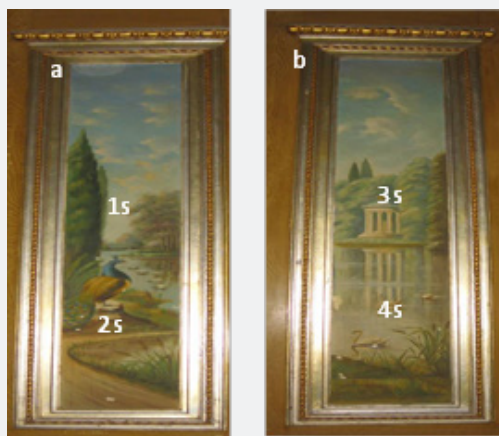
Figure 3: a,b: The two mural paintings in el shinawy palace and samples locations.

Under taken Mural paintings in El Shinawy palace were Rococo style as the colours were light and there is an obvious movement in the birds or in the planets (Figure 3), Those mural paintings exist in food chamber in second floor in El Shinawy palace in El Mansoura city they are rococo style as the colours are light and there is an obvious movement of birds and in the growing of planets their dimensions about 2.27 M X 53 cm with frame it's width 11cm. The current mural paintings in El shinawy palace were exposed to many deterioration factors amongst; the geometrical factors, the environmental factors, the biological factors, the dynamic deterioration factors which includes the

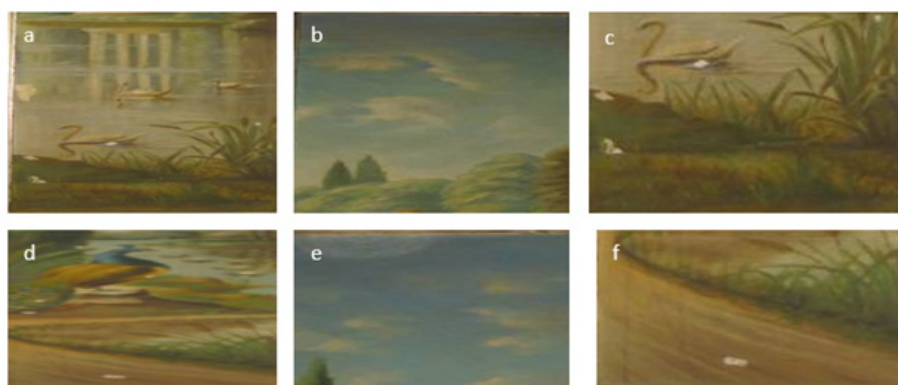
earthquakes and vibrations caused by transportation, in addition to the human made factors. The most common damage is found in the paint layer as a result of moisture; dust is covering those murals because of the long-time opened doors and windows.

The analysis of this painting was carried out in the occasion of the restoration treatment. From the visual inspection the condition of the painting is almost stable, failure in paint layers is the most apparent deterioration phenomenon (Figure 4). Therefore, the pictorial layer suffered from severe loss and color change around the lost areas, grassy spots

Figure 4: a,b,c: The condition assessment of the first mural painting; d,e,f: The condition assessment of the second mural
 a. losing of painting layer.
 b. yellowness in.
 c. grassy varnish spots.
 d. grassy varnish spots.
 e. Blisters.
 f. vital cracks.

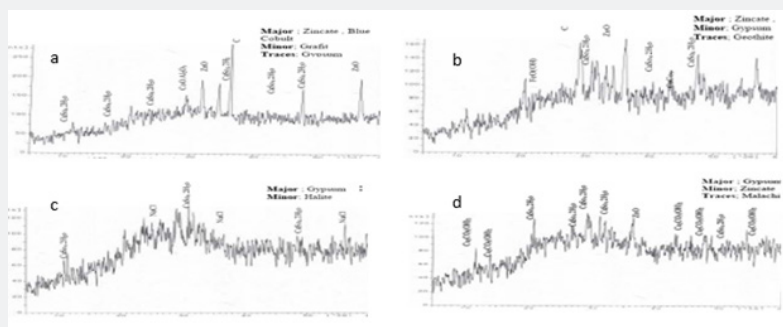
- a. Existence of gypsum in the four samples in different percentage assured that the ground layer of mural paintings was made of gypsum and zincate which used for whiteness.

So, the ground layer is consisted of zincate mixed with gypsum in percentage 2:1.

Figure 6:
 a. X-Ray diffraction patterns of blue sample revealed that the blue color is cobult blue with a little percentage of Grafit applied on the ground layer which consisted of zincate and gypsum.
 b. the yellow color is consisted of goethite and the ground layer consisted of zincate and gypsum.
 c. X-Ray diffraction patterns of sample of the ground layer which consisted of gypsum with halite.
 d. the green color is malachite applied on the ground layer which consisted of zincate and gypsum.

c. The yellow color is Goethite, the green color is the malachite, the blue color is cobult, (Figure 6) (Table 1).

d. Halite constitutes of the ground layer in 40% that result assured the occurrence of deterioration which can cause detachment in the future [2], which caused the detachment of painting layers or blisters Ashurst [3] by XRD as well as the calcite crystals are homogenously connected with big crystals of quartz.

The Conservation Possess of the Mural Paintings: XRD analysis revealed that the ground layer is full of salts with high percentage because of The solubilized salts in the groundwater rising in walls, the daily sun light or the high artificial light dried out the paintings, so the salts crystalize and recrystallize, becoming bigger and so causing interior pressure leading to the detachments of paint layers [4], First of all stopping the rising of groundwater in walls by albumin strips (the water stopper).

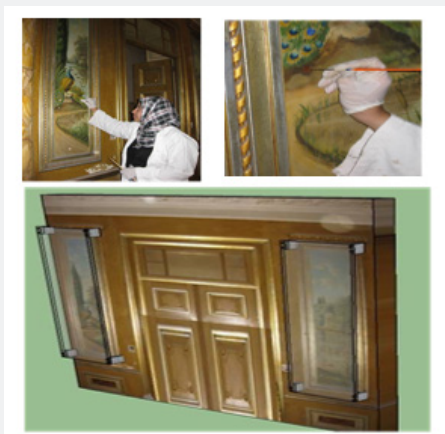
Figure 7:

- The cleaning step.
- The retouching step.
- The final view of the special glass on mural paintings.

- Cleaning using soft and hard brushes (Figure 6).
- Chemical cleaning using acetone for the hard stains.
- Consolidation using Beva371 with concentration. 3% [5].
- Retouching the paint layer using the suitable colors.

The Suggested way to Protect the Mural Paintings at El Shinawy Palace: This palace is preparing to be museum so the paintings Mural paintings must be protected by covering them with flat glass this method used widely in tombs in Luxor and Aswan to prevent visitors from touching the painted layers the flat glass must be light weight glass, smooth, high resistance for breaking and scratches as well as high transparent, it should also cutout all the harmful radiations and with suitable thickness (Figure 7) [6,7].
