Technique of Interpretation of Point of Impact Injuries by Using Helmet Deconstruction

Autopsy & Forensic Services, Inc, USA

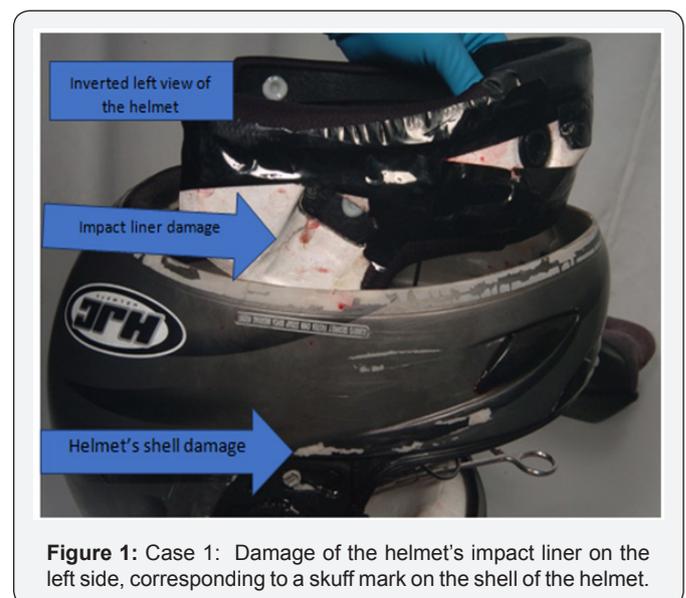
successfully removed, the damage was matched to the damage on the exterior of the helmet. As seen in Figure 1, a fracture of the impact liner corresponded to a scuff present on the outside of the helmet [1].

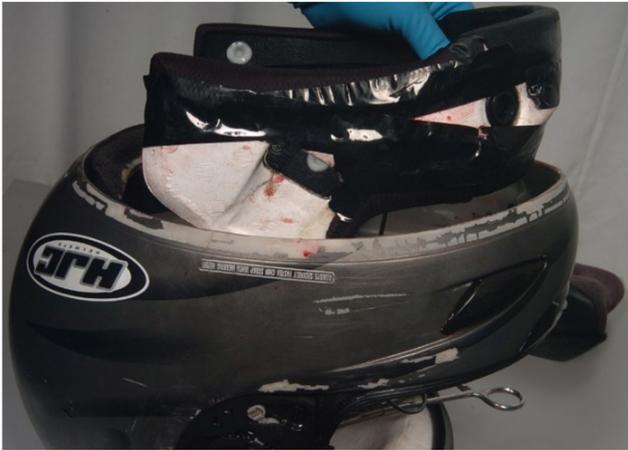
and autopsy showed injuries consistent with motorcyclist head impacting the truck resulting in the left temporal bone fracture. Matching of the injuries of the skull and the impact liner of the helmet are documented in the composite Figures 2 & 3 below.

Figure 2: Matching left impact liner damage with the left temporal bone fracture.

We ruled out the theory of the motorcyclist being run over by the truck, which a witness had testified to seeing. In this case, the helmet deconstruction was necessary to determine the single point of head impact on the helmet, and the impacting object (either the vehicle structure or the ground along with the vehicle tire).

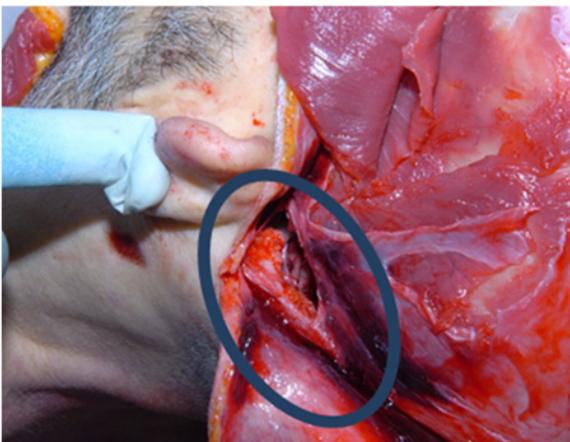
Figure 3: Fracture of the left temporal bone circled above.

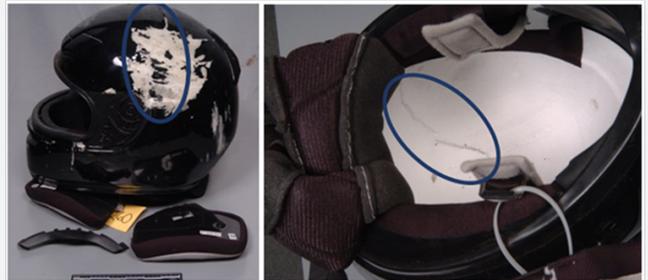
showed damage to the leftside of the front of the helmet. This damage matched the skull injuries found during the autopsy of the decedent. In addition, the victim was found lying on the leftside of the face, consistent with her injuries and the damage to the helmet. According to the prosecution, the motorcycle was going at least 85 mph when it collided with the fence. After the collision, the passenger was ejected and landed where she was later found with her helmet several feet away from her.

The defense’s version of events is slightly different. According to them, the motorcycle could have been going between 40-50 mph when it impacted with the fence. After the impact, the passenger was dragged until she reached her final resting place because the trajectory of the motorcycle post-impact could only have ejected her to where she landed at a slower speed. Since the prosecution and defense’s theories about the initial speed of the motorcycle and the way the decedent got to her final resting place were so different, the investigation of the damage done to the helmet and the head injuries helped solidify what really happened (Figure 4).

Figure 4: Damage to the left helmet shell and impact liner.

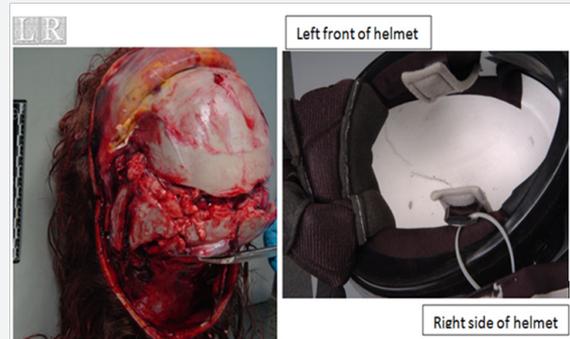
Figure 5: Damage of the skull compared to damage of helmet liner.

Matching of the injuries of the skull and the impact liner of the helmet are documented in the composite Figure 5 below. In this case, the medical examiner would not be able to determine the point of impact to the head based on autopsy alone. Deconstructing the helmet the decedent was wearing during impact clarifies the point of impact based on the helmet damage that corresponds with the decedent’s left parietal/temporal area. After the impact, the injury then continued along the back of the skull.
