# Rocks Fall in the Cape Aokas (Bsjaia): Geological Study Contribution and Reinforcement of the Rocky Slope

The Cape Aokas situated in the oriental coastal region of Béjaïa city (Algeria). The cape takes its origin from the babor mountain chain to the Mediterranean Sea along the Aokas city. Its relief is characterized by abrupt slopes. On May 9th, 2005 rocks fall in large mass (20,000 to 30,000m<sup>3</sup>) from one of the walls constituting the cape, blocked traffic on a busy road (RN° 9) at the entrance of Aokas city. The excavation work of fallen rocks was quickly undertaken by the authorities: 23 days after the rock fall, the road was reopened to traffic. The topometric monitoring was implemented between April and September 2014 during the summer. The reflection was started to find the best way to strength permanently the rocky slope. In this paper, we present a comparison between the stabilizing system applied to the rocky slope and an optimization proposal in both following cases: without earthquake and under reference earthquake solicitation.

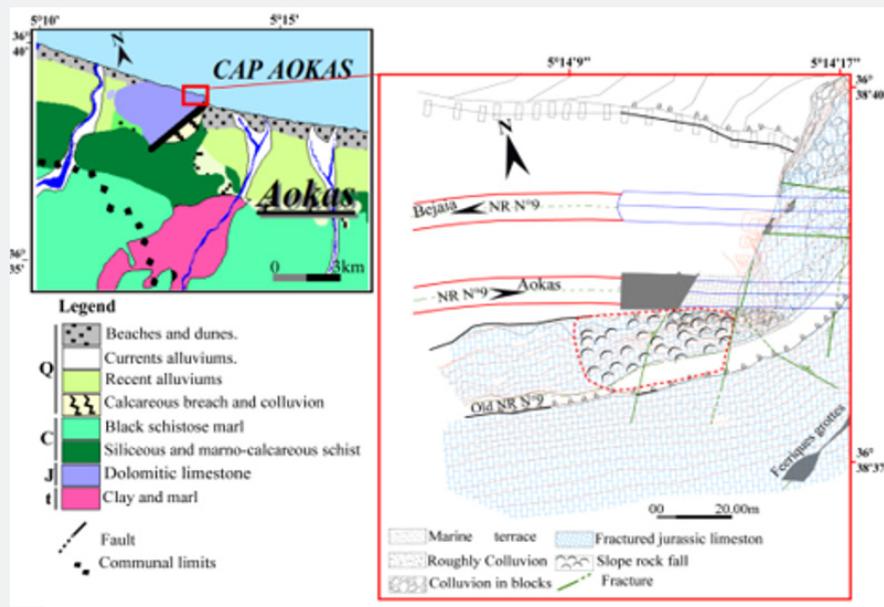
Figure 3: Geologic map and schematic plan of the study area.

Aokas city is bordered in the west by a limestone massif of the Lower Jurassic [1]. These hard limestones, of dark grey color and brown patina form the skeleton of the Mount Imma Tadrart (Figure 3). Most of the outcrops show intense deformations which expressed themselves by fractures more at least closed and papered with calcite and with deposits of iron oxides. A feature of Calcareous breach fairly homogeneous and finely cemented intercalates into this massive limestone. They probably correspond to a weakness area [2]. Locally, coarse

The calcareo-dolomitic massif of Cape Aokas is affected by a strong deformation due to the Miocene alpine paroxysmal phase [4]. It is crossed by a big vertical fault N010 °E (Figure 3). The fault extension towards the south bounds the massif calcareous and controls its morphology. It is characterized by a thick zone

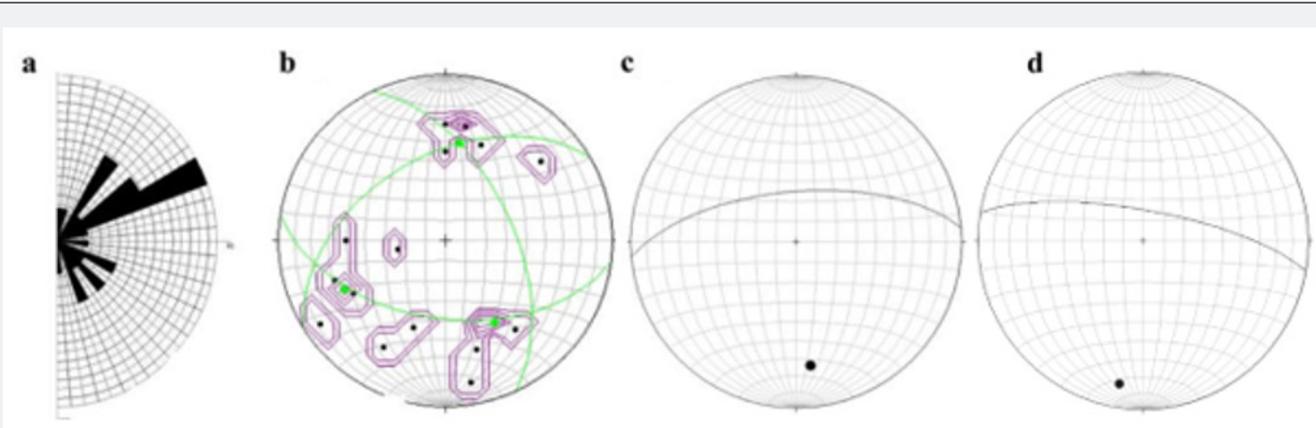
of breaches. Two families of faults were identified. The first one presents a direction N015 °E to N045 °E; it is about faults having replayed into normal faults (Figure 5), at the origin of break mechanisms in the versant of sliding plan type to the northwest [5]. The second family presents a direction N080 °E to N100 °E quasi-parallel to the cliff forehead.

Figure 5: a) Rosette of the fractures frequency in surface. b) Stereographic projection of the in-surface fractures. (Canvas of Schmidt, lower hemisphere) [5]. c) Cyclographic trace and pole of rocky sliding plan. (Canvas of Schmidt, lower hemisphere). d) Cyclographic trace and potential plan pole before sliding. (Canvas of Schmidt, lower hemisphere).

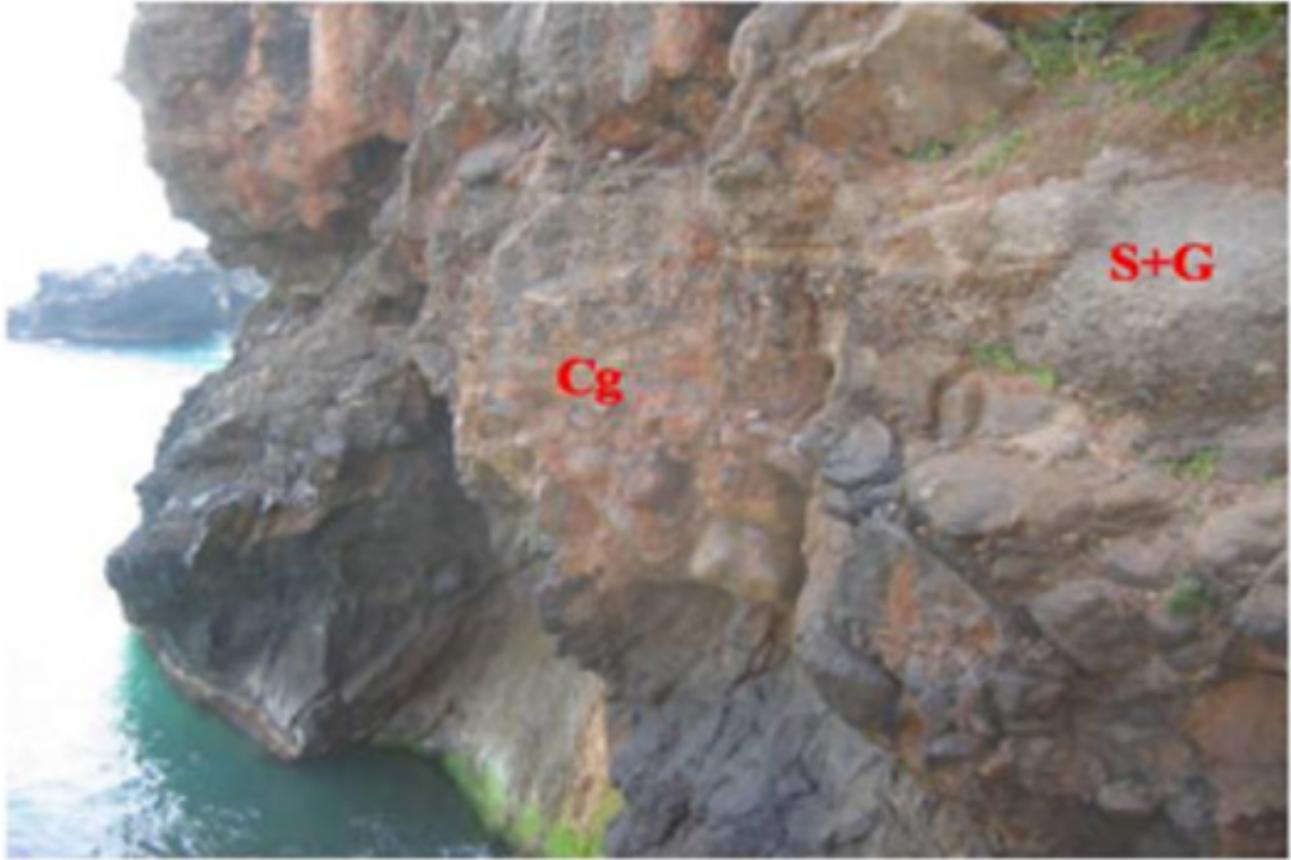
The Figure 6 shows the fracture caused by the tectonic constraints undergone by the rock during its geologic history. They present, generally, the same orientation as the fractures families observed in the Cape Aokas tunnel [2,5,6]. These

fractures are replayed to the faults collapses. The third fracture family is oriented N120 °E to N155 °E with a dip of 44° to 50° to the northeast. The opening spaces and discontinuities are very

variable; they contain calcite crystallized and iron oxide deposits [5].

**Figure 6:** Conglomerates (Cg), sands and gravels (S+G), quaternary, marine, near the shore.

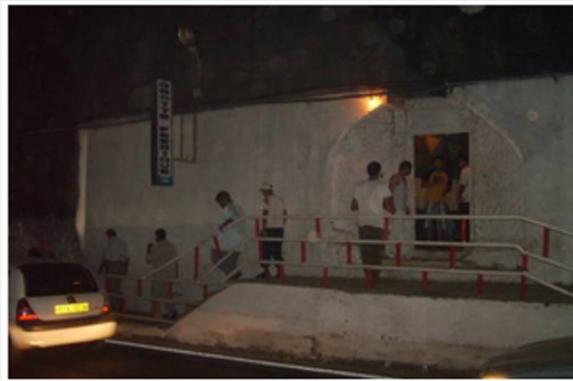
A Jurassic limestone particularity of Aokas Cape is the presence of natural dissolution cavities. The fairy cave, where the entrance is situated in the tunnel (Figure 7), nearby the place where the rocks have fallen, witnessing the strong aptitude of this training to the karstification.

Figure 7: Entrance of the fairy cave.

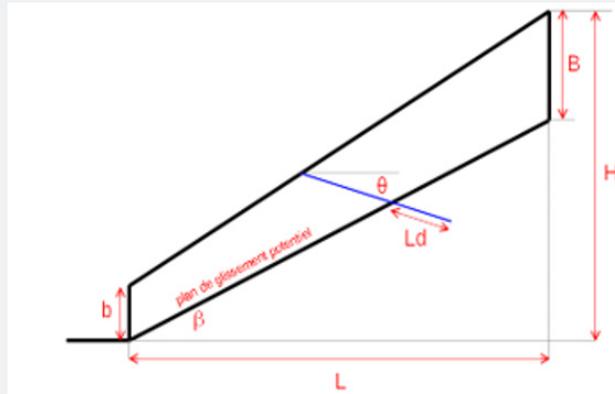
Consider the hypotheses exposed above and those exposed on the schematic (Figure 15) and in the Table 2 below, the rocky slope safety factor towards the sliding plan, noted C<sub>s</sub>, can be calculated in the equilibrium limit according to the following relations:

Figure 15: Plan of the rock fall slope with the potential sliding plan (F1).

The reinforcement rests on small diameter bars (without consideration the reduction bound to the corrosion), in steel very stiff and according to a small dimensions square stitch, induced an intense cutting of the rock massif. The remainder of article presents a possible optimization of the nailing.

The bars implementation an equal diameter of 50mm (with a reduction of 8mm in diameter among 100 years due to the corrosion) and of elastic limit equal to 500MPa, with an average square stitch of 2,04m x 2,04m, allows to result in equal safety coefficient in:

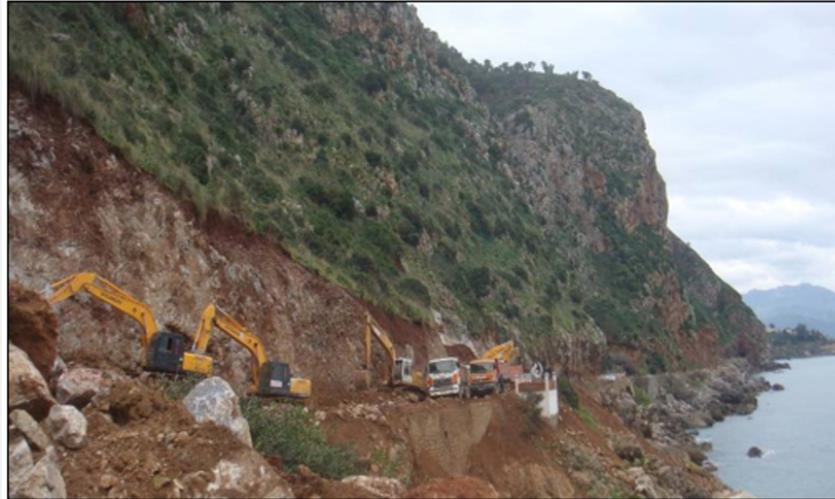
Figure 19: Widening works of the RN43 (calcareous cliff of the Melbou ledge).

In the study term of the reinforcement project of the rock fall scar of May 2005, the various aspects (geology, fracturing of the massif, the seismicity and geotechnical) allowed us to end in a detailed analysis of the slope stability. Small diameter bars (without consideration of a possible reduction bound to the corrosion in marine environment), very stiff steel and a small square stitch (induce an intense cutting of rock massif). The reinforced slope will have to be considered as a sensitive structure and be the specific surveillance object by the contracting authority (Periodic inspections, follow-up by infrared geodesic measures). This new rock falls put in evidence the necessity of detailed diagnosis towards the rocky risk on the threatened whole section of the NR9, on a linear about 1, 2km. A particular attention will have to be given to the strengthening sizing by passive nailing of the unstable rocky slope in the Melbou ledge after the completion works of the NR43 extension (Figure 19), situated in approximately 15km east of Aokas area.
