Effects of Overused Top-hammer Drilling Bits

Seunghyuk Hwang¹ and Hyongdo Jang^{2*}

Abstract

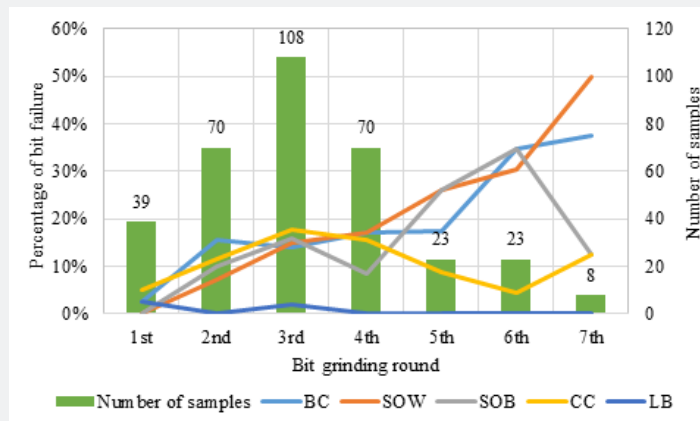
It is an apparent theory to propose that the more often a bit is ground, the more likely the bit will fail. This can be proved via calculating the percentage of failure modes in each round of grindings (NG) which is demonstrated in Figure 3 including the number of samples in each grinding round. As can be seen from Figure 3, the number of samples is steadily increased to the 3rd grinding round and rapidly drops after 70 in the 4th grinding. Given that the bits had been consistently collated from one mine, one can expect that the number of recyclable bits was gradually reduced after 3rd grinding round. In other words, bits were gradually discarded due to the accumulated damages through three rounds of grinding and reuse. Except for the LB failure mode (less than 2 or no occurrence), the percentage of bit failure modes is gradually increased up to 3rd grinding round. The percentage of BC and

SOW type failure modes is steadily increased up to 7th grinding round while the percentage of CC and SOB type failure modes is fluctuated between 5th and 7th grinding round due to the lack of samples. The BC, SOW, SOB, and CC can be recognized as the major bit failure modes as they have frequently appeared through the data collection. The relation between the number of bit grinding round and the percentage of bit failure can be analyzed via the linear regression analysis as demonstrated in Figure 4. The analysis was conducted excluding the 7th grinding data of SOB and the 5th to 7th grinding data of CC as they show abnormal trends due to small number of data sets. As a result, the grinding round and the percentage of bit failure shows a very high correlation with the correlation determination (R²) of 0.86. This result proves the higher number of bit grindings will cause a higher frequency of bit failures.

Figure 3: Relationship between the numbers of bit grindings and percentage of failure occurrence with all failure modes: Button chipped (BC), Sheared-off with body level (SOW), Sheared-off below body level (SOB), Cracked carbide (CC), Lost buttons (LB), Failure at skirt (FS).

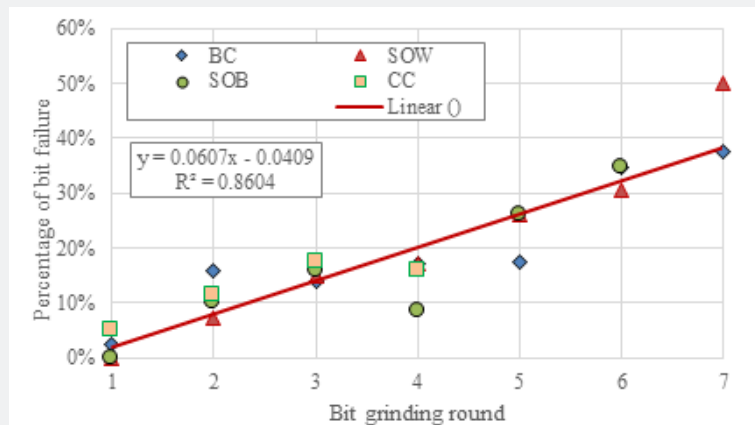
Figure 4: Linear Regression of the Bit Grinding Rounds and the Percentage of Bit Failures.

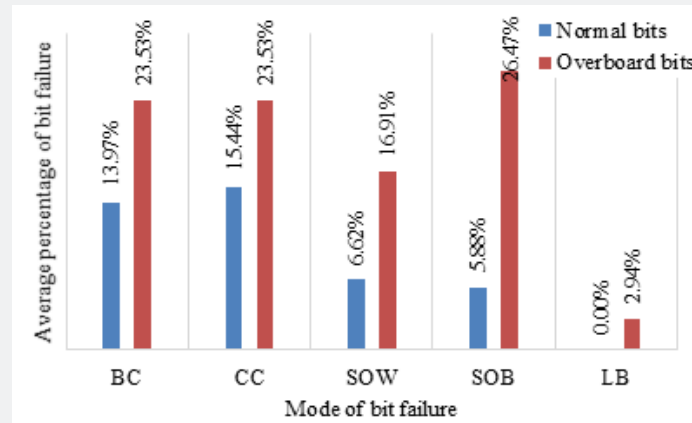
wear flat of buttons was less than 30% of the button diameter. The comparison has been conducted using the average percentage of bit failure of 1st to 7th grinding rounds in each failure mode. As a result, the average percentage of failures for normal and overboard bits were compared in Figure 5. The overboard bits significantly increase the chance of bit failures. As shown in Figure 5, the av-

verage percentage of bit failure of the overboard bit in BC, CC and SOW types of failures increases to 23.53%, 23.53%, and 16.91% respectively. The results are 1.68, 1.52, and 2.56 times higher than the average percentage of normal bit failures. Furthermore, the

overboard bits significantly increase the average percentage of SOB type bit failure to 26.47% which is 4.5 times greater than the average percentage of the normal bit failure (5.88%).

Figure 5: The Average Percentage of Bit Failure of Normal and Overboard Bits in five Typical Bit Failure Modes.

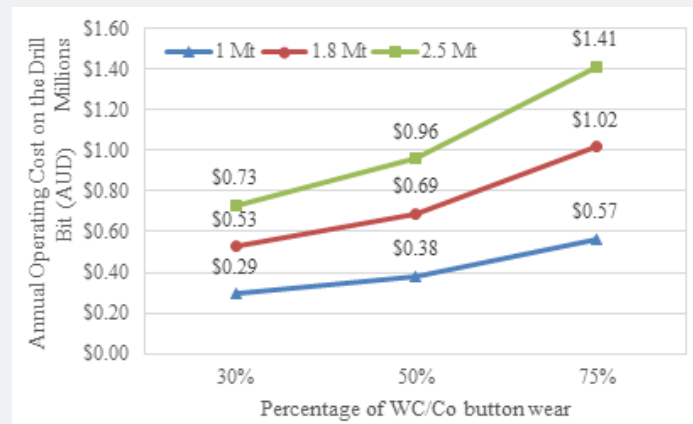
Figure 6: Annual Operating Cost Comparison in Different Production Rate and Percentage of WC/Co Button Wear of Rock Bit (ST68-102mm by MMTC).

calculated as \$1.6 per metre while CPM of 75% overboard bits is calculated as \$3.1 per metre. The annual operating cost increases as the production increases. The cost increments of 30% and 75% WC/Co button wear in the annual production of 1.0 Mt, 1.8 Mt and 2.5 Mt are calculated as \$0.28M, \$0.49M, and \$0.68M respectively. The results explicitly show the cost loss of using overboard bits. Given that the increasing bit failure percentage of overboard bits compared with normal bits, the cost loss would be significantly increased when bit wear is improperly managed.
