Research Article

Unusual Puncture Marks on Poly Vinyl Tubing – A Case Study

Ramakrishnan PN*

Department of Physics, Directorate of Forensic Science, India

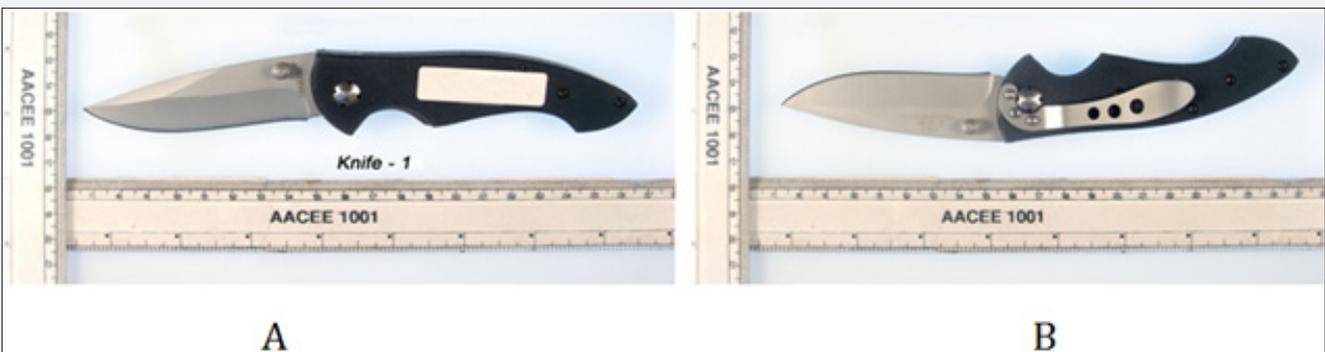
24 was utilized for making test cut marks on P.V. tubing. The Figure 1A and 1B shows the relatively thin blade single edge knife with choil.

Figure 1: A: Thin blade single edge (Reverse), B: Thin blade single edge knife (obverse).

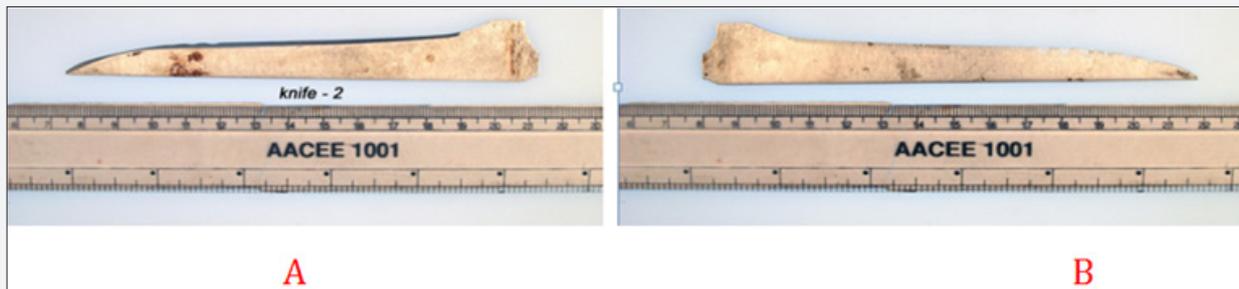
ii. The Figure 2A shows the relatively thin blade knife with serrated single edge blade whose handle is broken near the choil. The cutting edge is serrated up to the full length of the blade and is clearly visible in the Figure 2A and Figure 2B. The Figure 3A shows a very thin end sharp blade knife commonly used for surgical application with the provision to remove the blade as seen in Figures 3A & 3B.

Figure 2 : A: Thin blade single edge (Reverse), B: Thin blade single edge knife (obverse).

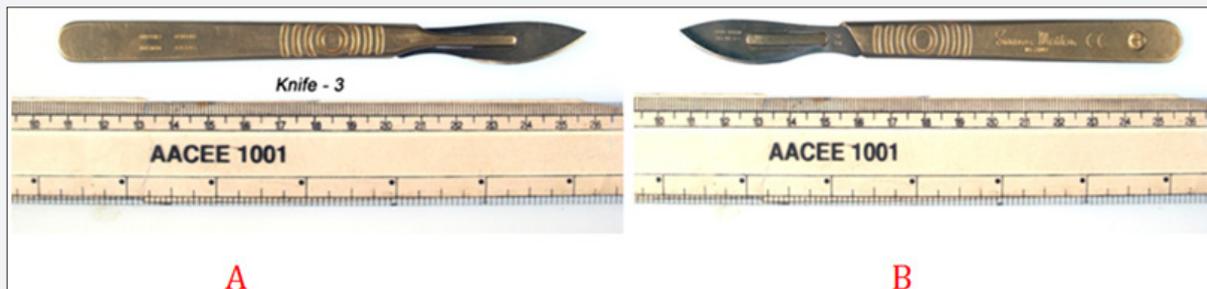
Figure 3 : a: Thin end sharp blade surgical knife (reverse), b: Thin end sharp blade surgical knife (Obverse).

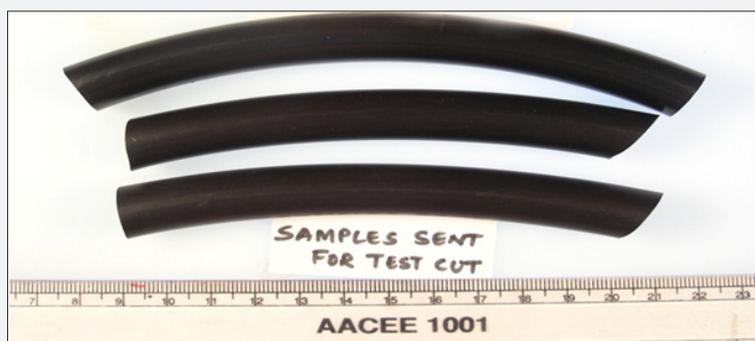
Figure 5 : polyvinyl tubing (for test marking).

iv. The Figure 5 shows the black colour, 1.7mm thickness and 12mm diameter cylindrical polyvinyl tubing cut and sent by the Investigating Officer (I.O) for the purpose of laboratory test cut marks.
