## Mini Review

# Phenomenon of initial brittle crack in high cycle fatigue

**M. Sc. Dzubiella-Fett Laura, THM Mr. Pfeil, Lothar THM, Mr. Moritz Rädels and THM Prof. Dr.-Ing. Jörg Gollnick\***

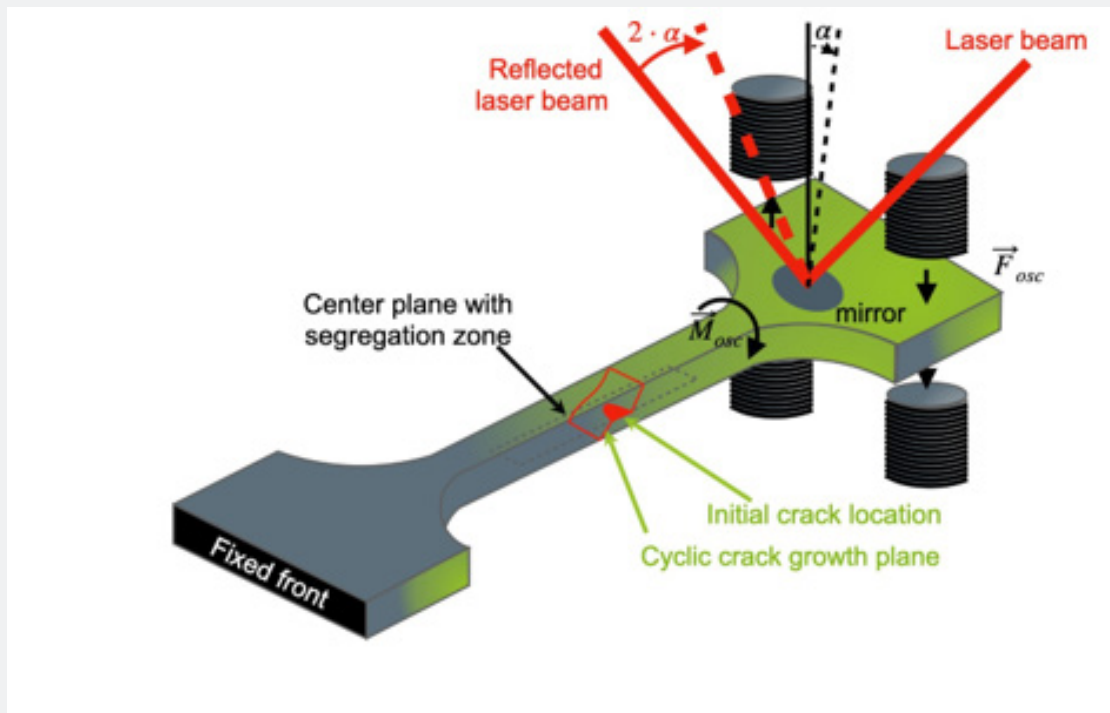
Thin-walled structures, made of valve sheet material 1.1274 Ck101 are tested under torsion, Figure 1.

Figure 1: Schematic test setup.
