Groundwater Level Estimation for Slope Stability Analysis of a Coal Open Pit Mine

Salih Yüksek^{1*} and Ahmet Şenol²

Keywords: Open pit mine; Slope stability; Underground water level; Conceptual model

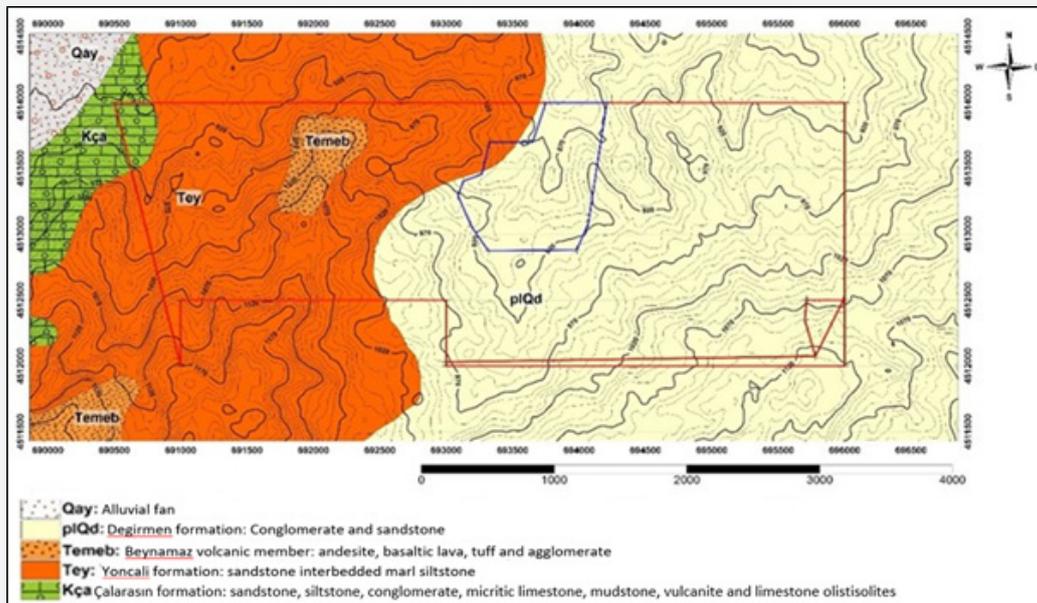
Figure 2: Geological map of the study area [6] (modified from MTA map).

The geology of the study area and its surroundings was investigated by a state-owned mine investigation and exploration institute-MTA. In the study, five different geological formations were defined stratigraphically from young to old or from top to bottom, namely the Alluvial fan (Qay), Degirmen formation (plQd), Beynamaz volcanic member (Temeb), Yoncalı formation (Tey) and Çalarasın Formation (Kça). The geological map of the region, including the license area and the operation area, was modified from the geological map (G34 map) prepared by MTA and shown in (Figure 2). The coal formation extends from the southwest to the northeast and is located within the marl, siltstone and sandstone units called the Eocene aged Yoncalı formation. There is conglomerate, sandstone, siltstone, claystone, mudstone, slope debris and alluvial fan materials of approximately 50 m thickness

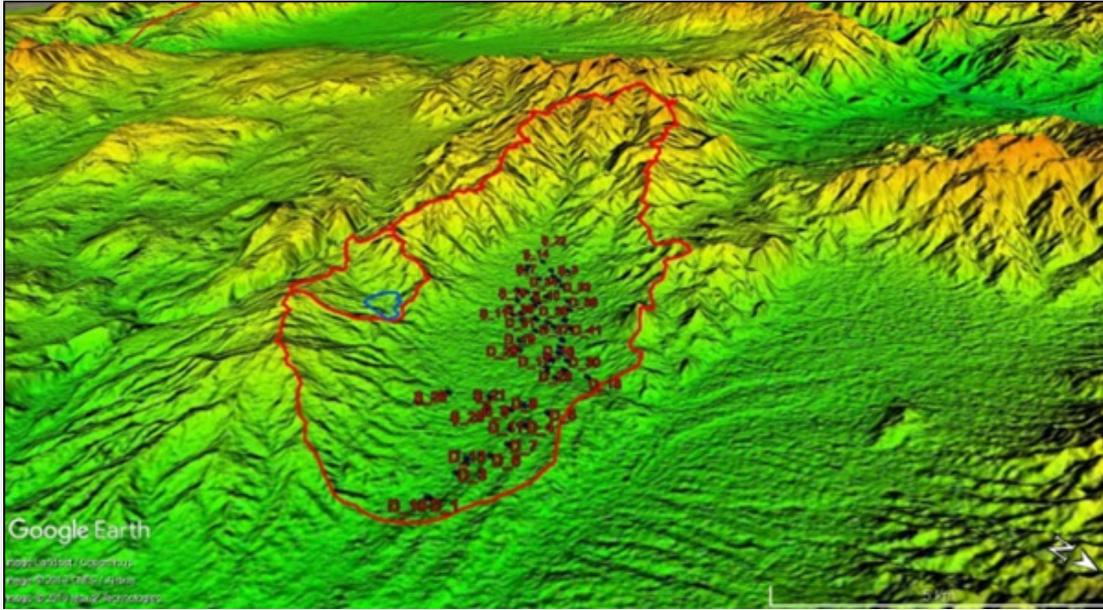
Figure 3: Distribution of water drillings in the operation site (blue line), the large basin, the operation sub-basin and the southern plain.

The part of Amasya within the Yeşilırmak basin is divided into 7 sub-basins/plains, namely Merzifon-Gümüşhacıköy plain, Suluova, Taşova, Geldingen plain, Göynücek plain, Mecitözü stream valley and Aydınca plain, considering the hydrogeological characteristics. The Hamamözü Stream Valley sub-basin, which also includes the Hamamözü district, and the Devret valley sub-basin, which stretches along the northwest of the Gümüşhacıköy district, are also within the Kızılırmak basin. Merzifon-Gümüşhacıköy plain is the region where the most groundwater level changes are experienced in the groundwater basins in Amasya [8]. There is no water well in the operation site and its vicinity. However, in the northern part of the field, in the settlements of Ovabaşı, Çitli, Diphacı, Koç, Bulak and Alicik sub-districts, a total of 70 water wells of varying depths have been drilled for use and irrigation, 44 of them by DSI 7th Regional Directorate and 26 of them by individuals. The locations of these drillings and the perspective view of the operational site boundaries are shown in (Figure 3).

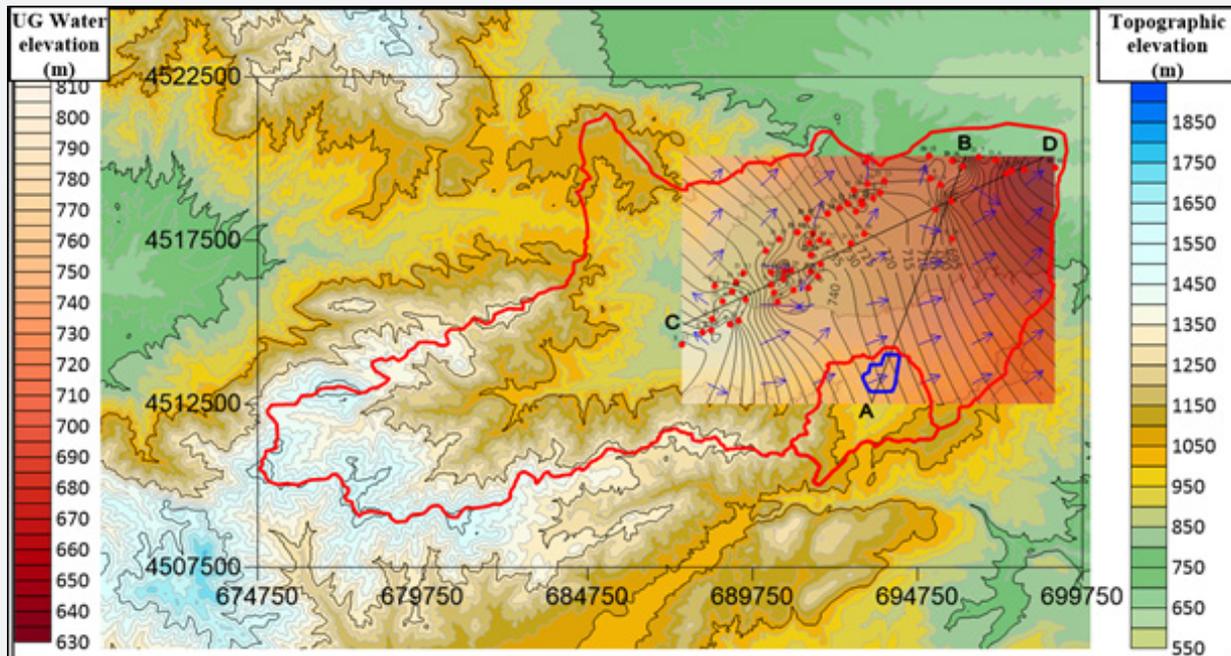
Figure 4: Topographical map of the region, large recharge basin and sub-feeding basin of the mine site, water well locations, Groundwater level and flow directions map.

the mouth elevation. In this case, the quarry floor elevations are 104m above the nearest groundwater level. On the other hand, the underground water map of the region was created by using the existing water well elevations in the plain. The precipitation basin, license boundaries, water wells, topography, groundwater level map and water flow directions of the region are shown in (Figure 4) collectively. The A-B section in the south-north direction

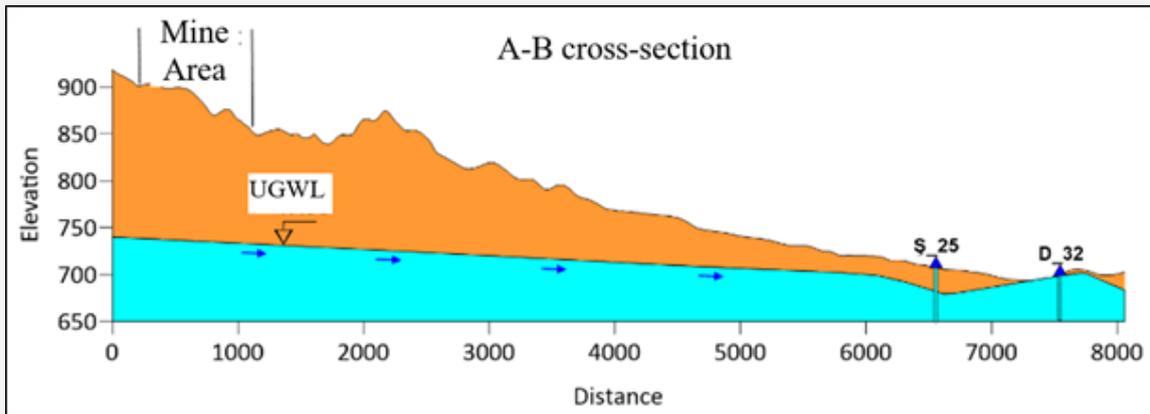
Figure 5: Sectional view of the topography and groundwater level in the south-north direction.

passing through the quarry is shown in (Figure 5) and the C-D section in the southwest-northeast direction is shown in (Figure 6). When the sections are examined, it is seen that the operation elevations of the mine site are quite above the groundwater level. However, since there are no water wells in the vicinity of the mine site, this interpretation is made according to the water well data in the plain area.

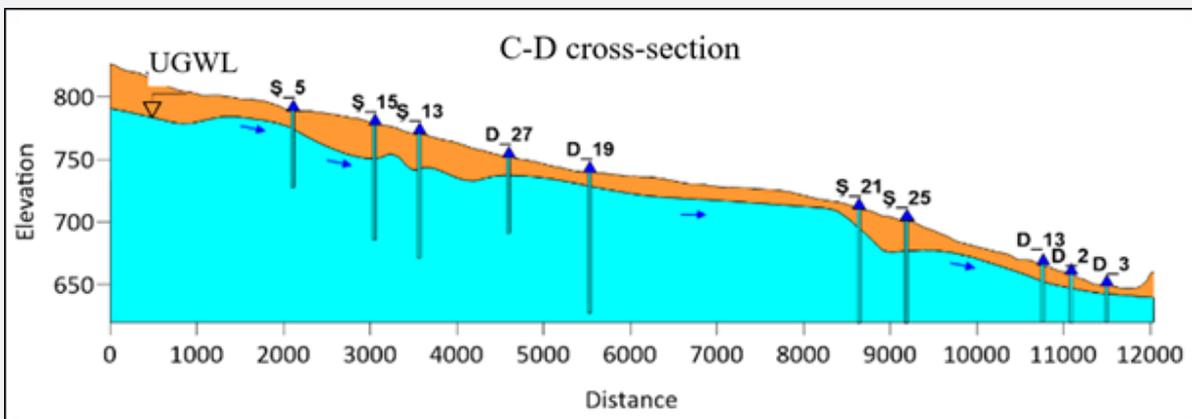
Figure 6: Sectional view of the topography and groundwater level in the southwest-northeast direction.

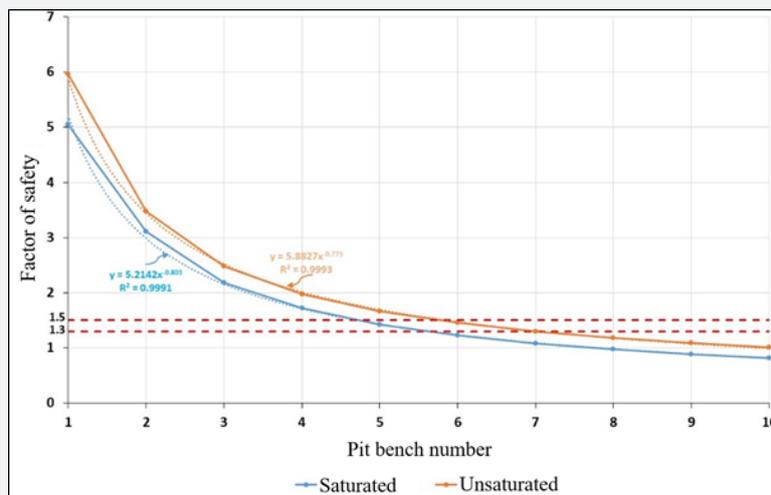
Figure 7: The relationship between the number of benches and the factor of safety for the marl unit saturated and dry condition.

In the previous section, it was determined that the groundwater level was well below the operating levels. However, since there is no water well in the operation license area, there is no clear information about the groundwater situation in this area. For this reason, the mining direction is to the east, and slope analyses have been made for the three units located in this direction, using the project pressure geometry (width and height: 8 m, step slope angle 60°) on the coal for fully saturated and waterless condition with groundwater. In (Figure 7), as an example, changes in the safety factor calculated according to the Janbu simplified method for the marl unit in the saturated and dry condition are shown. As can be seen from the figure, according to the project step dimensions, the safety factor or safety number for 10 benches is greater than 1 if the environment is completely dry, while the safety number is less than 1 if the environment is completely saturated with water. If the safety factor is taken as 1.3 or 1.5, the number of stable steps decreases to 4 in the saturated state. It is estimated that there is a highly correlated exponential relationship between the number of steps in the saturated and dehydrated condition and the safety factor.
