Guidelines for Restoring Fractured Central Incisors

Imen Kalghoum, Ines Azzouzi, Hadyaoui Dalenda*, Belhssan Harzallah and Mounir Cherif

Department of Fixed Prosthodontics, University of Monastir, Tunisia

Faced with fractured central incisors, many solutions are available and the practitioner has to choose the appropriate one. Rehabilitation of the compromised teeth number 11 and 21 was performed with lithium disilicate veneers. The purpose of this clinical case is to outline the treatment approach and to highlight the different guidelines to establish function and esthetic using ceramic veneers.

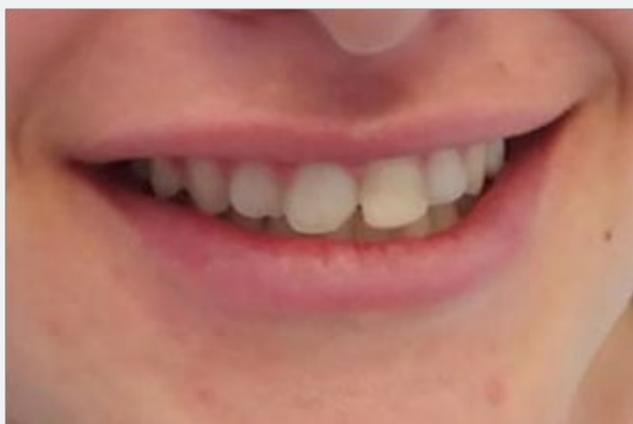
Figure 1: Extra-oral view.

history of the patient along with preoperative photograph was taken (Figure 1). Medical history was non-contributory. Extra oral examination showed an ovoid face with a convex profile.

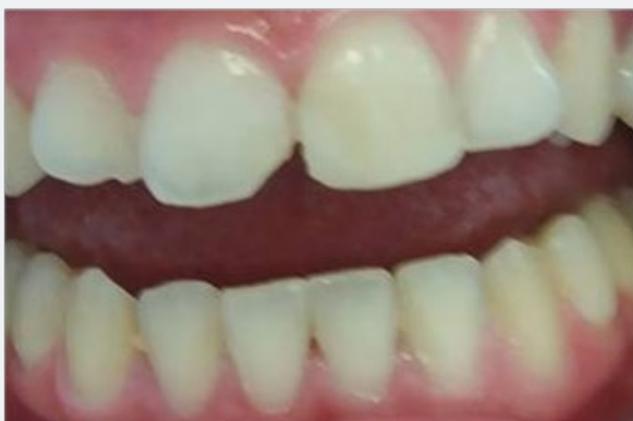
Figure 2: Facial view of fractured central incisors (Right incisor was restored by composite).

Intraoral examination revealed that the right central incisor was fractured in the middle-third of the crown, involving enamel and dentin without pulp exposure (Figure 2) and without symptoms of concussion or contusion, The left central incisor was restored by composite but she complained from it repetitive loss.. Oral prophylaxis was done and dental hygiene maintenance instructions were given. Radiographic examination and tooth vitality tests were positive. Anterior guidance was evaluated.

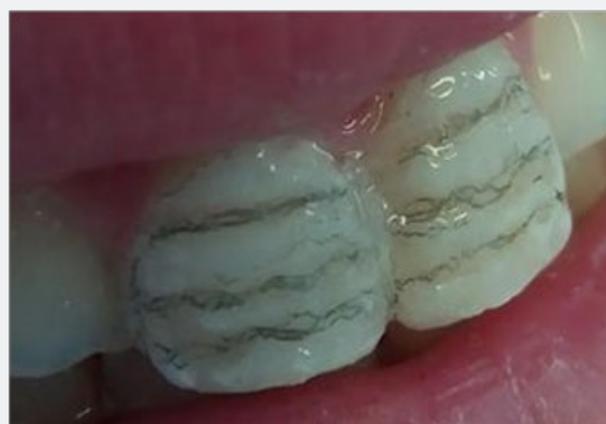
Figure 3: Starting teeth preparation within the mock-up.

Various techniques for accurate tooth reduction have been proposed, including silicone matrices, depth limiting burs and free hand preparation (Cherukara et al. 2005). It is important that whatever tooth reduction guide method is used, it is based on the definitive wax up and not the original tooth. Failure to do this may result in excessive and unnecessary removal of tooth enamel. Tooth should be prepared within the enamel whenever possible. In this case depth limiting burs were used to prepare directly through the bis-acryl mockup, as described by Gurel (2003) (Figure 3). The teeth were prepared with a marginal chamfer labially and interproximally, and a butt fit margin palato-incisally with wrap around onto the palatal aspect as described by Castelnovo et al. 2000 (Figure 4). Contact points were not preserved, in order to allow freedom for the technician to change the width and shape in the final restoration. Ensure smooth finish lines and surfaces, using 40 micron diamond abrasives. A smooth surface avoids stress under the veneer and also a more uniform thickness of cement. This also leads to better adhesion.

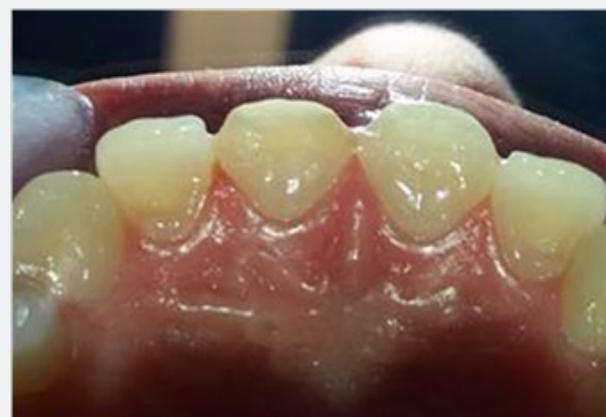
Figure 4: Palatal view of preparation.

After adequate gingival retraction (Figure 4), a two step dual impression was made and sent to the laboratory for fabrication of lithium disilicates (IPS e max cad) veneers.

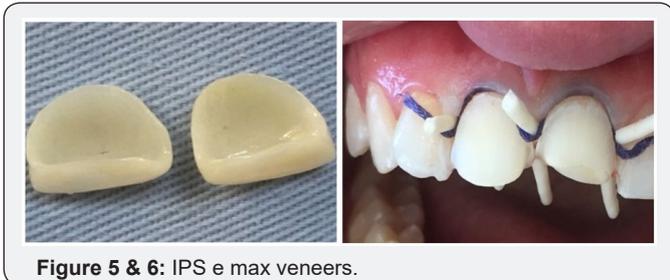
Figure 5 & 6: IPS e max veneers.

Lithium disilicate veneers were aided by computer (CAD), by copying the contours from the diagnostic wax-up (Figure 5 & 6). Veneers were individually checked intra-orally to control gingival

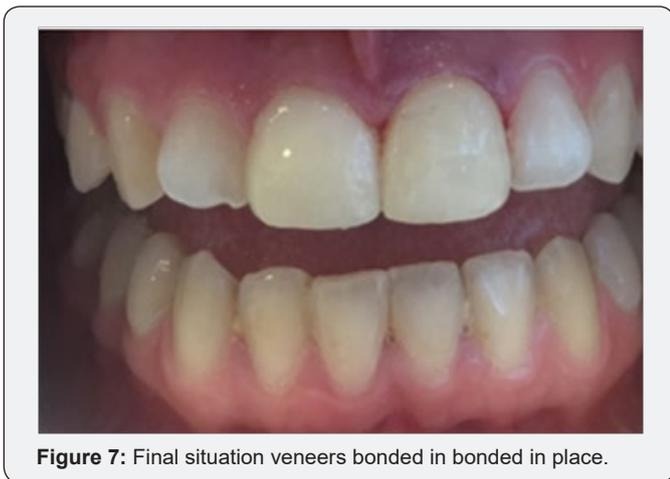
Figure 7: Final situation veneers bonded in place.

At the end of the treatment, the patient was pleased with the results and no longer hides her smile (Figure 7 & 8). Periodic follow-up was scheduled to evaluate the gingival health and patient comfort and satisfaction. (Figure 9 & 10)

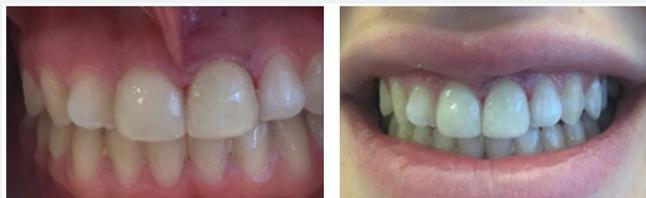
Figure 9 &10: Natural look of teeth restored after two months: Satisfying esthetic outcome: characterizations reproduction, periodontal integration and function.
