Instrumentation Issues and Problems in Earth Dams (Case Study; Shah Qasim Dam in Yasouj, Iran)

Installation and monitoring of instrumentation is one of the practical methods for controlling safety and stability of earth dams. Piezometers existing in dam body and dam abutments are one of the various types of precision instruments used in dams, which indicate the height of water level in different parts of the dam. In order to evaluate the performance of piezometers of Shah Qasim Dam in Kohgiluyeh and Boyerahmad province (in south east of Iran), we compare water level changes in piezometer and water level changes in the dam lake over time. In this paper, the above-mentioned dam is modelled using the SEEP/W software, then after imposing boundary conditions, water levels are computed at various points. For more accurate comparison, water level changes are plotted in transverse and longitudinal piezometers over time. The results of analysis indicate significant increase of permeability in vicinity of some piezometers. The piezometers BX4, BX14, BX13 and SP6, and the region near them, as well as piezometers SP24 and SP18 and their surrounding area, have critical conditions which should

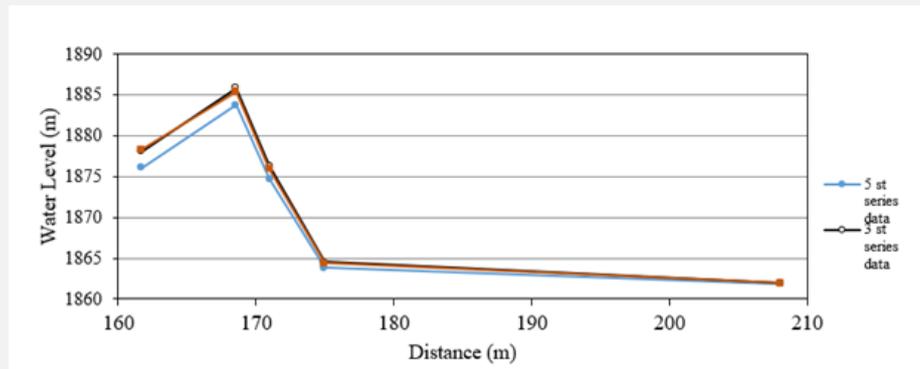
Figure3: C-C transverse axis.

were dysfunctional (Figure 6). At C-C, the water level, moving from SP18 to SP17, suddenly had a high upward jump. Physically, the fluid travels from a point with more energy to a point with less energy; therefore, upstream piezometer should have a higher water level than downstream observational well. In this way, this law was violated. Thus, results of the piezometer SP18 indicate a problem (Figure 4).

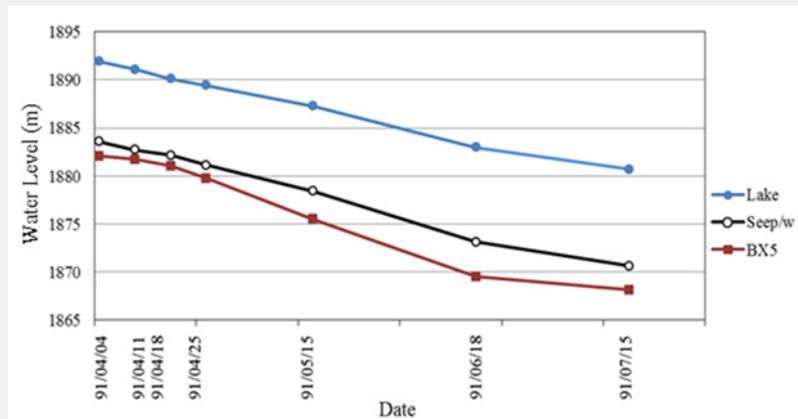
Figure 4: changes in water level of piezometer BX5 over time.

At first, water level variations of piezometers and the dam lake were plotted over time. For example, Table 1 shows variations in the piezometer SP23 and (Figure 3) shows variations in piezometer BX5. At the upper level, variations in observed data and calculated data were similar. At the lower level, observed data was more than calculated data, which was due to increased permeability. Thus, it had logical function.

It can be claimed that it functioned properly. Although the difference was greater in the lower levels, it was not high enough to cause a problem and the piezometer had no problem (Figure

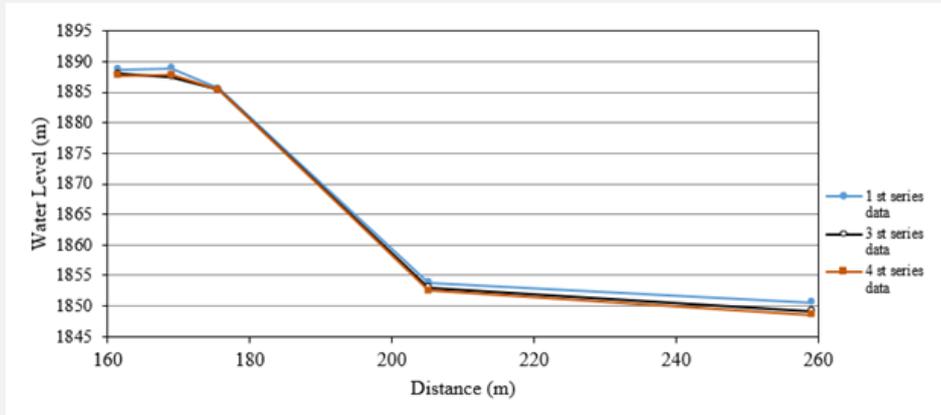
Figure 5: A-A transverse axis.

Figure 5 shows physically proper functioning of the A-A axis; water level decreased with the movement from upstream to downstream of the dam. Physically, water always moves from a higher level to a lower level. Regarding this, the concept of hydraulic gradient is presented by;

fundamental problem requiring rapid examination, because water level in this area is very low; this is despite the fact that these piezometers are located above the dam. Permeability increased in the area surrounding some of the piezometers, particularly near A-A transverse axis.

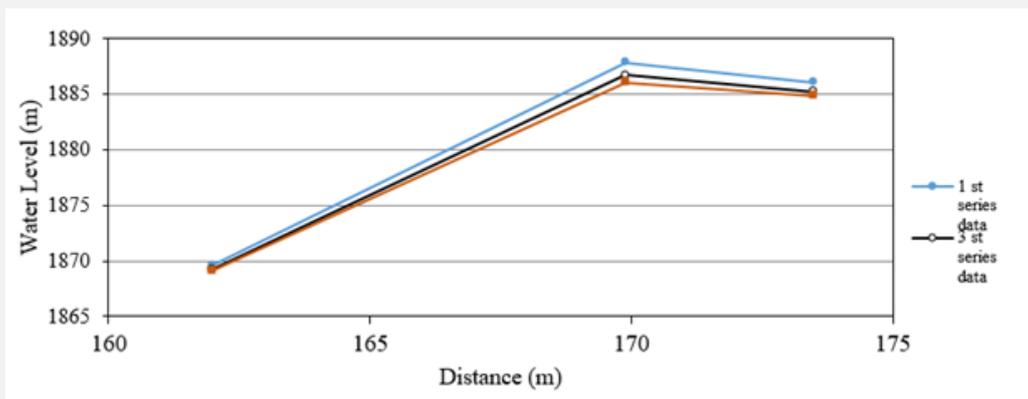
Figure 6: B-B transverse axis.

At B-B axis, water level of the piezometer SP6 was lower than water level of the piezometers SP5 and SP4. Thus, the above rule was violated because the piezometer SP6 was located on upstream, while it had lower pressure equivalent height than downstream piezometers. Therefore, the piezometer SP6 or its surroundings

Function of piezometers is summarized in Table 2. BX4, BX14, BX13, SP6 or close proximity of these piezometers, as well as SP24 and SP18 or the area surrounding these piezometers have a

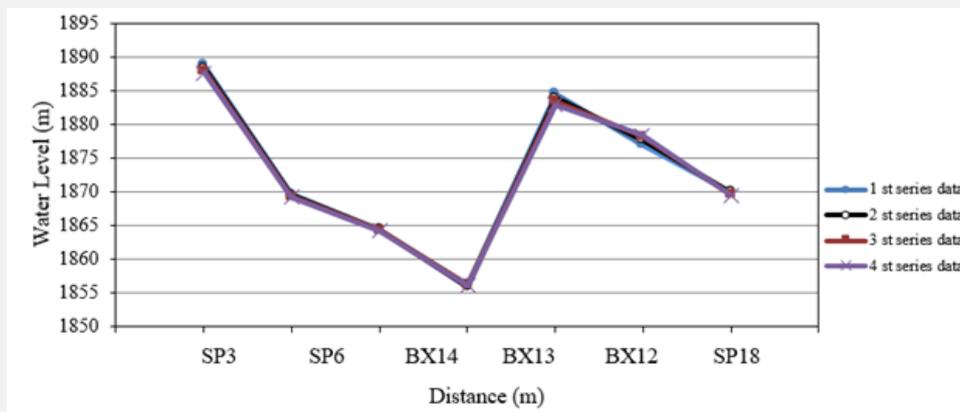
Figure 7: E-E longitudinal axis.

At the E-E axis, only SP3 and BX12 functioned properly and logically. Water level should be close to each other in all piezometers of this axis, while it was 15 m lower in SP6 and SP24, 20 m lower in BX14 and approximately 25 m lower in BX13. Given the close proximity of SP6, BX14 and BX13, a major problem can be expected in this area (Figure 7). All piezometers in the F-F axis functioned logically; permeability increased in their surroundings. Observed water level was more than calculated water level.

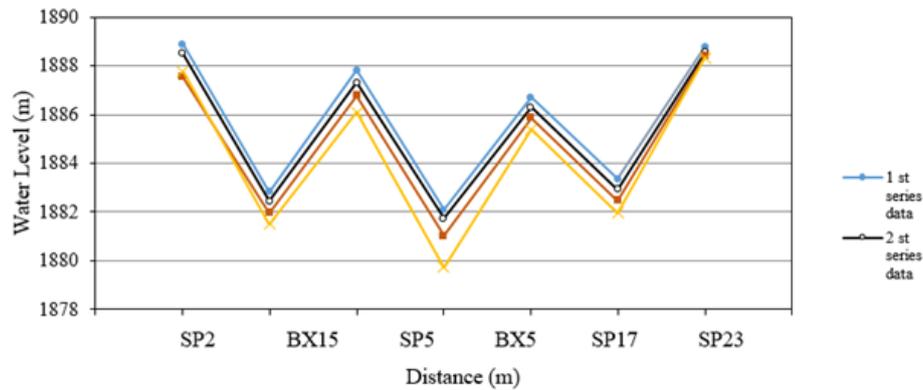
Figure 8: F-F longitudinal axis.

Perhaps the reason for differences in water level of these piezometers can be explained by the difference in permeability along the dam and the fact that permeability changed curly along the dam (Figure 8). At the D-D axis, water level was even lower in

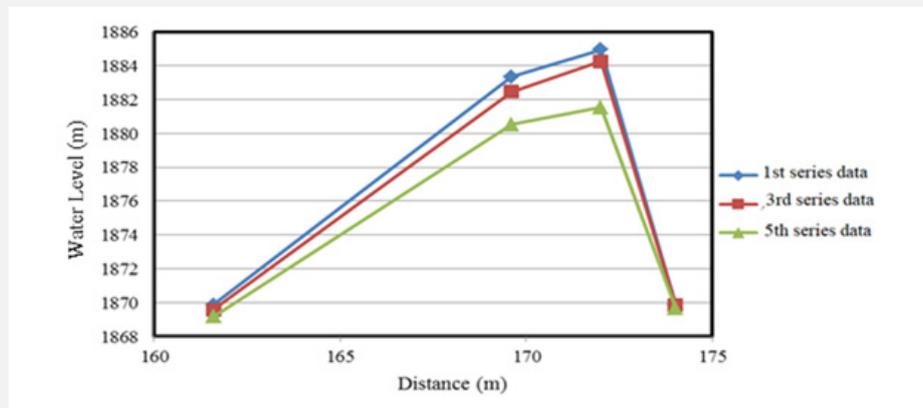
Figure 9: D-D transverse axis.

SP24 than the water level in the last piezometer of this axis and violated physical rules, as well as the SP18. The close proximity to SP24 proves the existence of a problem in the vicinity of these two piezometers or a problem with two piezometers (Figure 9).
