An Unusual Accident during a Molar Extraction: A Rare Case Report Breakage of Surgical Instrument an Uncommon Intra-Operative Complication

Ajit Joshi*, Manu Goel and Mayur J Gawande

Department of Oral & Maxillofacial Surgery, Swargiya Dadasaheb Kalmegh Smruti Dental College & Hospital, India

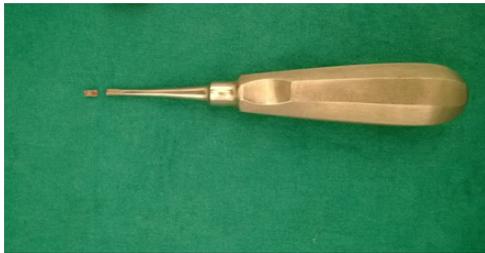
Figure 1: Illustration Broken elevator and its matching fractured piece.

A safe and effective elevator should have extreme values for torque and stress values. Metal instruments used in clinical practise may be subjected to fatigue from sterilization. Standard Autoclave machine should be used for autoclaving and instruments should be kept dry to avoid corrosion, which ultimately weakens the instrument to avoid corrosion [9] (Table 1 & 2).

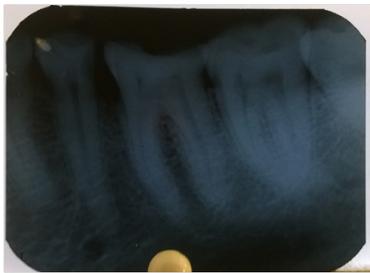
Figure 2: Illustration of IOPA with lower left first Molar.

A 35 year-old male patient reported to the Department of Oral & Maxillofacial Surgery at Swargiya Dadasaheb Kalmegh Smruti Dental College & Hospital, Nagpur with chief complaint of pain in lower left back region of jaw since 1 month. The tooth was firm with long roots (Figure 2). Extraction was carried out with the help of dental elevator (Coupland type). Surprisingly, the elevator's broken edge point was lodged in the mesial part of the first molar from where the elevator was applied. However, it was observed that the dental elevator tip had broken during extraction. The metallic fragment was removed to assure it completed the whole missing part of elevator (Figure 1 & 3). However, extraction was perform with routine dental forceps. Suture and postoperative medication were giving.

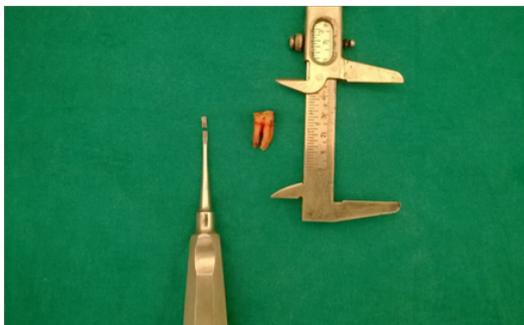
Case report: A 35 year-old male patient reported to the Department of Oral & Maxillofacial Surgery at Swargiya Dadasaheb Kalmegh Smruti Dental College & Hospital, Nagpur with chief complaint of pain in lower left back region of jaw since 1 month. But, it was observed that the dental elevator tip had broken during extraction by operator. The metallic fragment was removed to assure it completed the whole missing part of elevator.

Figure 3: Illustration of extracted molar with broken elevator (Coupland) tip.

Management
Radiological assessment should be practised using conventional or modern techniques available to ensure the foreign body.
Instrument's working end should be examined after every procedure.
If observed broken, it should be retrieved immediately followed by curettage.
On diagnosis at later stage, a surgical removal should be performed under all aseptic precautions.
