# Are the Biomechanics of the Feet Considered Enough in their Contributory Relationship to Leg Length and Femoral Head Height Difference? Advanced Technology Provides New Information

Tim Maggs<sup>1</sup>, Steven Brownstein<sup>2\*</sup> and Alexandros Siozos<sup>3</sup>

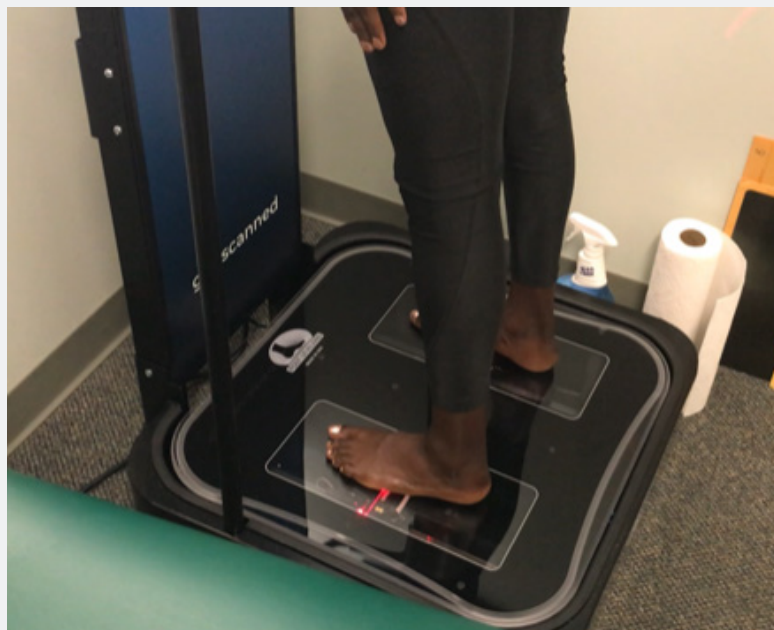
Figure 1: Digital Laser Scan of the feet.

Our 3D scanners use a laser triangulation method to capture true 3D data. It's accurate to within 250 microns, which is one quarter of a millimeter. By capturing the foot with this much precision, we are able to determine imbalances in the plantar vault of one foot to the other. Not only does this provide detailed information for prescribing doctors to discuss with patients but it also gives our lab an accurate depiction of the patient's pedal foundation for crafting custom orthotics (Figure 1). The 3D scanner uses a moving laser to capture the entire plantar surface of the foot, developing a complete topography of the plantar vault. Colorized images are created with red pixels being closest to the laser and blue pixels being farther away. A second pass with a high-definition camera takes a scan of the foot to provide a flesh tone image as well. This allows the provider and our lab to look for sores, lesions, or other foot-related pathology.

- About 6 feet tall
- About 2.5 feet wide
- About 3 feet deep
- Takes 26 key measurements
- 250 micrometers scan resolution
- Uses a Class 2M Diode Laser Product with line generating optics
